Mitigating Earthquake Risk
in Health Facilities

A Structural Vulnerability Assessment of Hospitals in Kathmandu Valley

Kathmandu, Nepal
August 2002

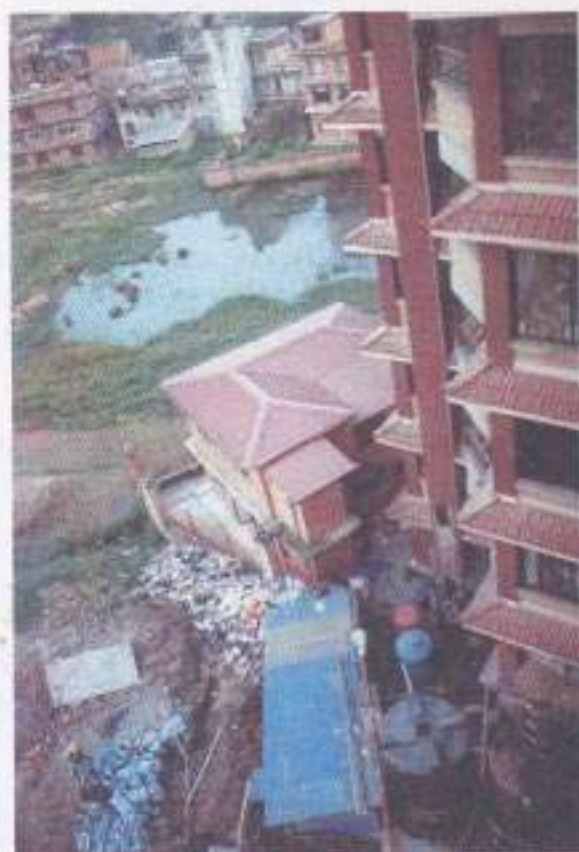
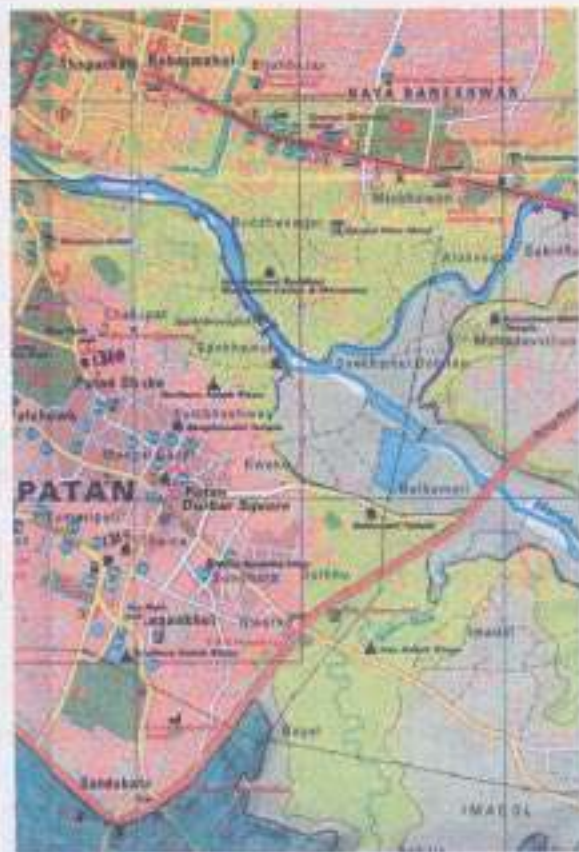
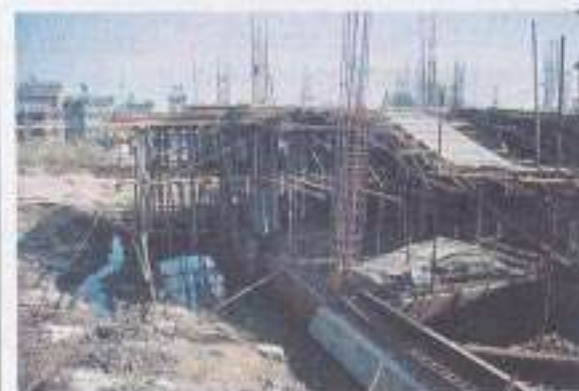
*Drainage problems at Gwarko – Lalitpur.
A pond had formed next to B&B
Hospital as a result of water damming.*

To solve the drainage problem it is recommended that two culverts are placed in the roads referred to above. In this way, the water-table level will be decreased, and the liquefaction potential – if it exists – will be reduced. For the time being, the drainage problem at B&B Hospital is not only a potential source of liquefaction, but also a source of major environmental and sanitary problems.

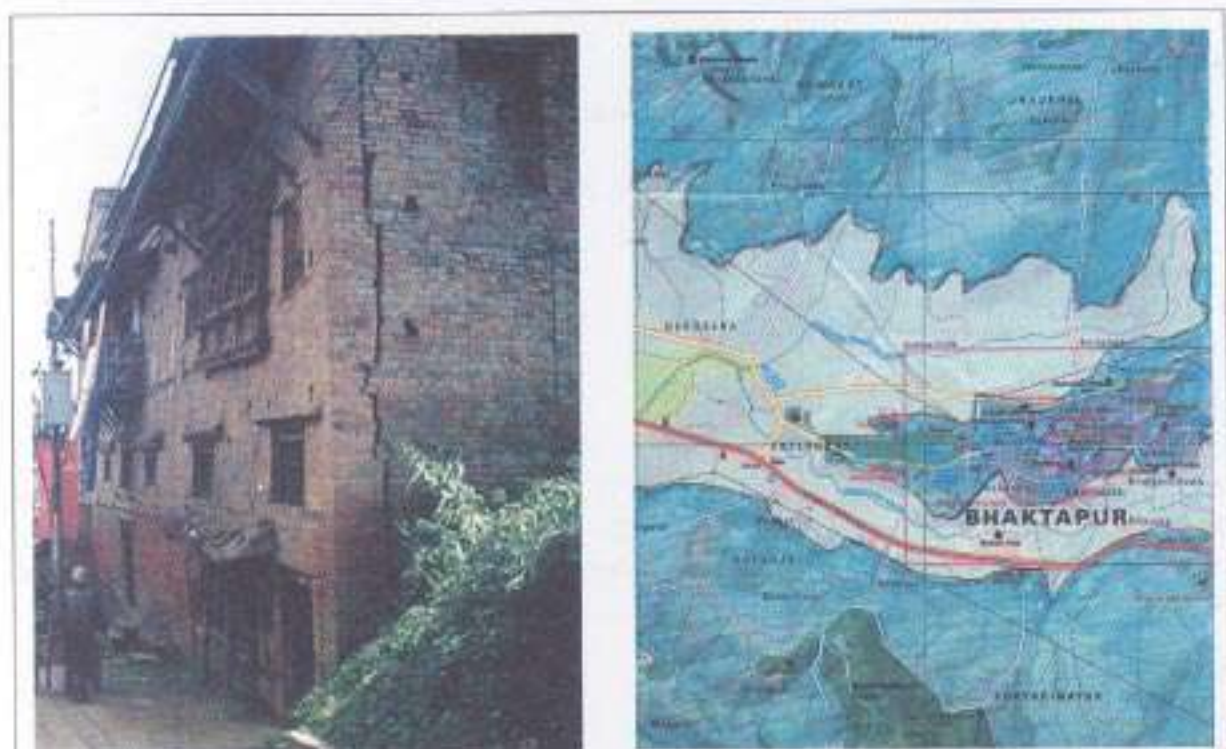
Left: Damage to a building in Bhaktapur city due to previous ground shakings of intensity $MMI = VI$.

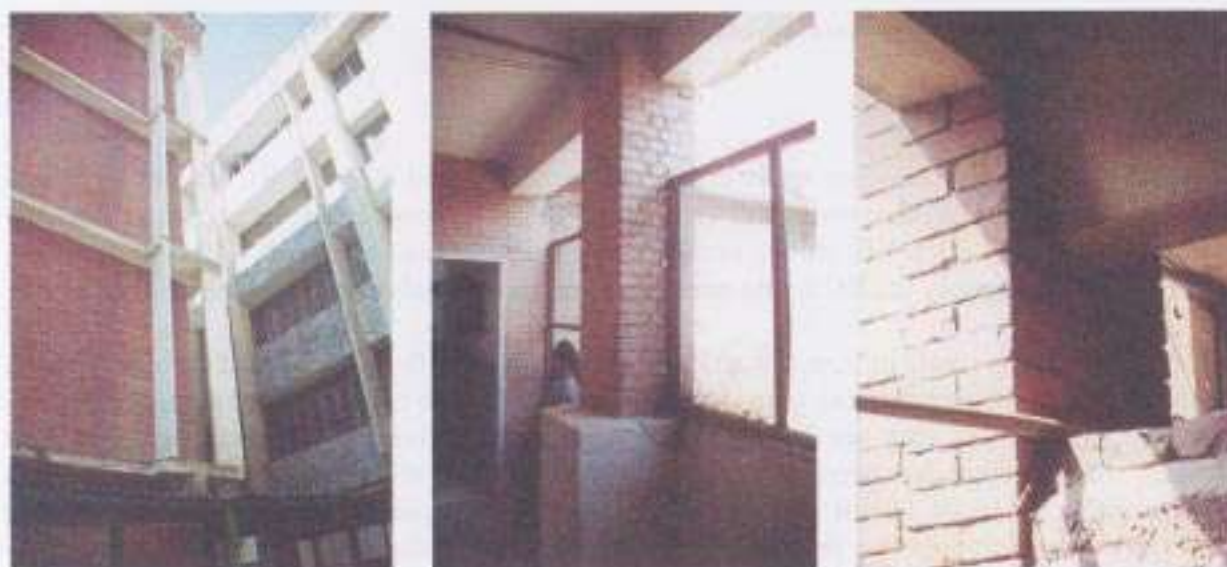
"L" building: Left: Masonry or RC blocks can fall down and injure people during a MMI = VI-VII earthquake. Middle and Right: Short columns will be able to trigger the building and lead to fragile-collapsing-mechanism (pancake failure) during a MMI = VII earthquake.

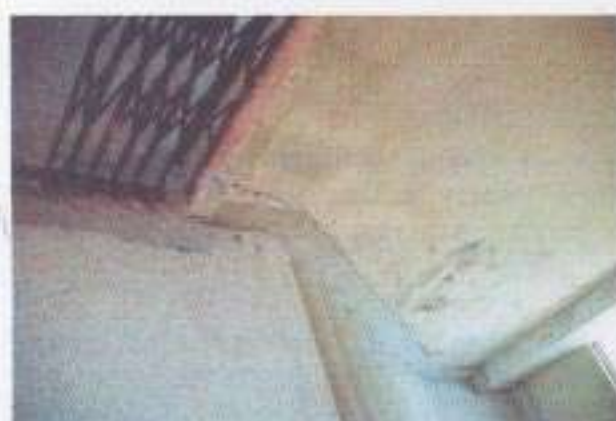
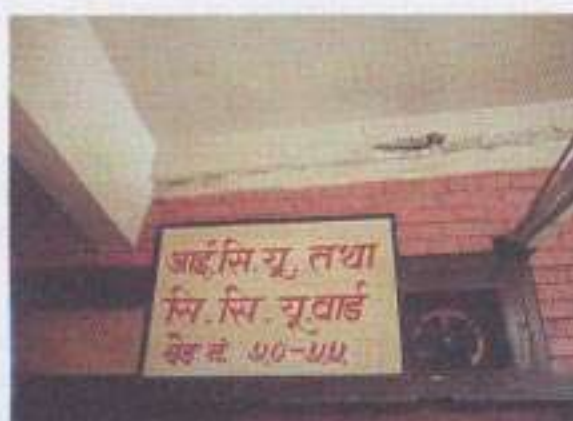
*Cracks in pounding area between the "wedge" and the "L" building.
Left: Top storey. Right: First storey.*

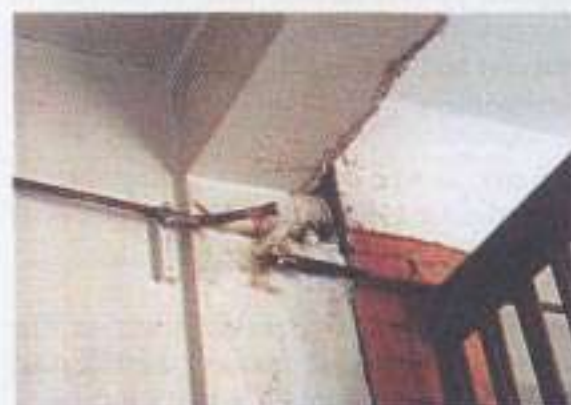
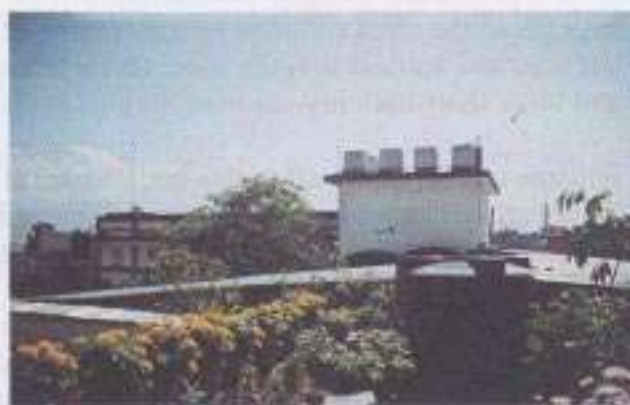
*Left: Broken oxygen pipeline at pounding area of "L" building and the "wedge".
Right: View from the "wedge".*

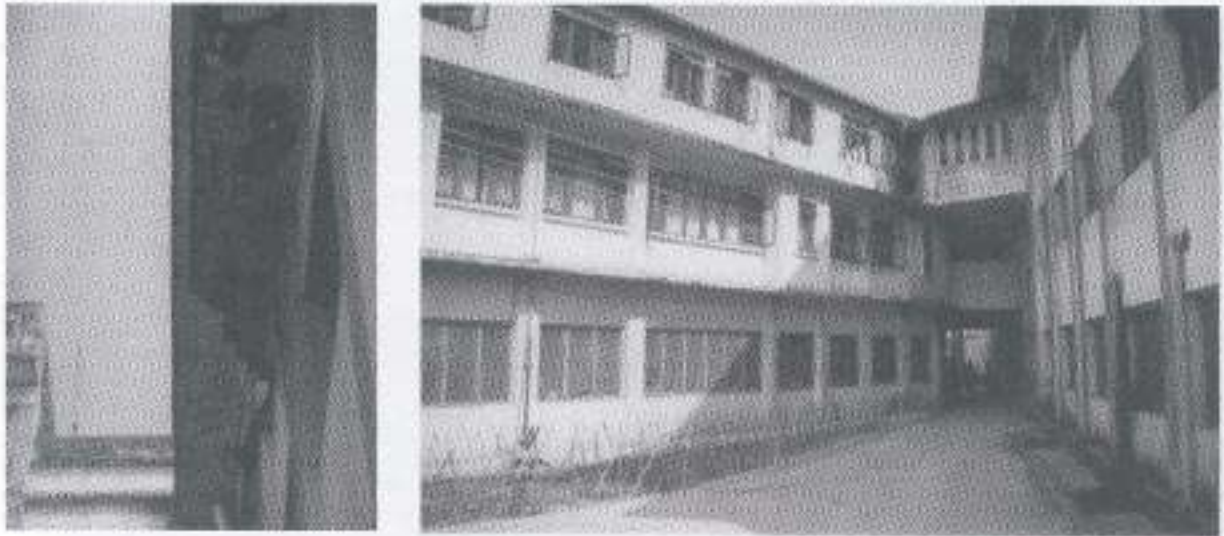
Left: Deterioration of concrete and steel corrosion in "I" building's roof due to dampness. Right: "V" and "I" buildings connected by a "weak corridor"

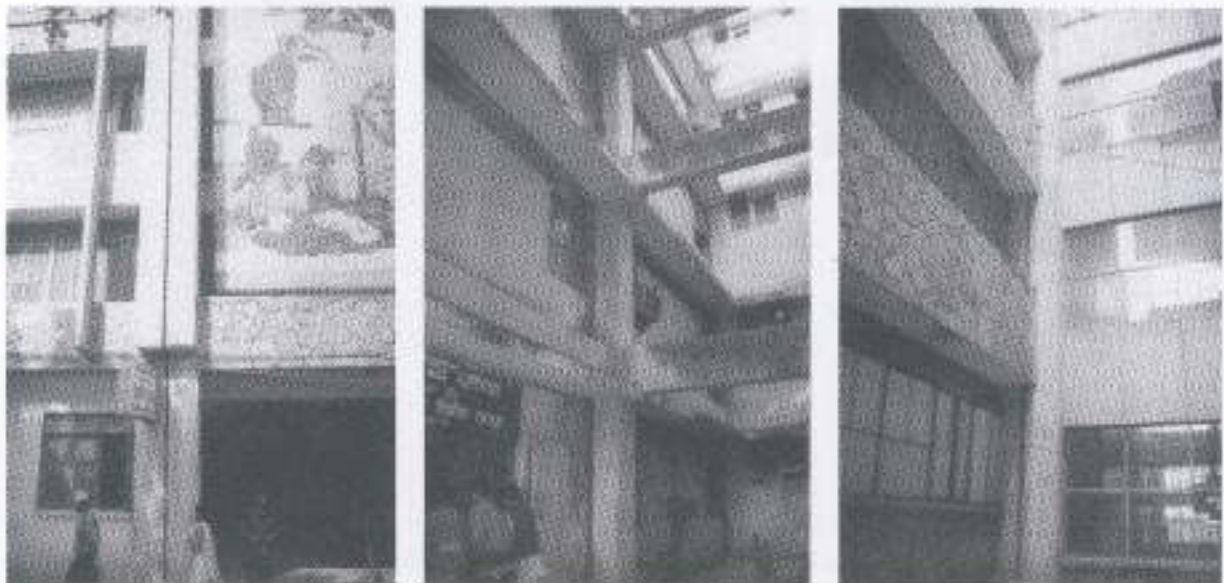
"New" buildings. Left: Seismic joint of small size in the main building facing Kanti Path. Middle: Diaphragm discontinuity in one of the three structures composing the main new building. Right: Masonry parapets rigidly connect the new buildings where a seismic joint was designed.

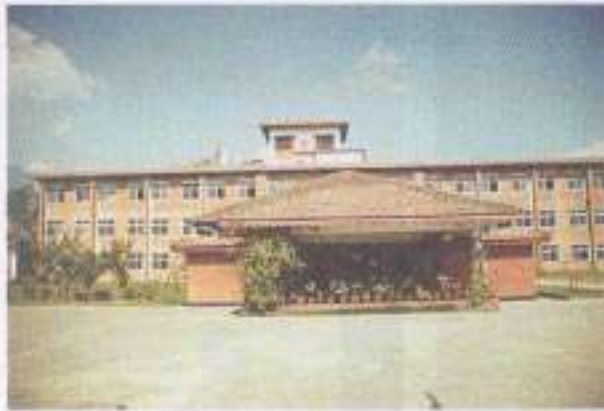
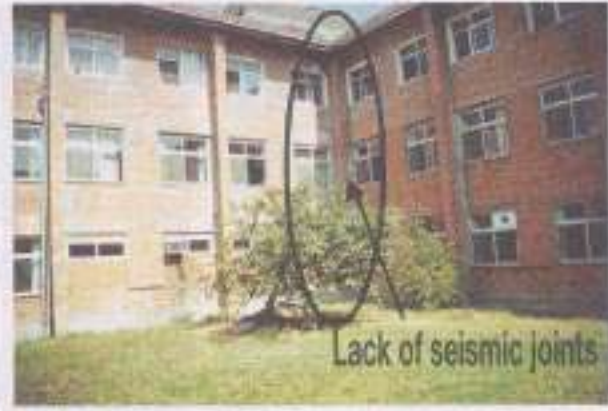
Left: Army Hospital main entrance. **Right:** One of the many re-entrant corners in the hospital. Decorative bricks cover the columns in the outer frames.

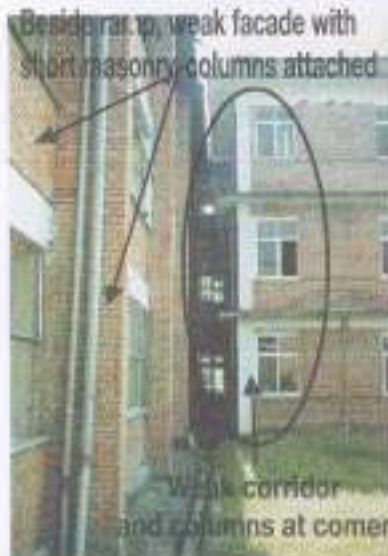
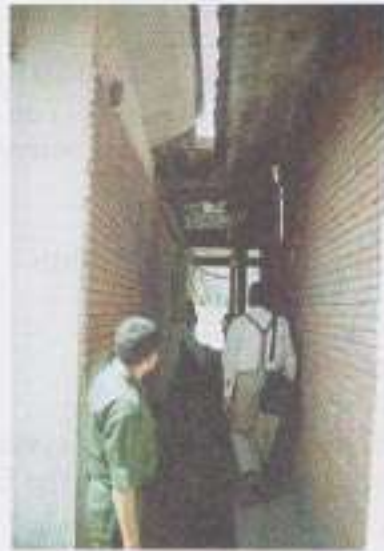
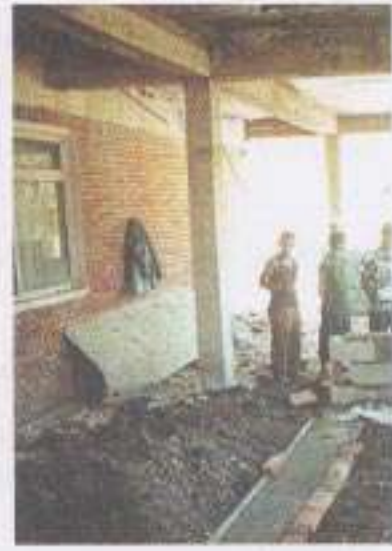
Left: Two blocks are rigidly connected with a weak corridor, which is likely to be crushed by strong ground shaking. The block on the right side is the out-patients, physiotherapy, and medical trainee centre block that has outer columns of 35 x 35 cm in size.

Centre and Right: A new one-storey block is under construction without seismic joints. The lack of joints and the plan irregularities can produce moderate to heavy structural damages in columns at outer and re-entrant corners during intensity $MMI = IX$.

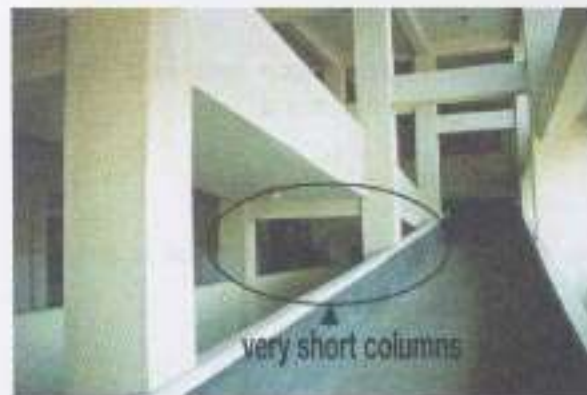
Indoors, there is a rigid inclined ramp defining short columns. Other central columns not bearing the ramp are considered to have enough seismic capacity according to their size.

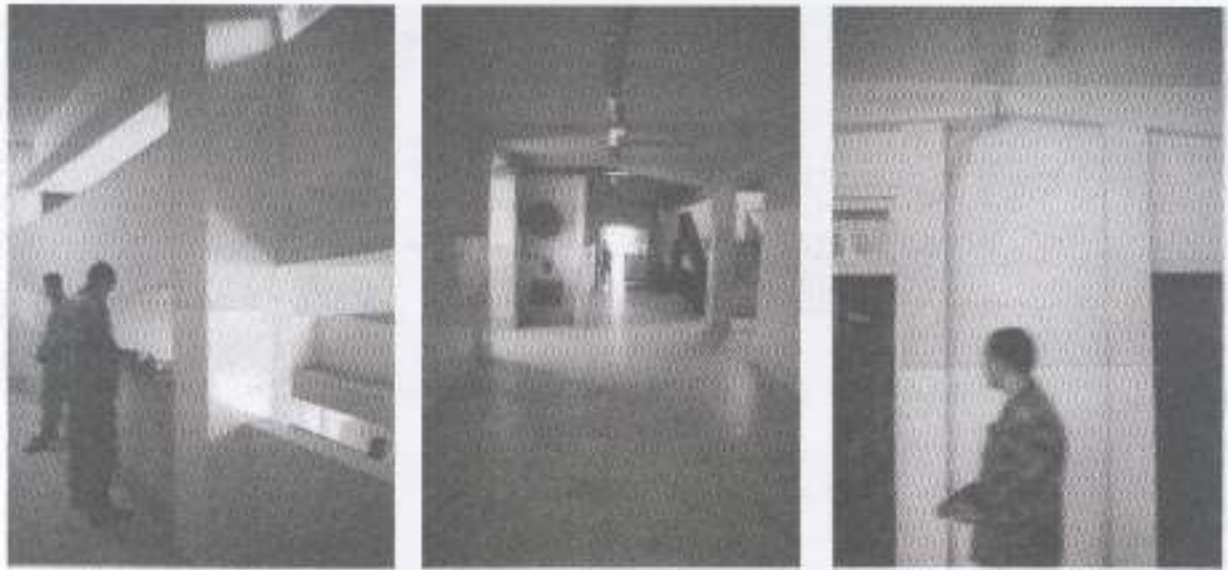
Left: Short column in the ramp area. Centre: Seismic joints closed by tiles, cement mortar, and a seal to avoid water leaks. Right: Seismic joint closed by masonry, and a repaired crack – probably caused by a previous small ground shaking - can be seen. In areas where seismic joints are closed, earthquakes usually produce the most severe damage.

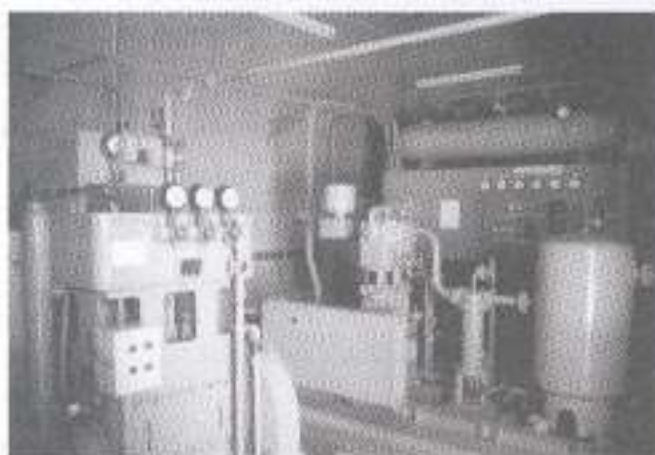
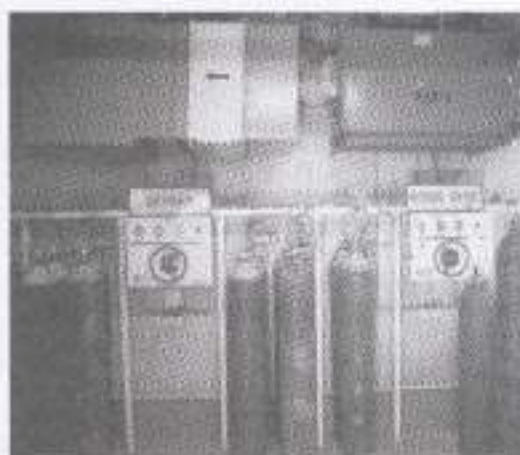
Central oxygen room. Left: Oxygen plant. Maintenance is very good for local standards. Right: Oxygen cylinders being refilled. The lateral stability of such cylinders should be improved by using devices designed to fit the cylinders to the ground while they are refilled.

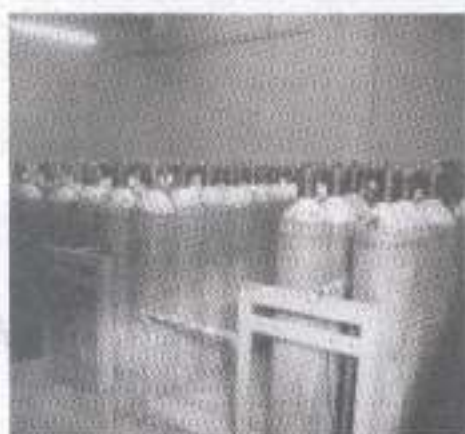
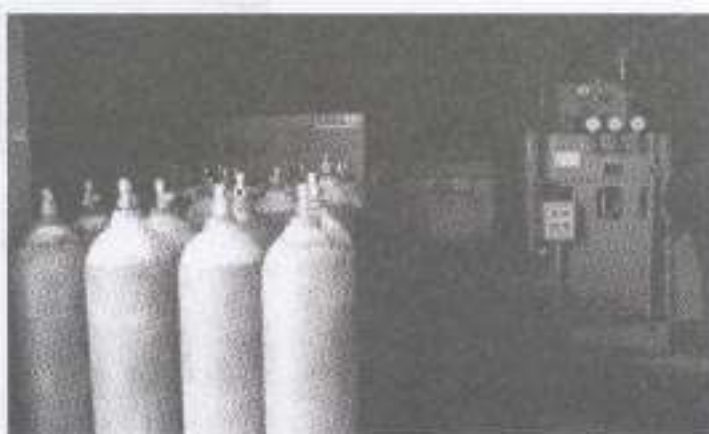
Left: Oxygen cylinders in a storage area. Right: Oxygen cylinders in the central oxygen room. To reduce non-structural vulnerability it is necessary to keep slender equipment, harmful to people, well-fitted and restrained against overturning.

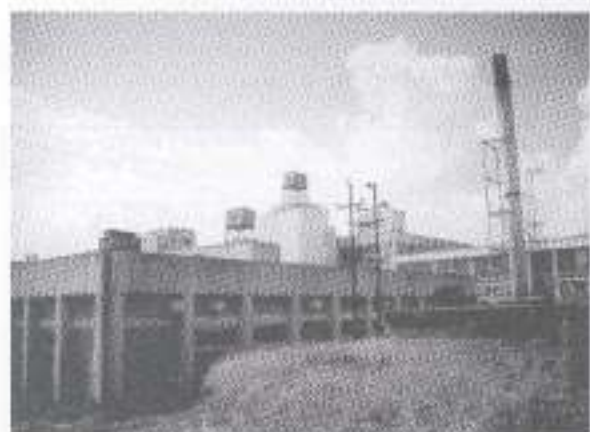
Left: Water tanks (12 cubic-metres in capacity) on the roofs of buildings. The stability of such structures under intensity MMI = VIII-IX earthquakes need to be assessed.

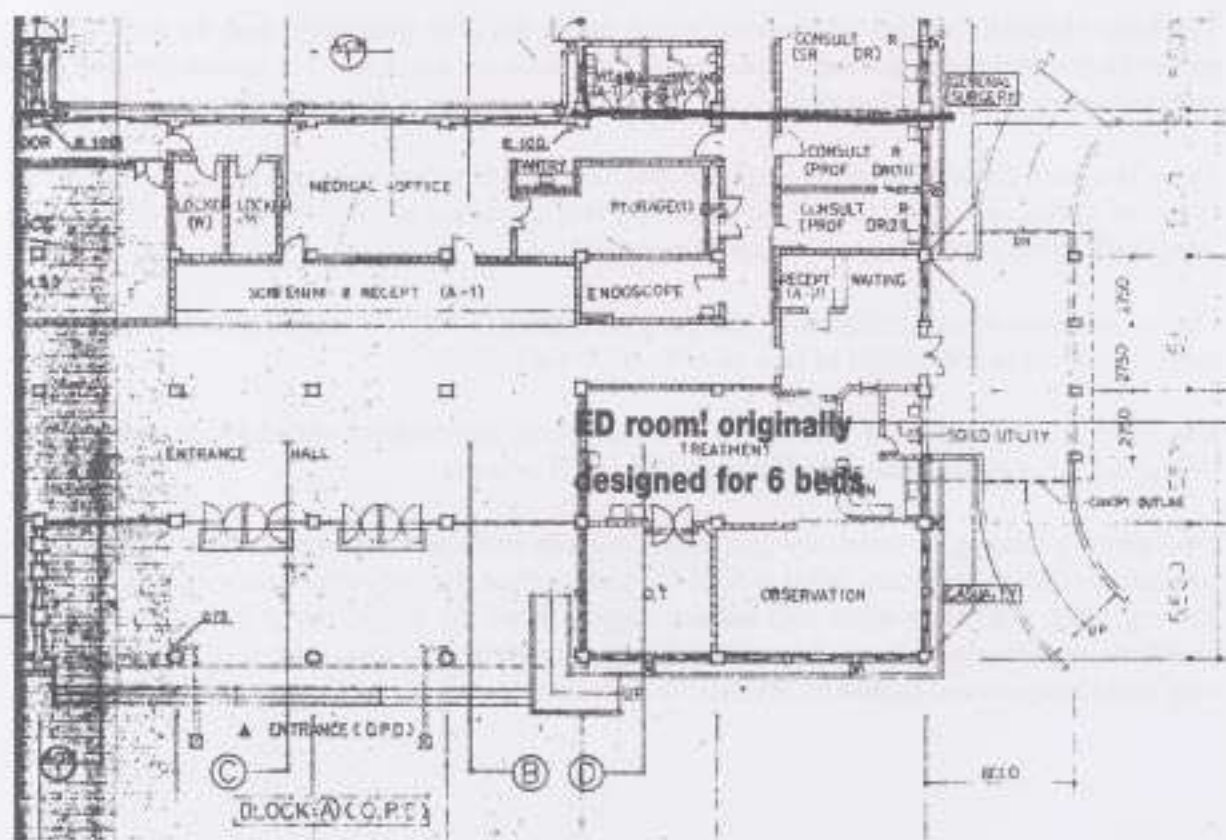
Originally designed to accommodate 6 beds, the emergency department room now has 16. Its current capacity is permanently exceeded. It is necessary to enlarge this room to a capacity of at least 35 observation beds.

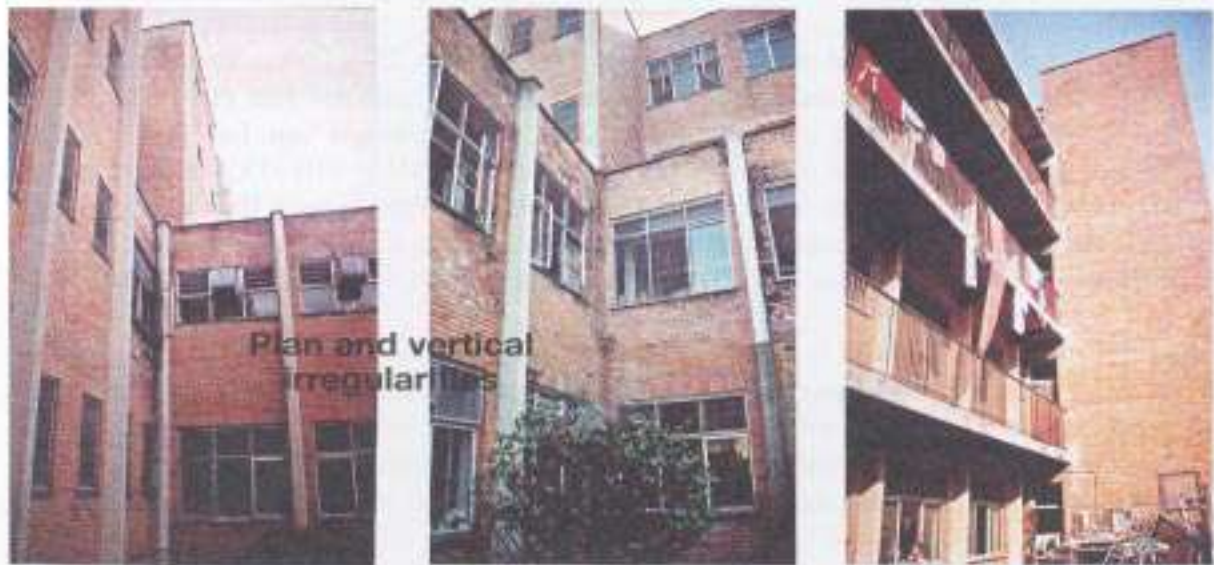
Left and Centre: Outer and re-entrant corners, and a closed seismic joint between the main 4-storey building and the surgical block, which is a 2-storey building. The vertical and plan irregularities due to the building setback in elevation and irregular plan shape can also be seen. **Right:** Reinforced concrete wall covered by a masonry wall with decorative bricks that are not well connected to the RC wall and can easily fall down during an earthquake of intensity MMI = VII or above. The RC wall of the main staircase is attached to the main building's floor slabs, and is not well connected to its moment-resistant-frame-structure.
