Environmental Geology

Causes of large-scale landslides in the Lesser Himalaya of central Nepal

Shuichi Hasegawa · Ranjan Kumar Dahal ·
Minoru Yamanaka · Netra Prakash Bhandary ·
Ryuichi Yatabe · Hideki Inagaki

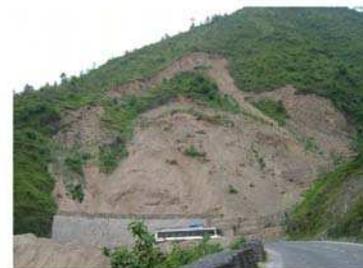
Fig. 7 X-ray diffraction of landslide materials from location 1 (see Fig. 5) of the Prithivi Highway

From the X-ray diffraction patterns of the tested soil samples, it is clearly understood that the main constituent minerals of the collected samples (Table 2) are chlorites, illites, muscovite, actinolite, feldspar and quartz with occasional appearance of smectite, talc and metahalloysite. In Sample 1 of the Prithvi Highway at Khatripauwa village, some traces of montmorillonite (smectite) were observed and confirmed by conducting oriented aggregate analysis and ethylene glycol treatment analysis (Fig. 7). Metasandstone with alternate bands of slates is the main unit in the site. A marked presence and significantly high intensity of X-rays corresponding to illites (along with muscovite) in almost all samples indicates that the landslide materials consist of a higher percentage of illites. High content of quartz in soil samples also gives a clear significance of high value of peak and residual shear resistance ($>30^\circ$).

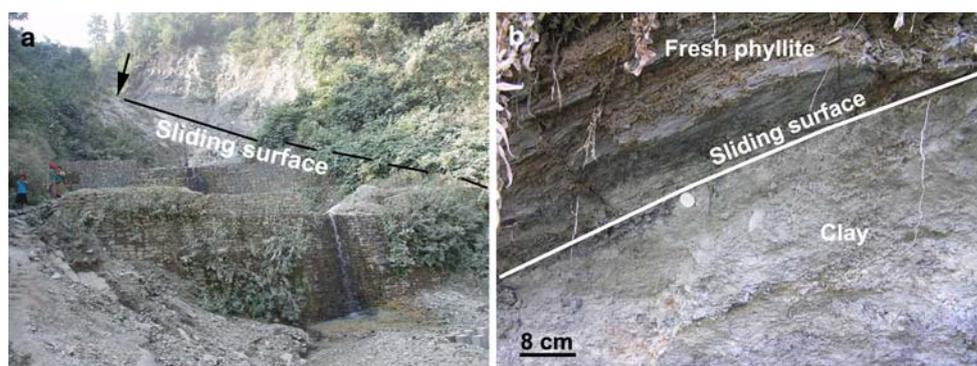
Fig. 10 Large-scale landslide at Location 15 along Narayangadh-Mugling Road and a close view of slip surface and altered clay zone. *Arrow in a shows the location of b*

of such zones are provided in Fig. 10 (location 15) and Fig. 11 (location 16). At location 15 (see Fig. 6), the sliding surface of the large-scale landslide consists of more

than 1-m-thick gray clay layer (Fig. 10). The overlaying rock is fresh phyllite, but it has abundant open joints and fracture. The boundary between sliding surface and overlaying phyllite is very sharp and phyllite does not have shear structure. These observations indicated that the sliding surface which resembles fault gouge was formed by hydrothermal alteration. Similarly, at location 16 (see Fig. 6), the sliding surface of the large-scale landslide consists of more than 1-m-thick greenish grey clay and breccia layer (Fig. 11). The overlaying rock is amphibolite and it is also fresh as in location 15.

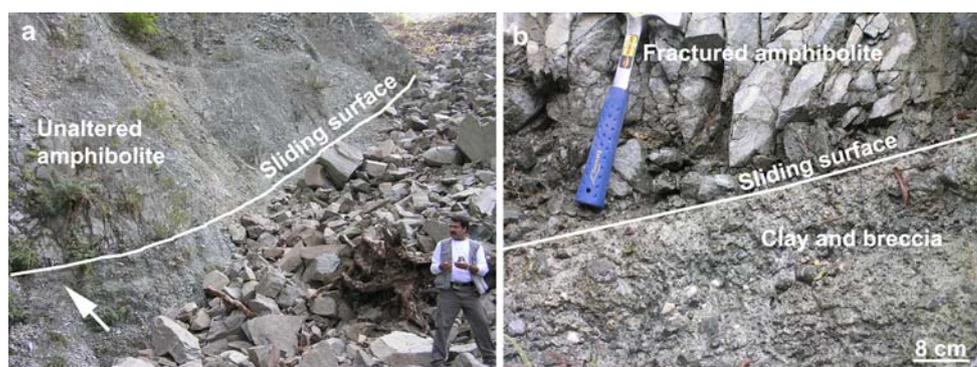
Fig. 11 Large-scale landslide at Location 16 along Narayangadh-Mugling Road and close view of slip surface and altered clay zone. *Arrow in a shows the location of b*

The rockmass of amphibolite also has abundant open joints and fractures. The boundary between sliding surface and overlaying amphibolite is very sharp and clay and breccia layer does not have shear structure (Fig. 11). This emplacement also indicates that the sliding surface which has many similarities to fault breccia was previously formed by hydrothermal alteration.
