Evaluation of Earthquake Disaster Risk for Safer School Buildings Construction in Nepal

Dr. YOUB RAJ PAUDYAL
Department of Education

Flagship 1: School Safety National level workshop
In collaboration with Flagship 4: Integrated Community Based Disaster Risk Reduction
Hotel Himalaya, Kopandole, Lalitpur
5 June 2013

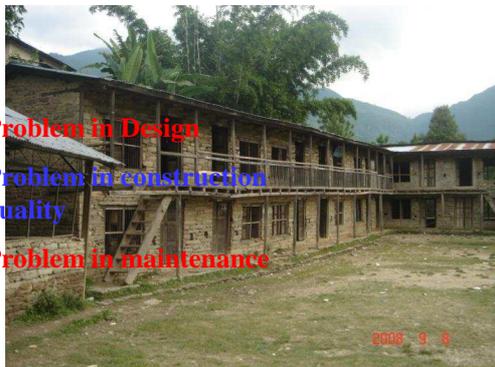
Visit in Sindhupalchok District

- ❖ Problem in Design
- ❖ Problem in construction quality
- ❖ Problem in maintenance

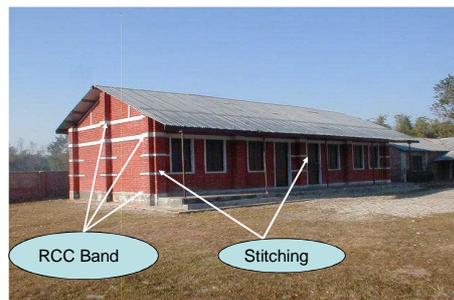
Example: Type Design Prepared by Department of Education

Load Bearing Wall and Steel Truss

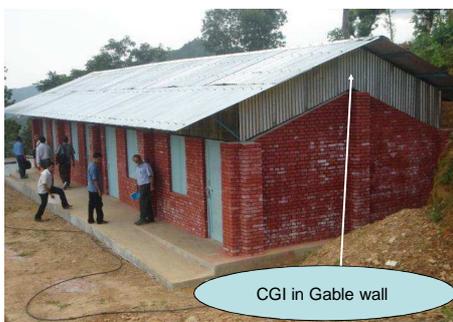
Example: Type Design Prepared by Department of Education

Tubular Steel Frame Structure

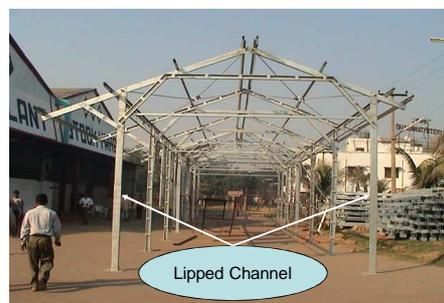
Example: Type Design Prepared by Department of Education

Galvanized Lipped Channel Frame Structure
