# Present Status of Landslides in Nepal and way forward

**Kabi Raj Paudyal, PhD**

Coordinator: Master in Engineering Geology Program, Central Department of Geology

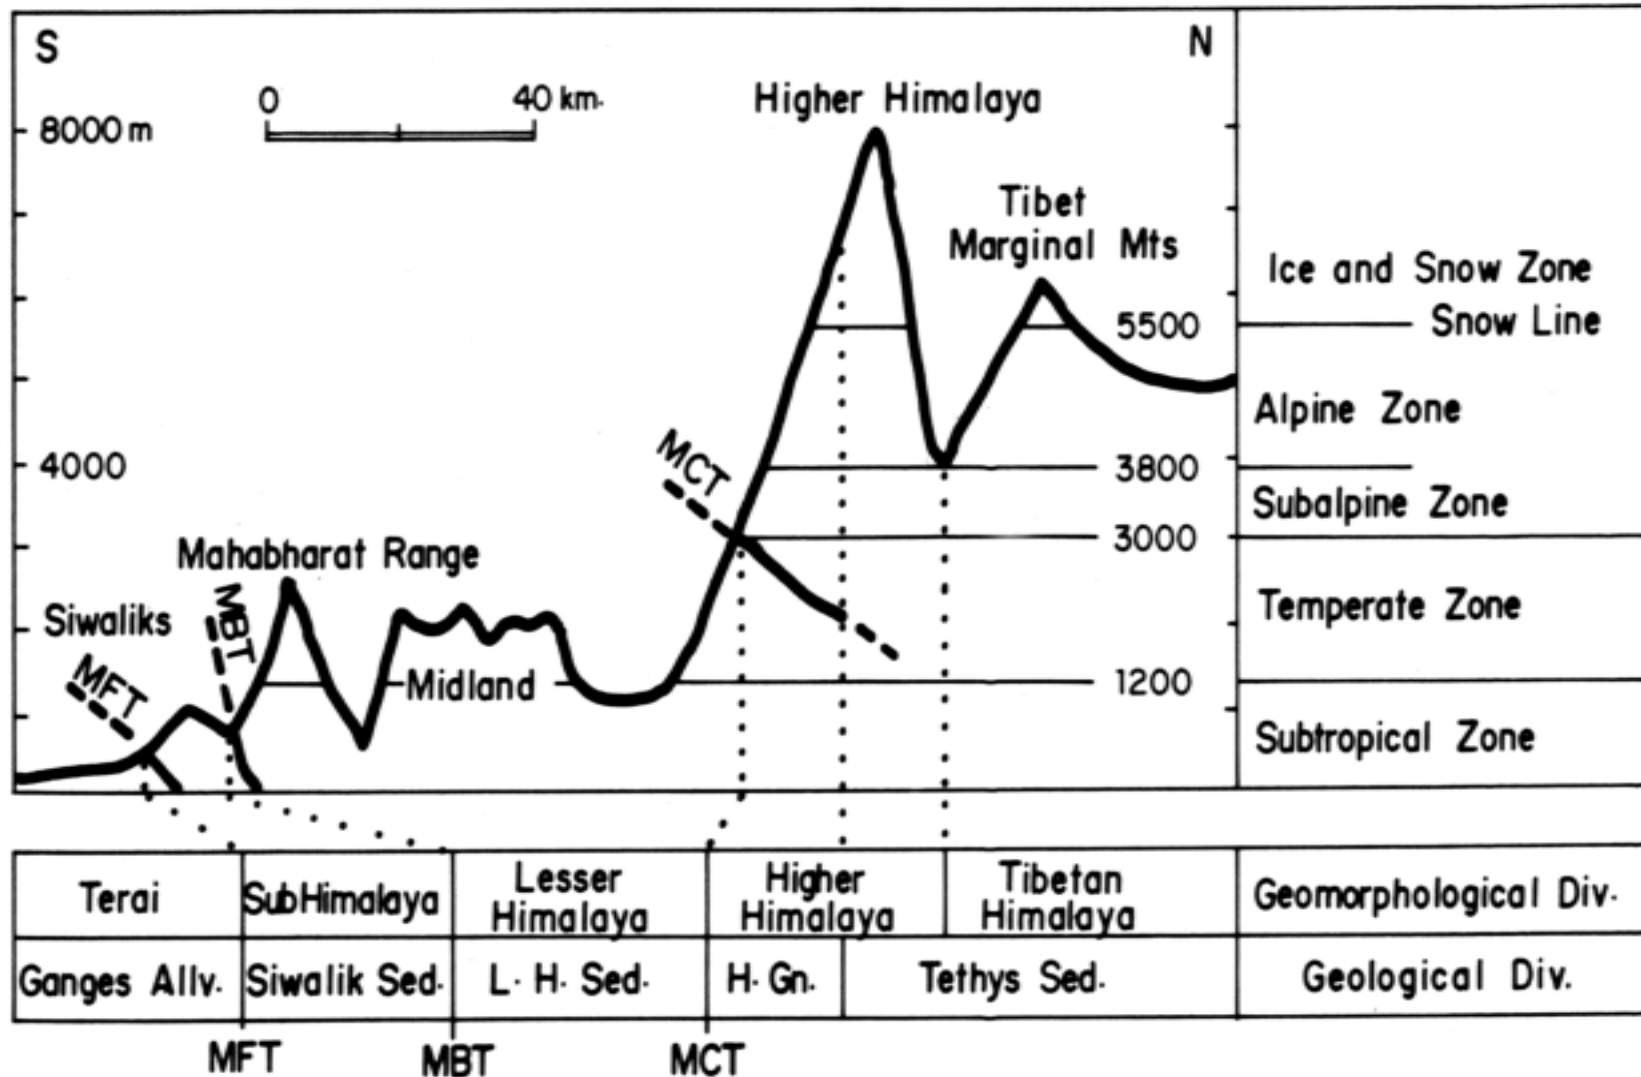
**Fig. 1. Simplified cross section of the Himalayas. MFT: Main Frontal Thrust, MBT: Main Boundary Thrust, MCT: Main Central Thrust.**

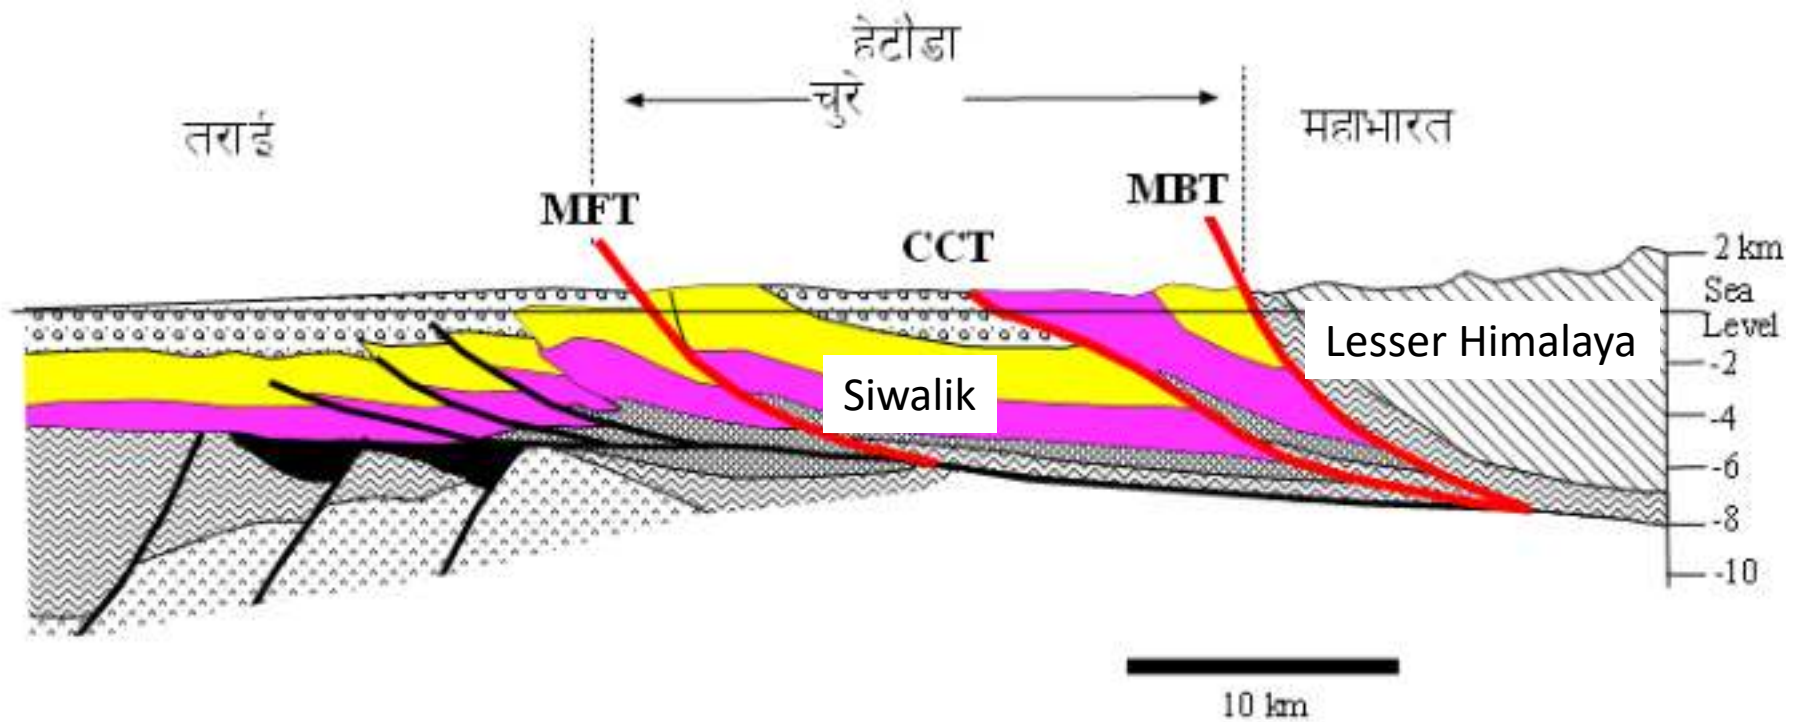
CCT: Central Churia Thrust  
 MFT: Main Frontal Thrust  
 MBT: Main Boundary Thrust

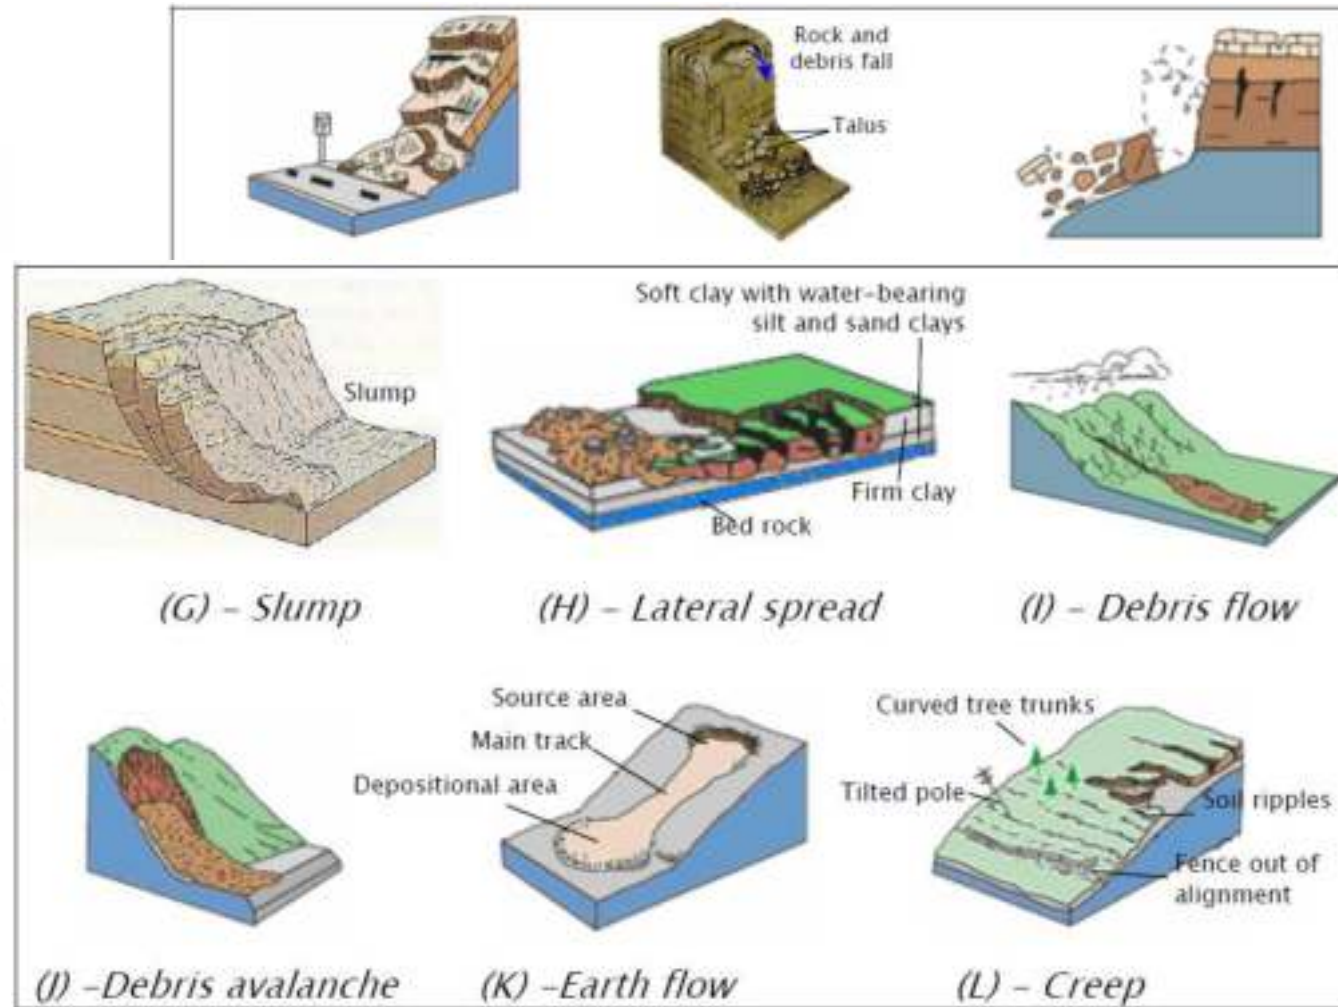
Different landslide types can be identified as shown in following Figure (USGS, 2004)

Schematic illustration of the major types of landslide movement (USGS, 2004)

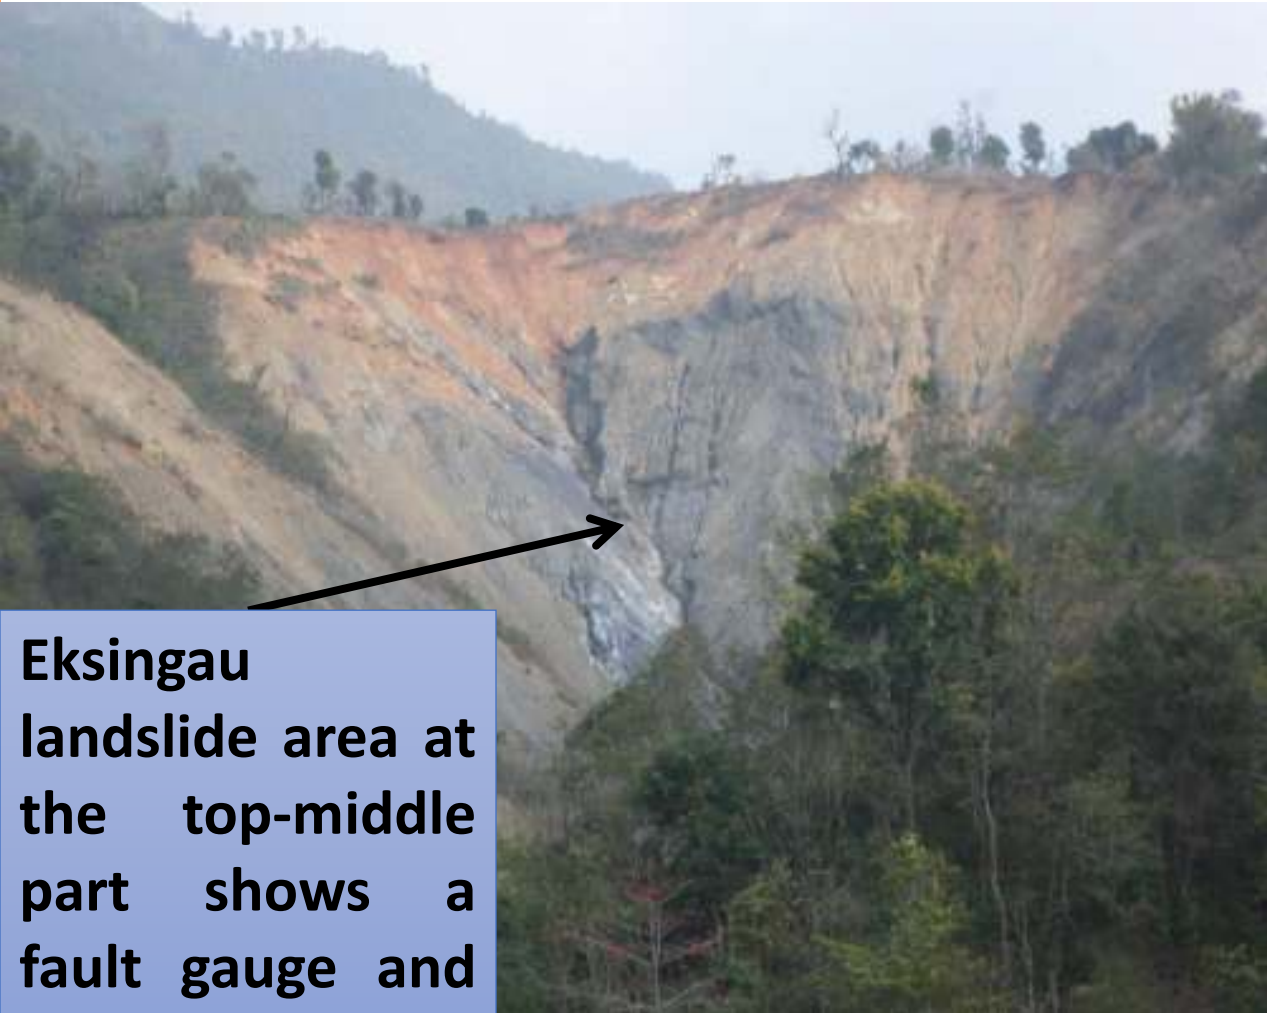
**Eksingau landslide area at the top-middle part shows a fault gauge and slickensides**

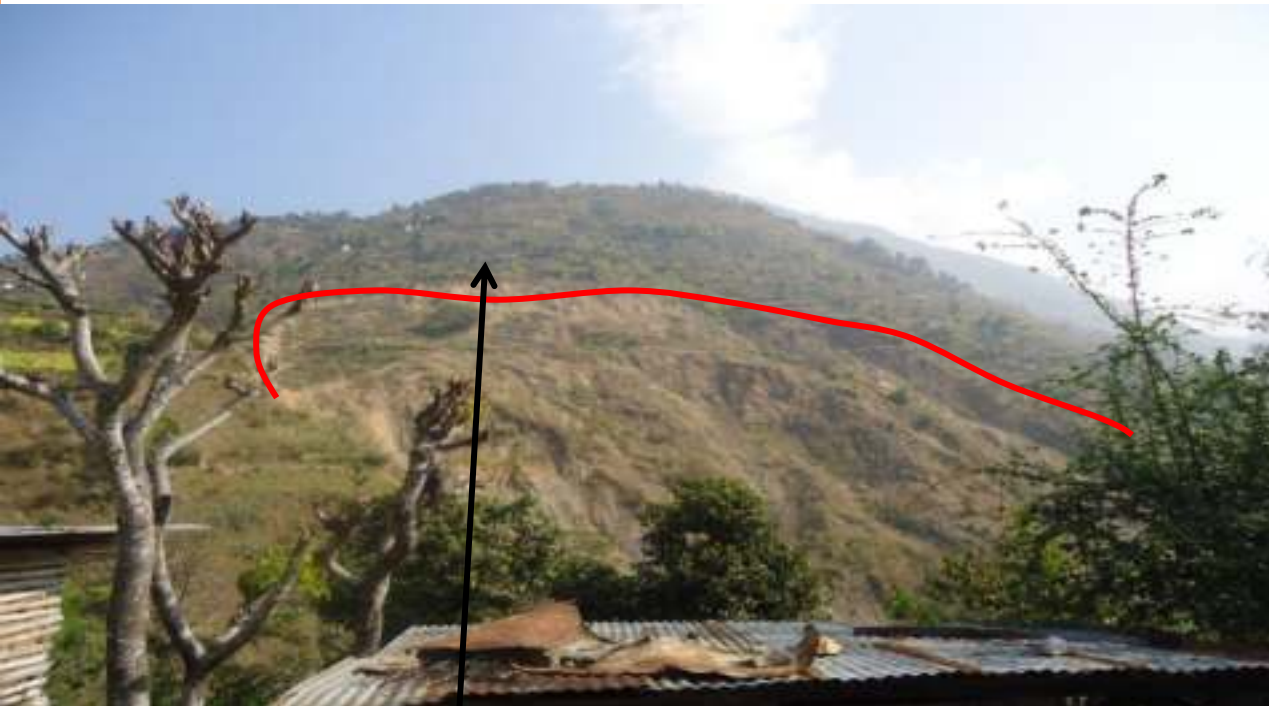
**Rupakot Shear Zone (RS):** lies in uphill section of Rupakot VDC. In this shear zone a large landslide occurs. At middle part of this landslide has a wide zone of fault gauge and a number of slickenside were observed.

**Outline of Rupakot landslide**

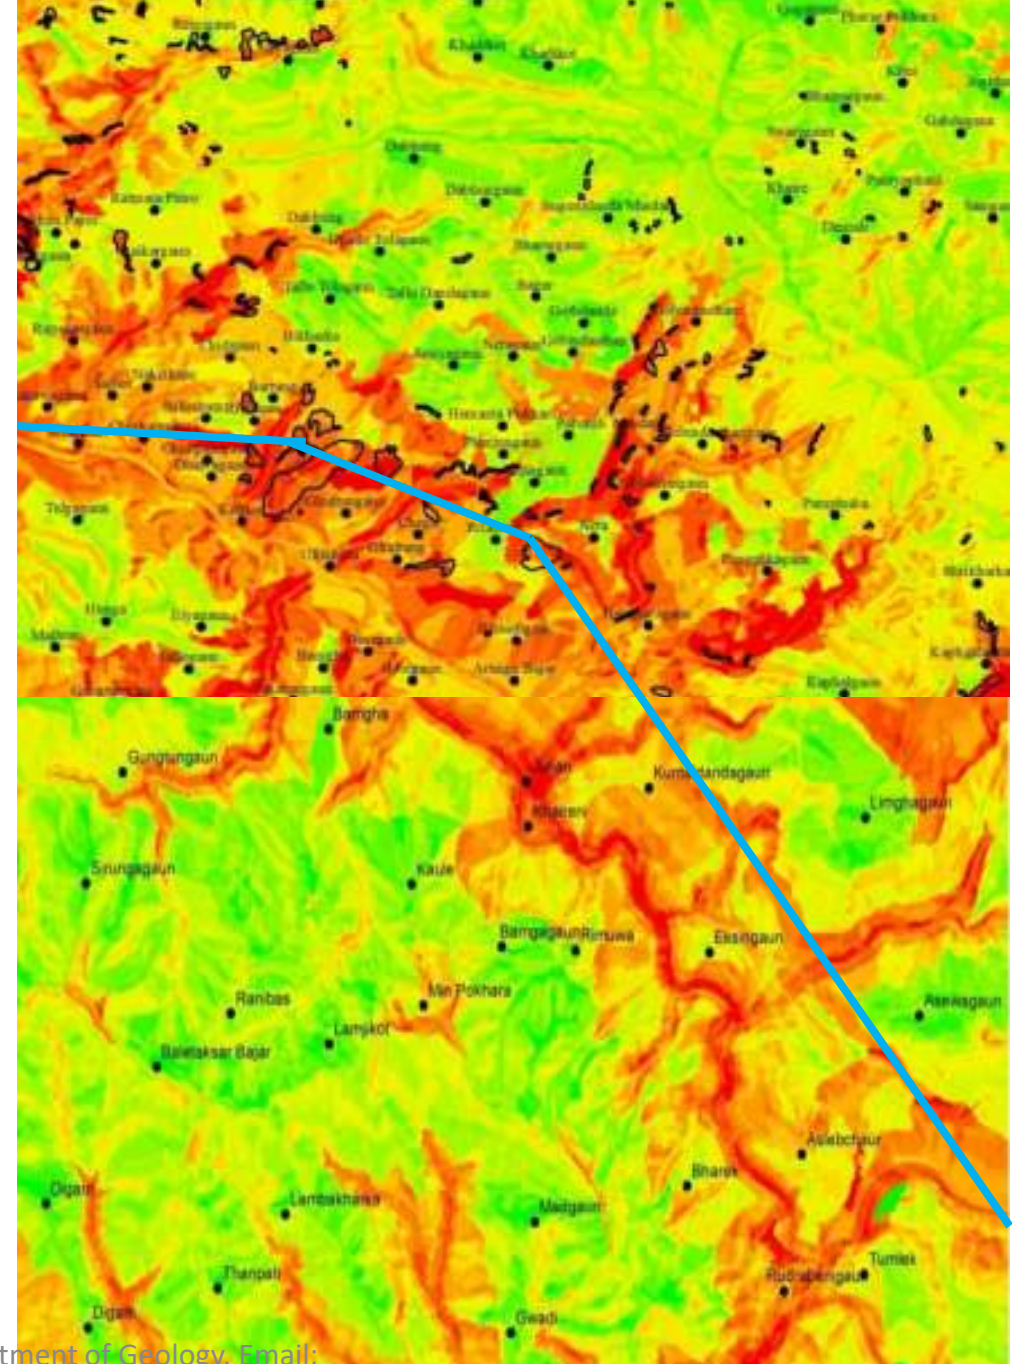
- Google earth clearly shows the extension of the Badi Gad Fault in the present study area which is also verified in the field.

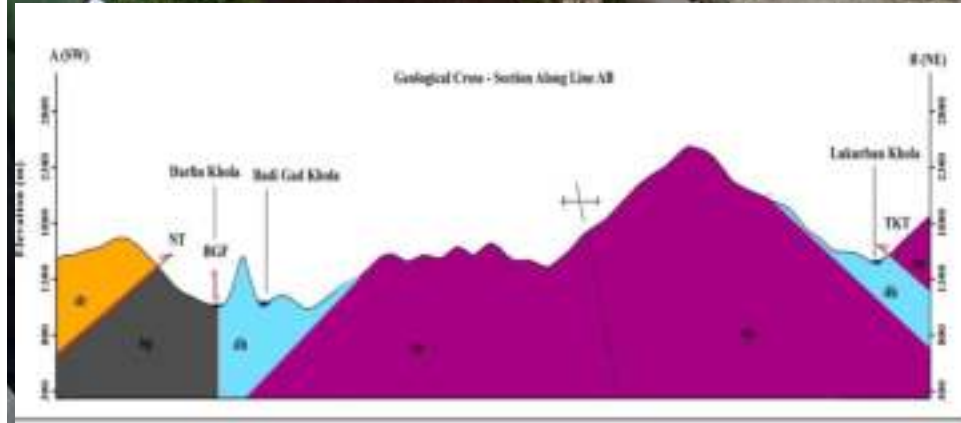
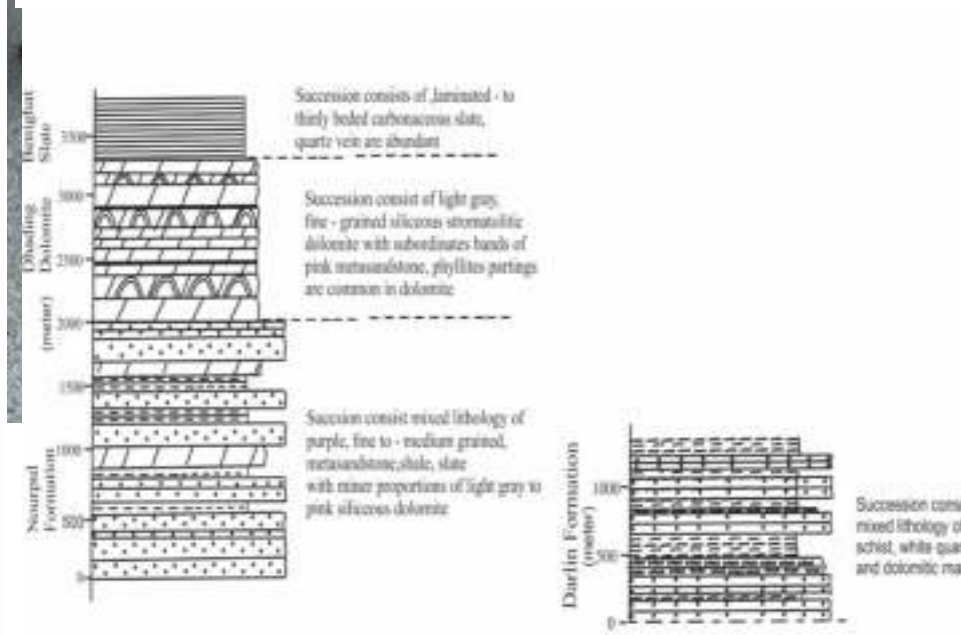
# Geological map of Burtibang – Turture Area

Fig. Generalize stratigraphy of the study area

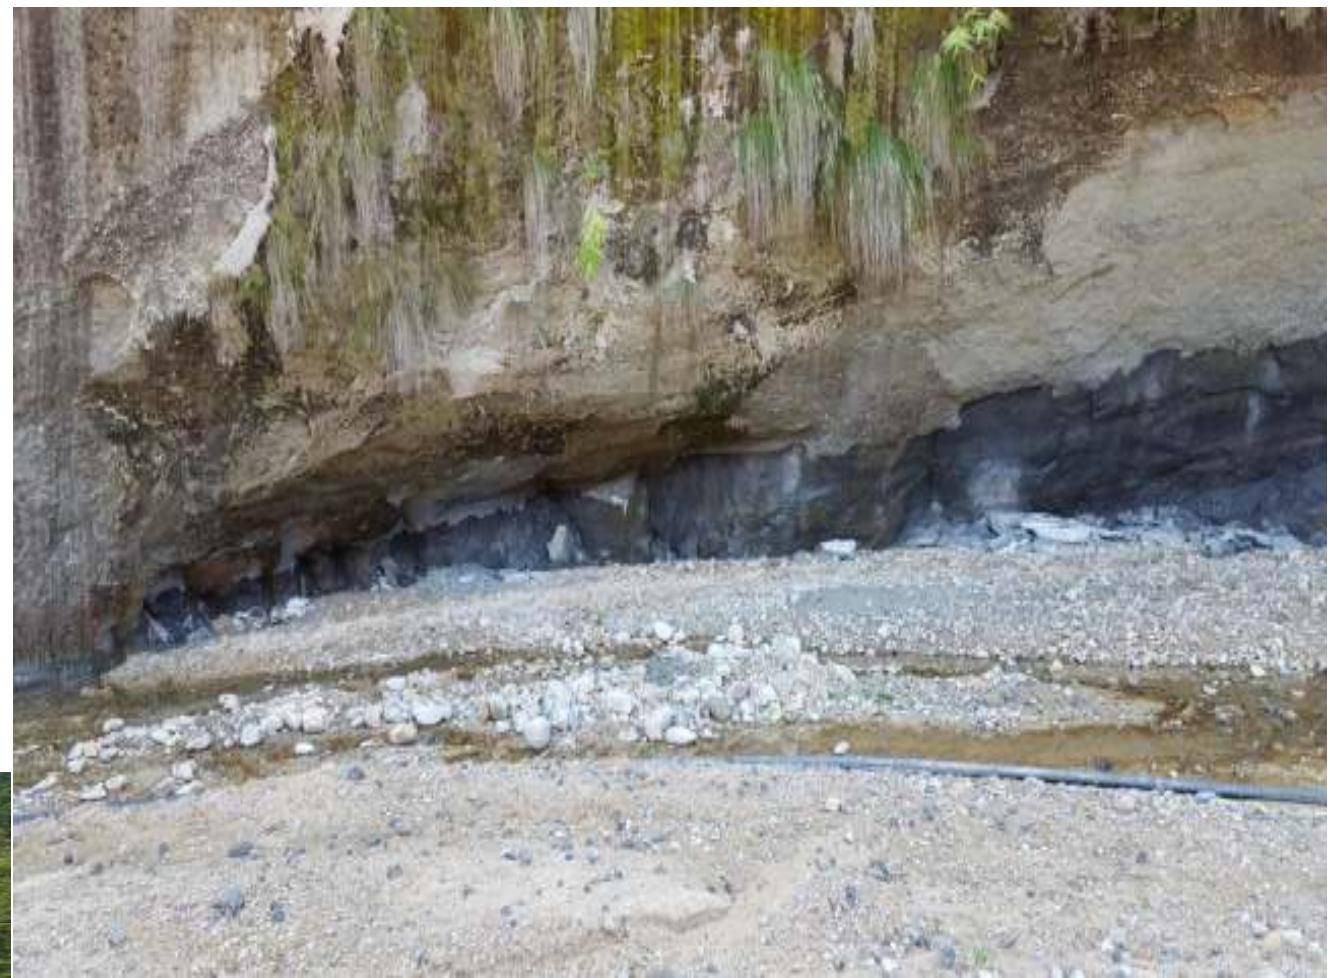
**Toe cutting of hill side by river during flood at Tintale.**

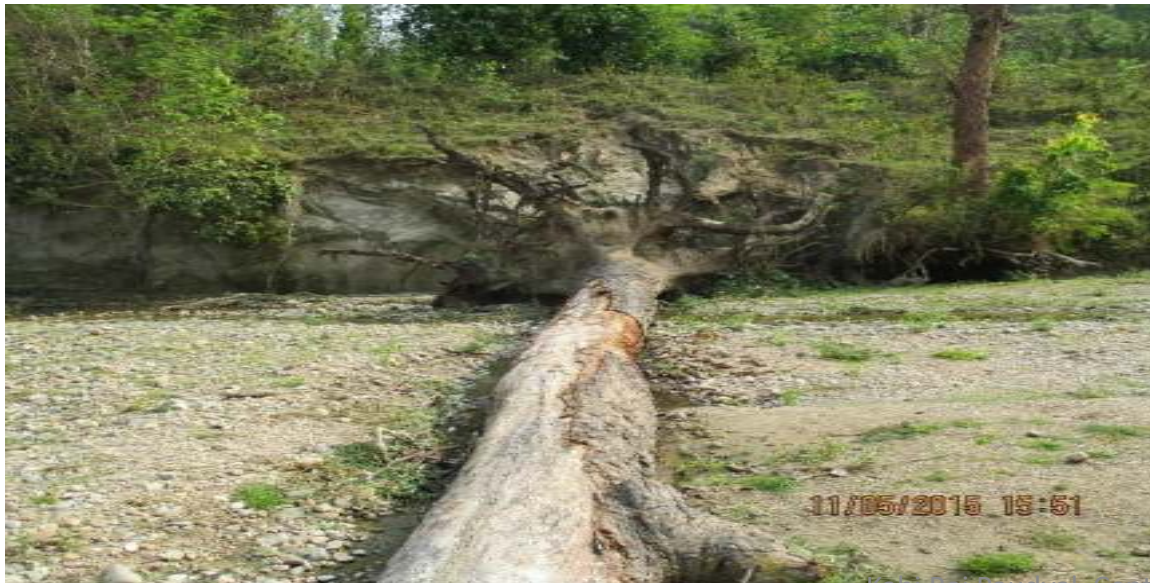
**Rainfall induced land damage around Pathharkot.**

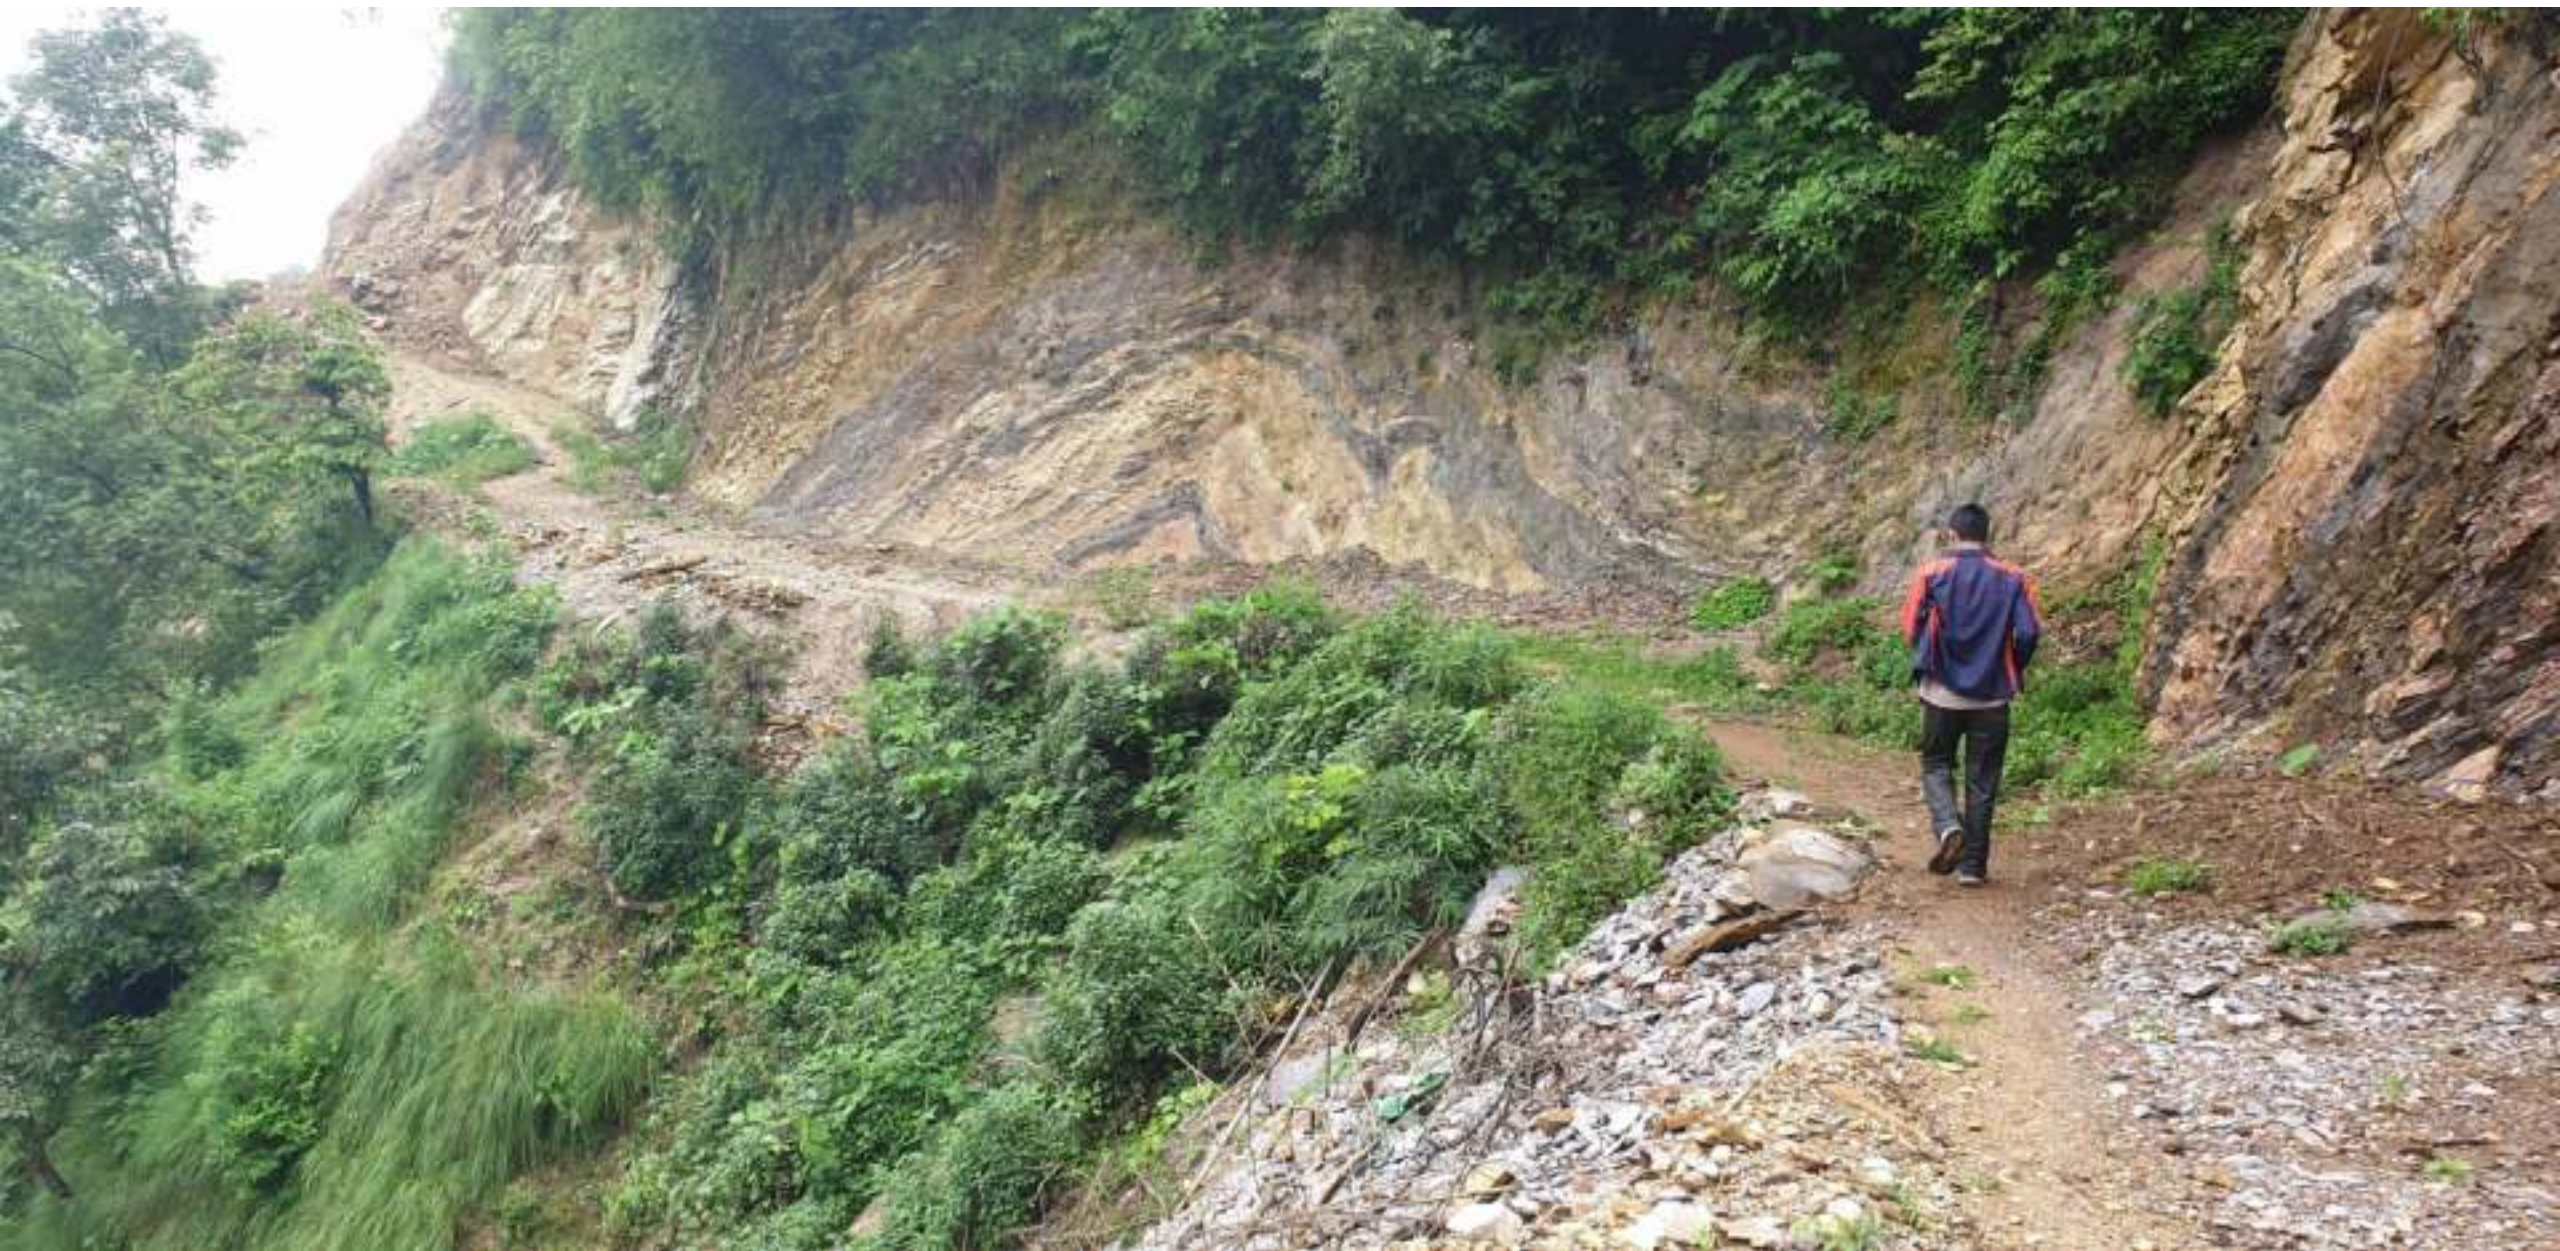
Geological Map of Sindhi Areas of Thulo Lumpek, Gulmi, Province-5

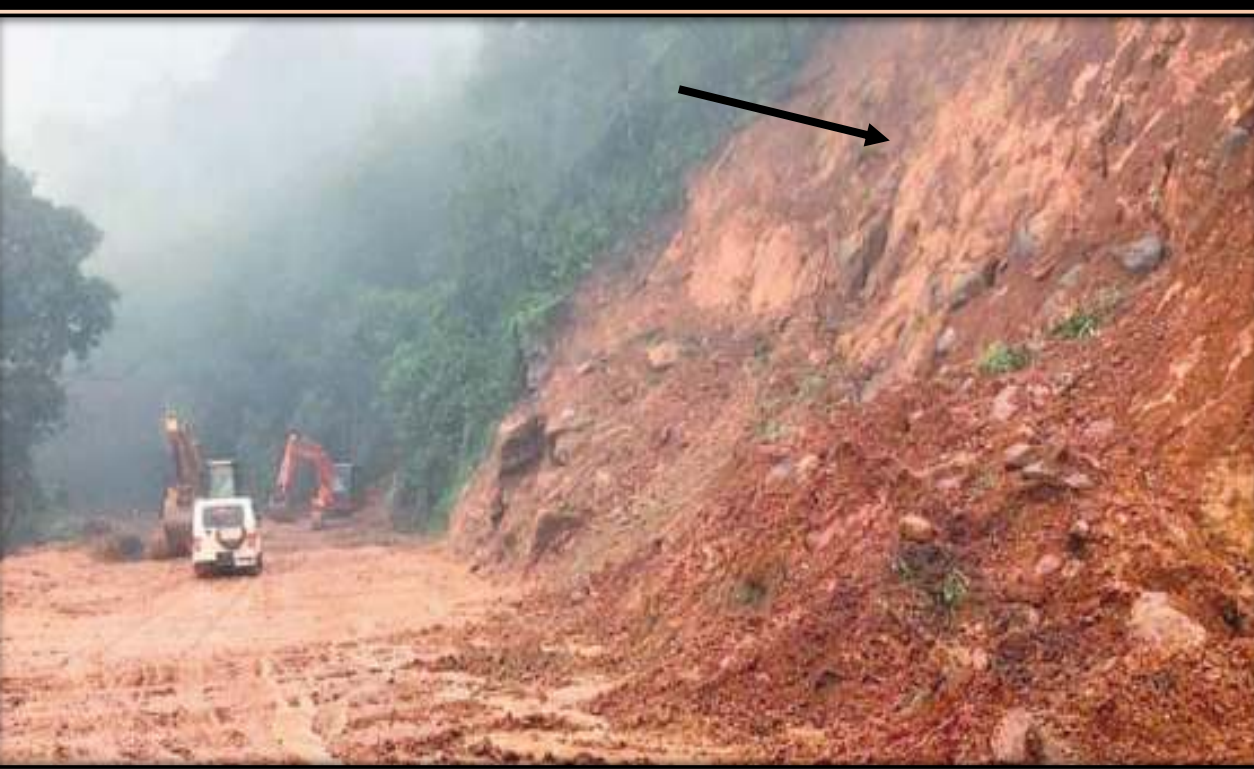
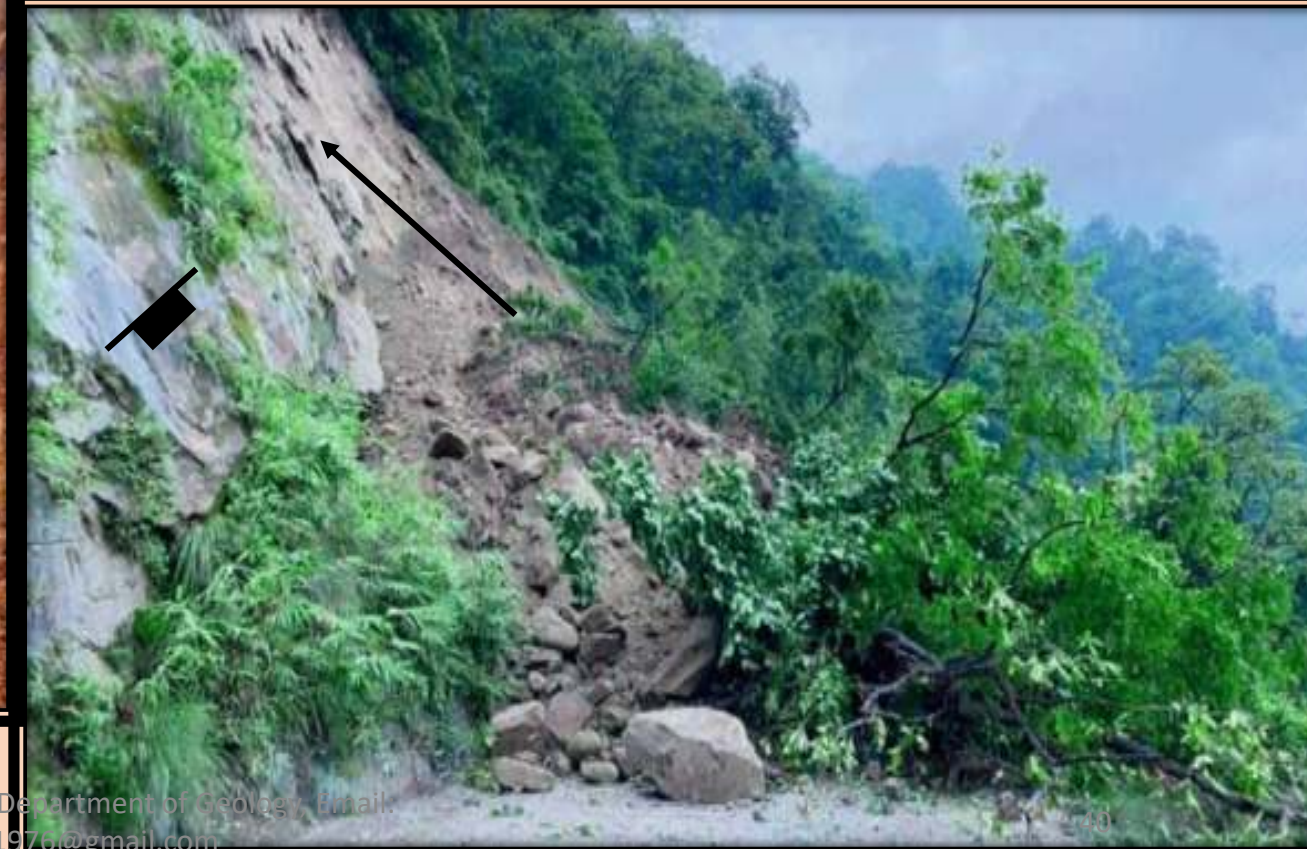
Landslide at Dhovan, Palpa-Butwal Road Section, road blockage, possibly plane failure with big boulder, increased unit weight due to heavy rainfall, results due to **unscientific road excavation practices though CCT.**

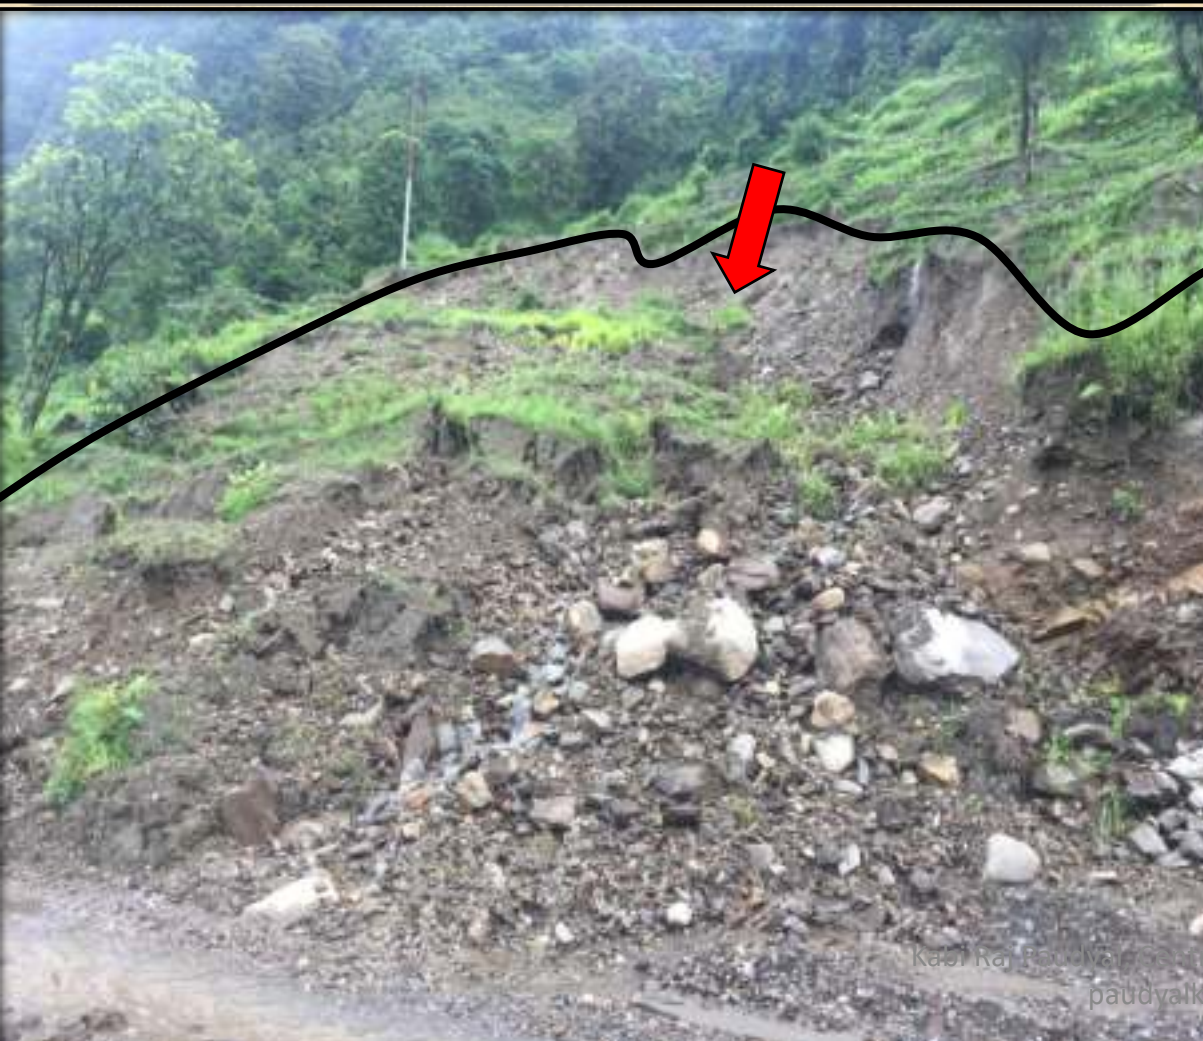
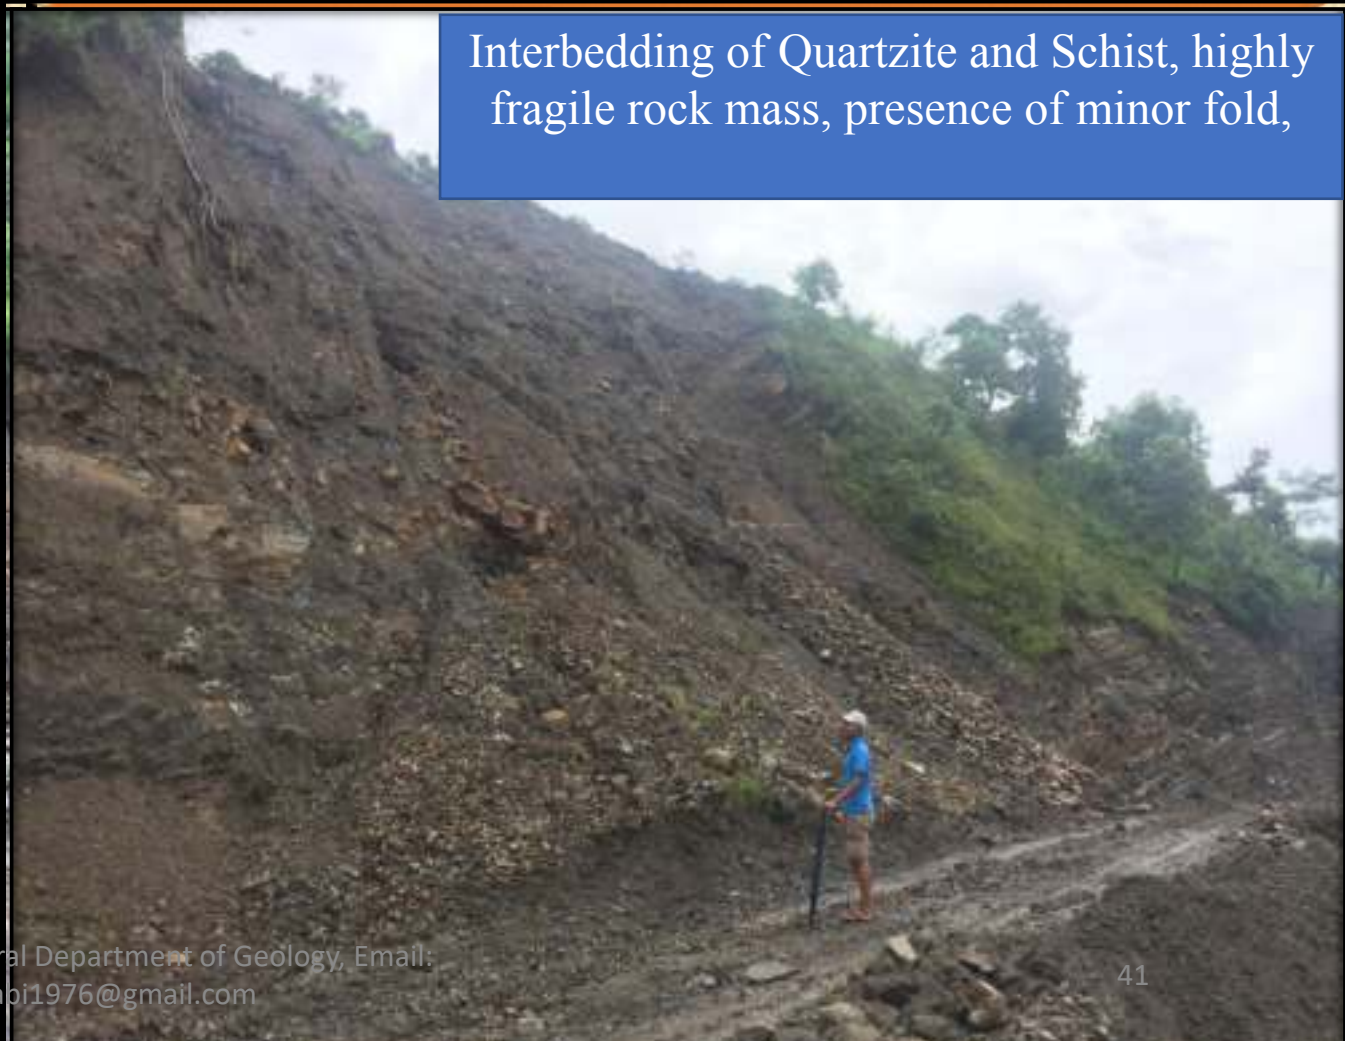
Cultivation land slide down due to slope cutting

Slope failure due to road cutting at Dordi, Lamjung (10<sup>th</sup> Ashad 077)

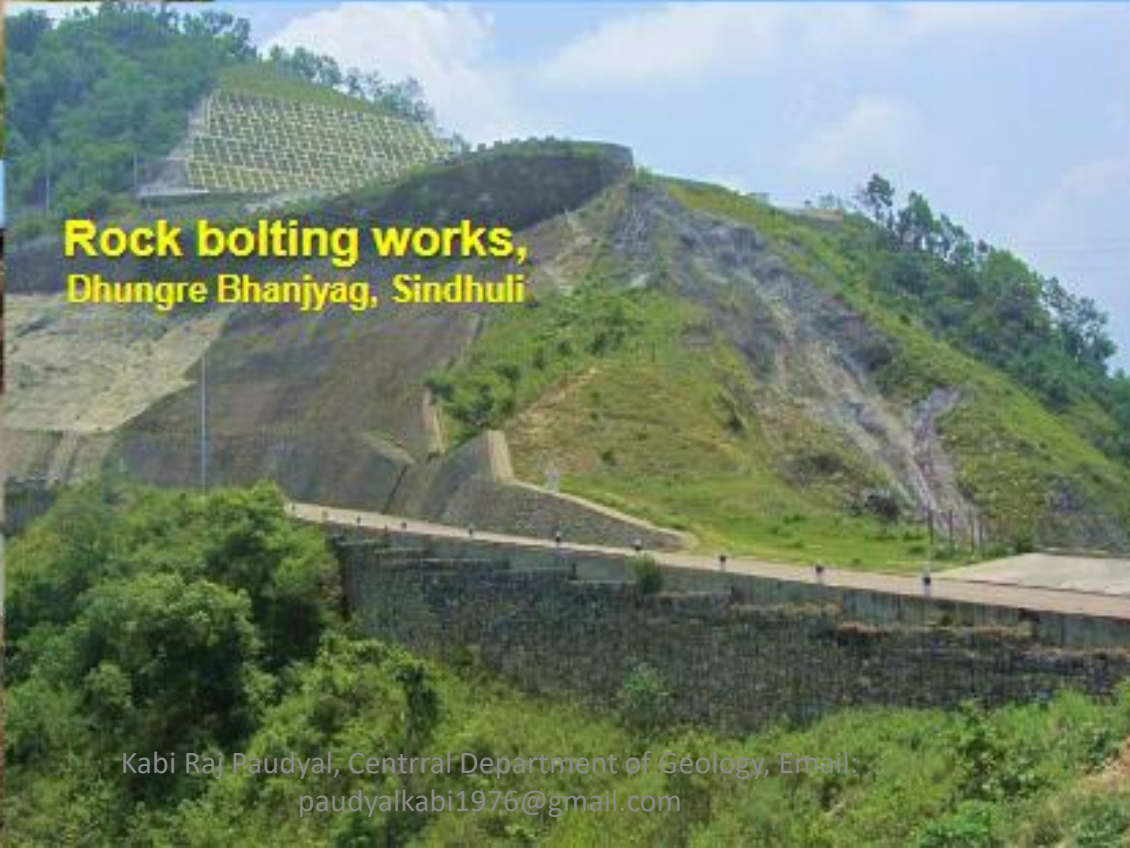
**Rock bolting works,  
Dhungre Bhanjyang, Sindhuli**

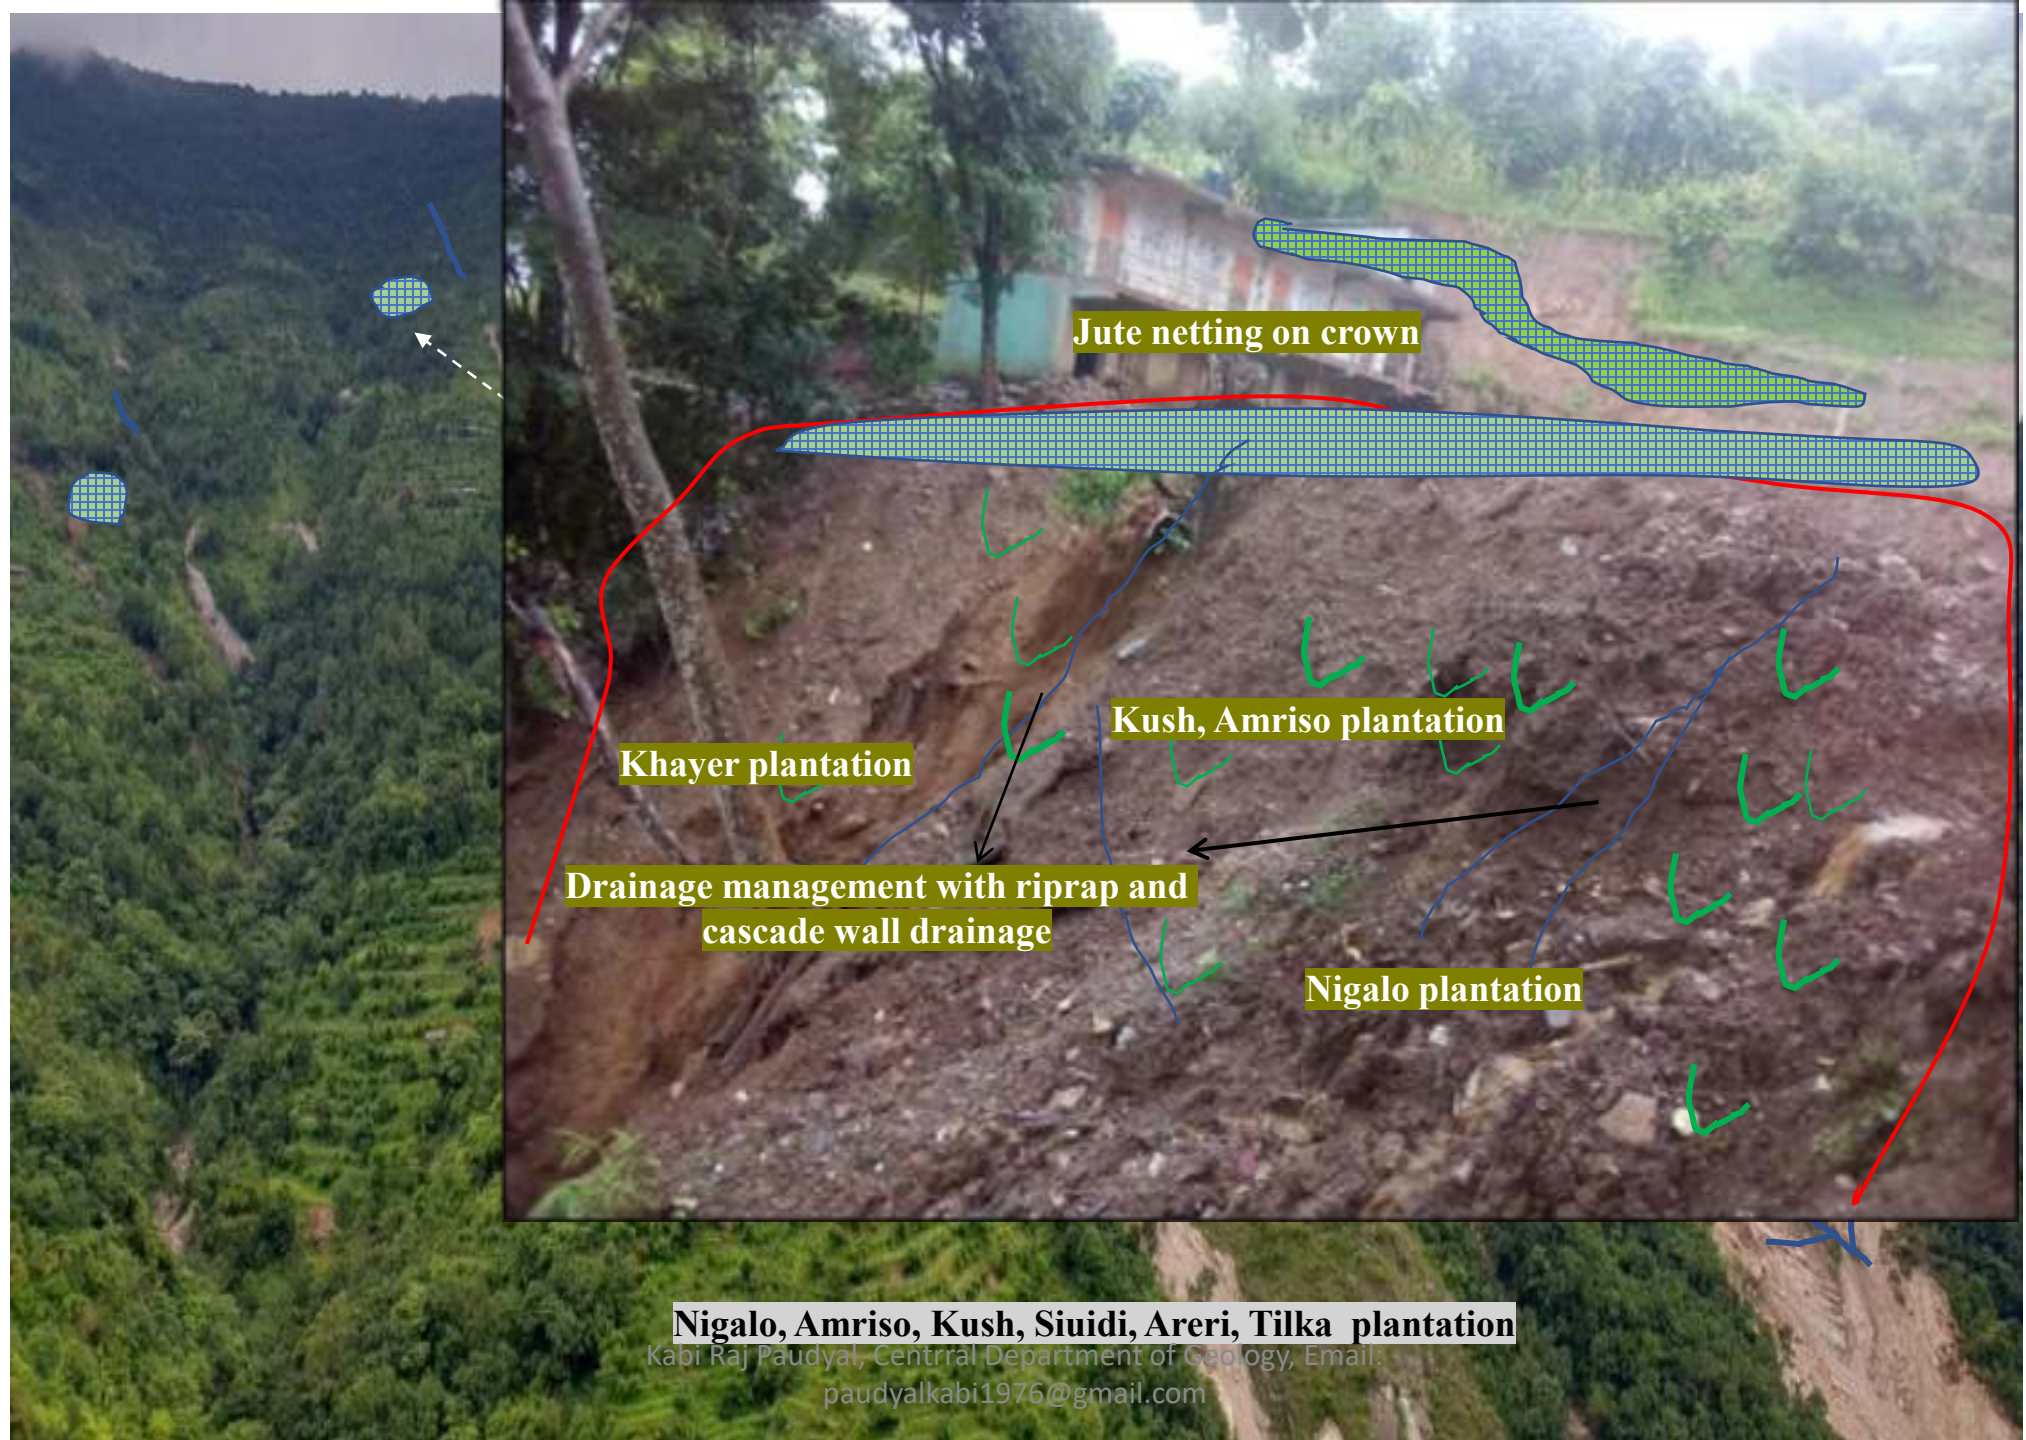
**Jute netting on crown**

**Kush, Amriso plantation**

**Khayer plantation**

**Drainage management with riprap and cascade wall drainage**

**Nigalo plantation**

**Nigalo, Amriso, Kush, Siuidi, Areri, Tilka plantation**
