# Present Status of Landslides in Nepal and way forward

**Kabi Raj Paudyal, PhD**

Coordinator: Master in Engineering Geology Program, Central Department of Geology

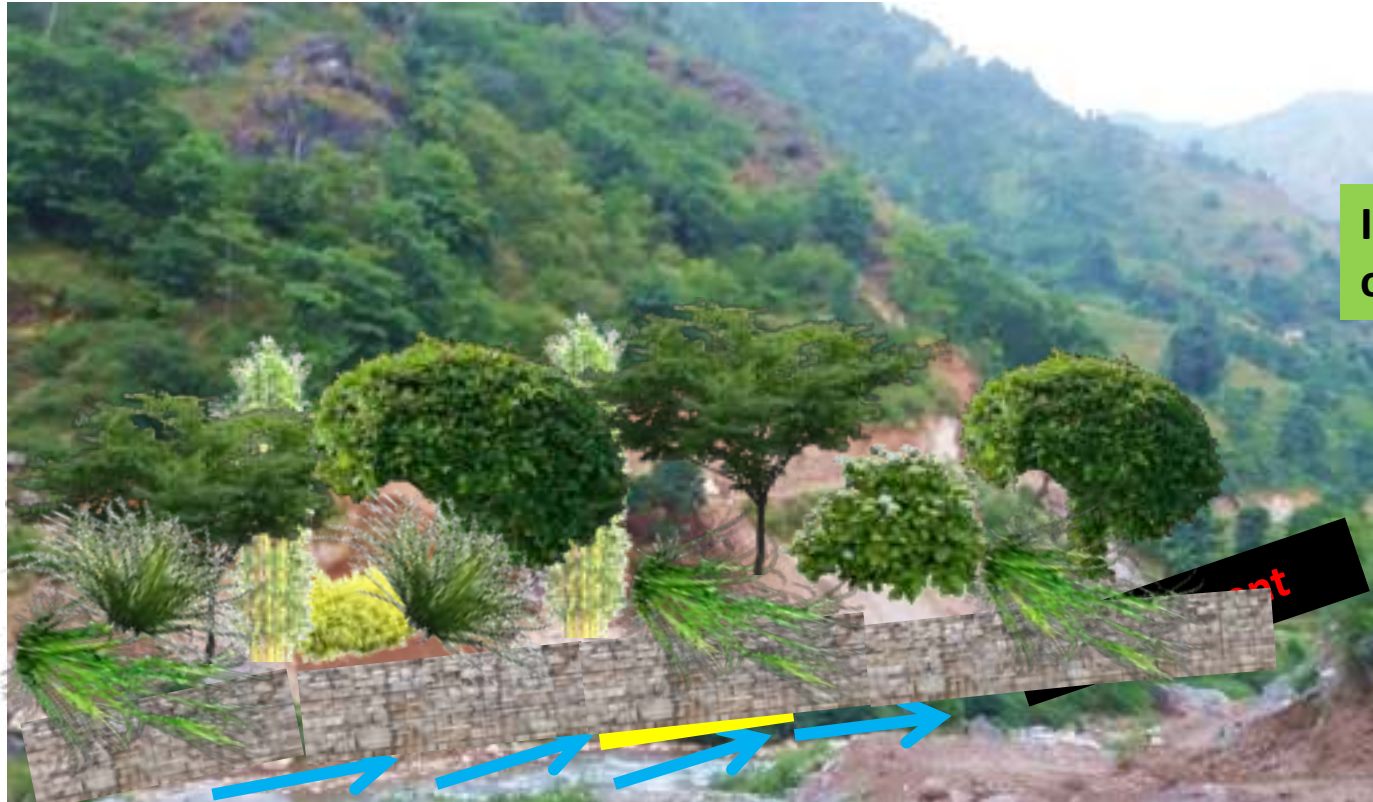
**Mitigation of road cut slide by various process, such as embankment and bioengineering. First priority is not to excavate in this geologically unstable region.**
