# Drone-Based Rapid Assessment of Melamchi Flood 2021

### **Melamchi Flood 2021**

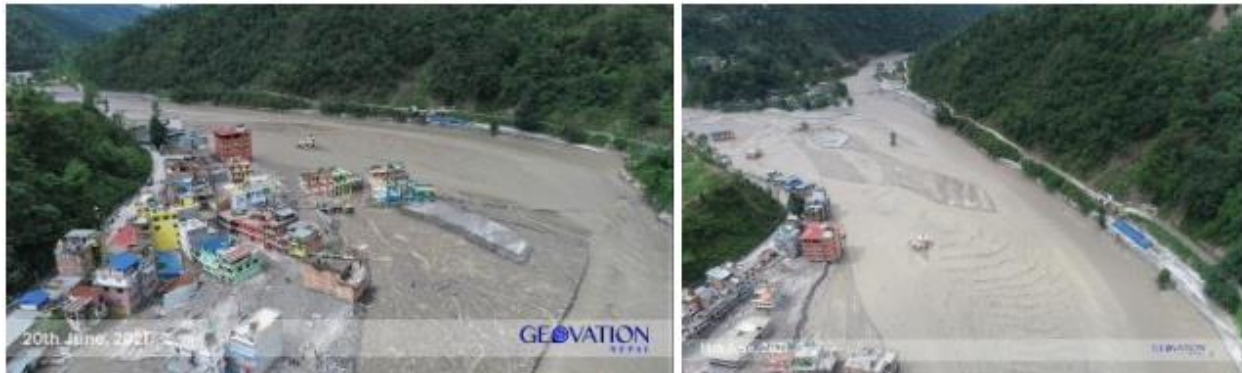
*Photo of Melamchi Bazar and flood plains on the left and photo near the confluence of Indrawati-Melamchi river on the right from the drone survey (2021/06/20)*

Melamchi Bazar area, Sindhupalchowk district, was just recovering from the heavy impact of the earthquake. The prolonged rainfall during this early monsoon season triggered the unstable slopes in the Melamchi region generating numerous landslides. One of these landslides blocked the Melamchi River for a few hours creating Landslide Dam. This dam could not withstand the large amount of incoming water and burst generating flash floods with lots of debris downstream. The images obtained from the Planet lab also confirm that huge sediments were deposited at multiple places upstream. The flood carried a mixture of sand, boulders, and wood fragments. This is a typical example of the cascading effect of multiple hazards in the mountains.

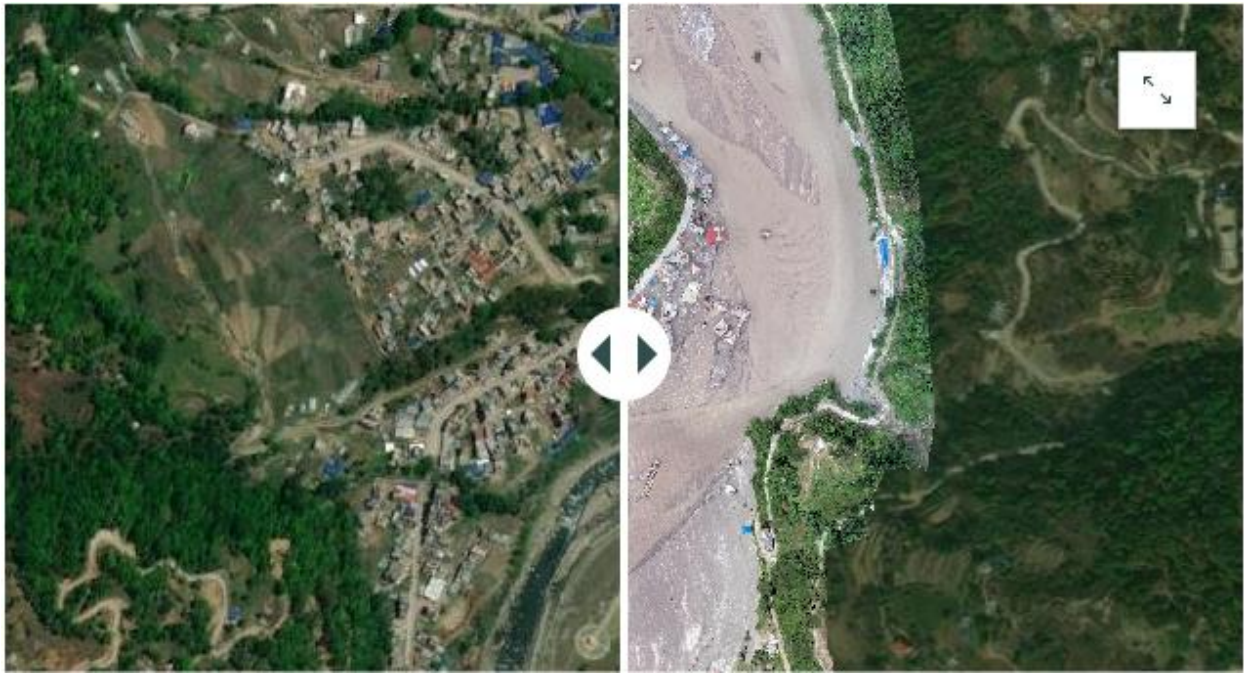
## Before and After

*Baseline imagery from Maxar compared to drone-collected imagery from Geovation Nepal ( June 18, 2021)*
