# Rainfall triggered flow-like landslides: Understanding from southern hills of Kathmandu, Nepal and Northern Shikoku, Japan

**Abstract:** Flow-like landslides triggered by rainfall are very prominent in Nepal and Shikoku, Japan. In July 2002, many landslides occurred in the southern hills of the Nepalese capital, Kathmandu, because of torrential rainfall. A single flow-like landslide occurred at Matatirtha, a small village situated at the south marginal hill of Kathmandu, killing 16 people who lived at the foot of the hill. Much damage was caused to roads and houses because of landslides and debris flows in small streams.

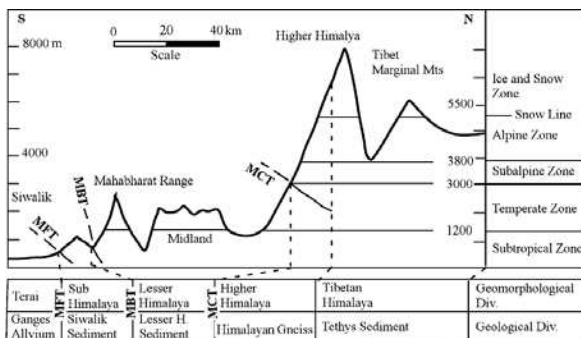
**Figure 1.** Cross section of Nepal Himalaya, MCT (Main Central Thrust), MBT (Main Boundary Thrust) and MFT (Main Frontal Thrust) make Himalaya tectonically active and dynamic mountain of world (modified after Upreti and Yoshida, 2005 and Kizaki, 1994).

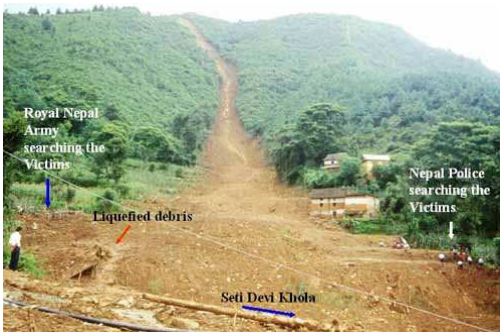
**Figure 4.** Flow-like landslide of Matatirtha, July 2002, site after 40 hours

In Nepal, it is felt that flow-like landslides affect human settlements, bridge and roads by destroying and burying (Figure 3). In the year 2002, many flow-like landslides occurred along southern marginal hills of Kathmandu and damaged many infrastructures. Single flow-like landslide occurred in Matatirtha, a small and beautiful village situated at the south western marginal hill of the capital city Kathmandu killed 16 people inhabiting on the base of the hill (Figure 4 and Figure 5). Although some more flow-like landslides occurred in southern marginal hills, the Matatirtha was most devastating one. Some of flow-like landslides also damaged road of hills (Figure 6) but casualty was not reported.

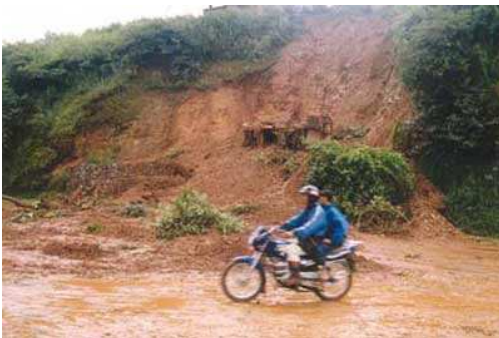
**Figure 6.** Flow-like landslide on roadside slopes of southern hills of Kathmandu, triggered by Rainfall of July 2002

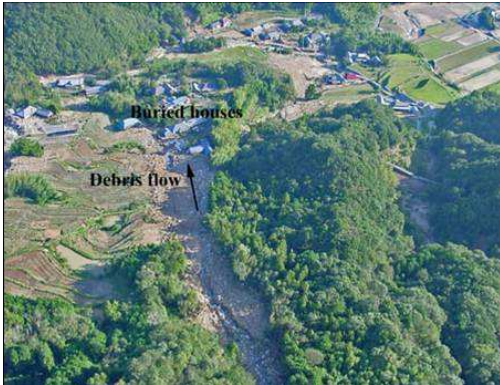
Figure 9. Buried village in Moriyoiki (see Figure 7 for location)

There is a good rainfall measurement system in Shikoku Region and it is available on the internet also. During typhoon of 2004 August to October, there is extreme rainfall occurred in central northern Shikoku and north east Shikoku (Figure 8, Figure 9 and Table 2).

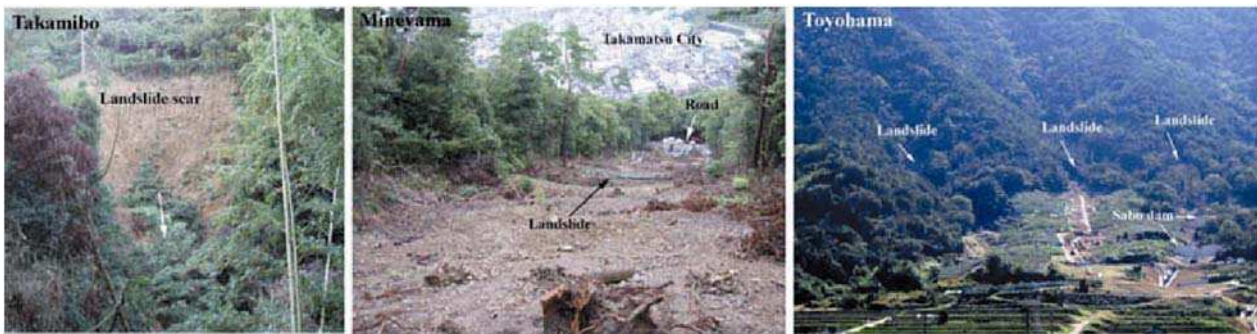
**Figure 11.** Rainfall triggered flow-like landslide in Kagawa (Takamibo, Mineyama and Toyohama)

There is much local scale damage in highway and forest areas around Takamatsu City (regional headquarter of Shikoku). Middle Kagawa is also affected by the typhoon and there are many slides in forest area also (see Figure 7). Takamibo forest area and Mineyama landslide near to Central Takamatsu are some examples. Landslides occurred at base of hills in Toyohama city (Figure 11 and see Figure 7 also) are some other examples of flow like landslides of west Kagawa.

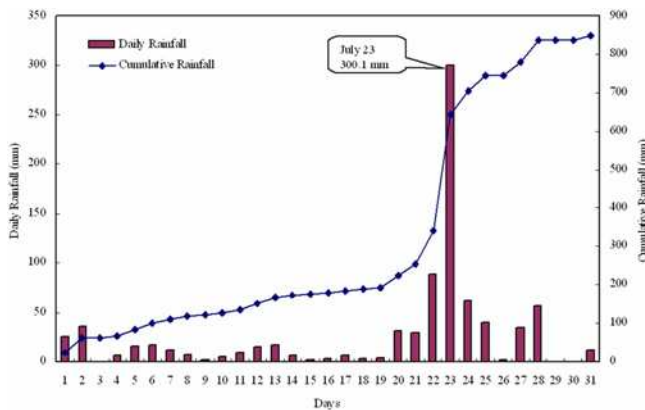
Figure 14. Rainfall pattern of Thankot area in the year 2002

From the meteorological point of view, the month of July is very critical for the southern hills. There are not much rain gauge station and hourly rainfall data is also not available. Most nearest rain gauge station from the failure area is in Thankot (situated at about 1.5 to 3 km aerial distance from Matatirtha and other slides see Figure 12). Plotting of last 32 years rainfall data of south and south-west Kathmandu reveals that month of July of every year has been facing maximum rainfall (Figure 13). Rainfall data recorded by the Department of Hydrology and Meteorology (DMG) at its Thankot station is 300.1 mm at 24 hr in the day of major failures, i.e. 23 July 2002 (Figure 14).
