Nepal Disaster Report 2015

4.4 Seti Flash Flood: Technical Analysis and DRR Interventions

Deo Raj Gurung¹, Sudan Bikash Maharjan², Narendra Raj Khana³, Govinda Joshi⁴, M.S.R.Murthy⁵

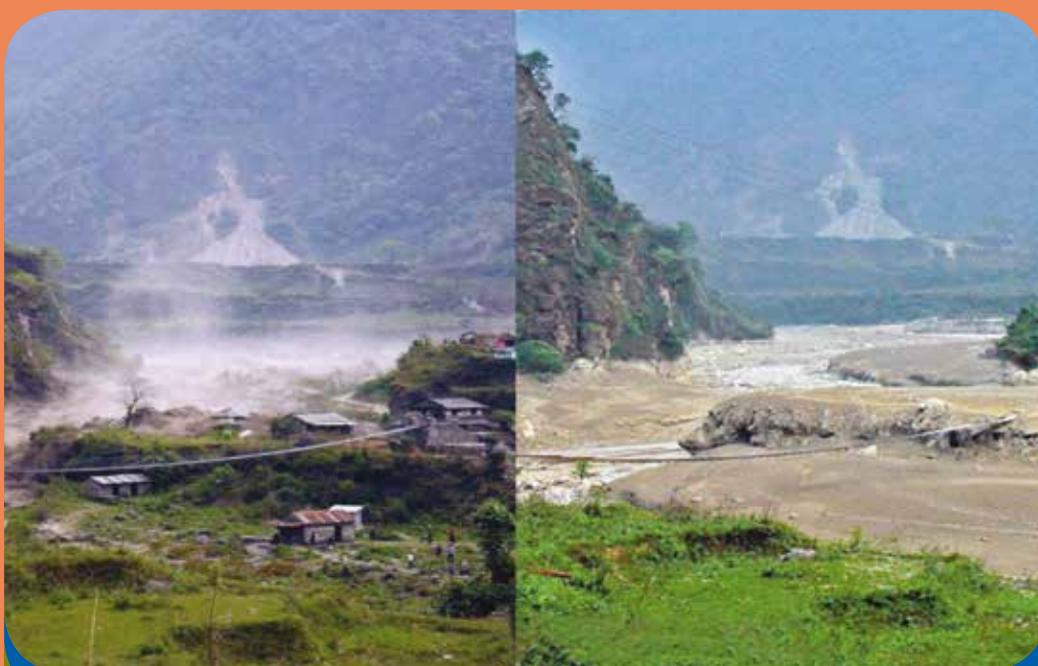
Before the Seti River Flood Disaster

After the Seti River Flood Disaster on 5 May 2012

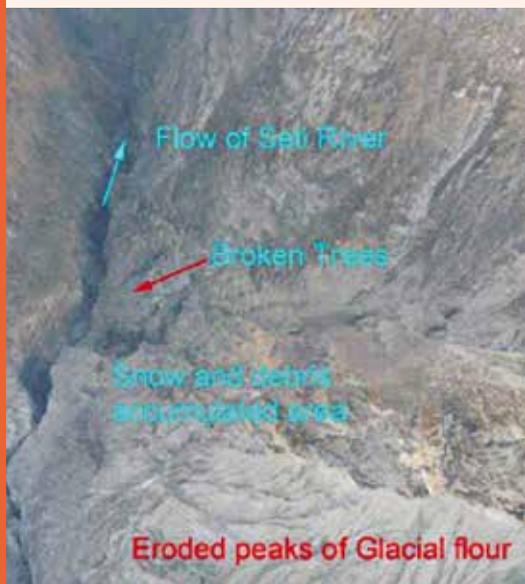
Photo 1. Narrow and deep gorge in the upper reaches of Seti River. Also visible are fallen trees due to air blast the avalanche in ensuing processes generated (Source: [2]).

Dimension of the failure that initiated the avalanche is summarized in Table 1. The avalanche made near vertical fall of about 1,500m from 6,700 m asl to 5,200m asl [7] which generated high potential energy rock enough to pulverize unconsolidated rock debris (glacial moraines and ancient glacial lake silts and gravels) resting unstably in the deep bowl of the Sabche Cirque [8]. The volume of material that fell on the base of the Sabche Cirque is estimated as 14,500,000m³, while the volume of debris which flowed into the Seti River was calculated at around 18,230,000m³ [6]. Estimate velocity of the avalanche was 200km/hr [6] and the high energy fall caused the failed rock mass to disintegrate into pieces producing a large amount of dust clouds, and frictional heat produced due to debris movement melted ice and snow which formed hyperconcentrated slurry flows leading to even accelerated movement of the debris towards the Seti gorge [6]. The high speed avalanche created air blast strong enough to fell trees along the right flank of the upper part of Seti gorge (Photo 1).

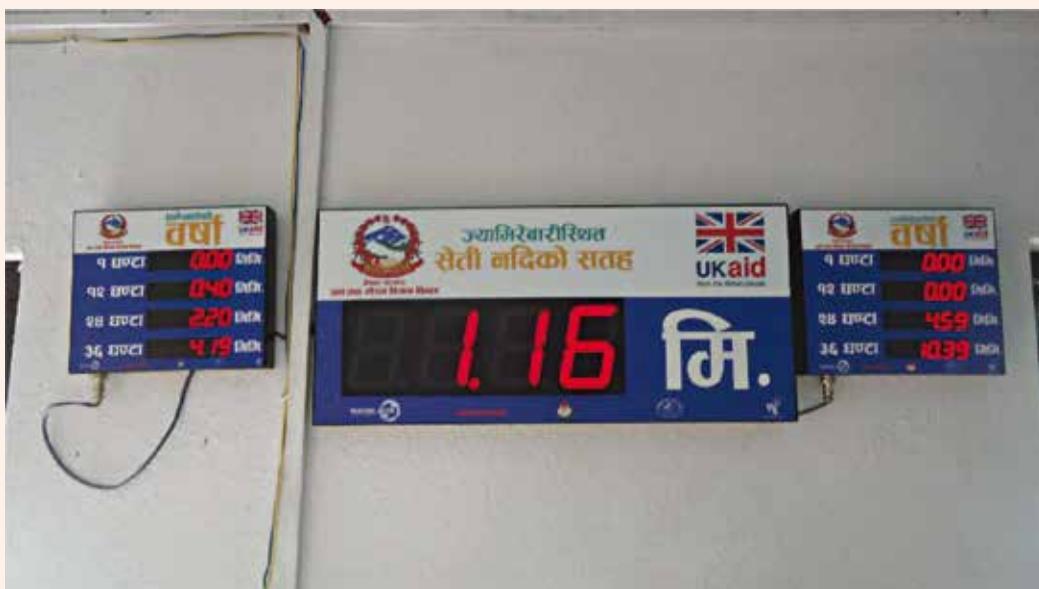
Photo 2. Display board at District Administrative Office, Pokhara displaying river water level.
