Mitigating Earthquake Risk
in Health Facilities

A Structural Vulnerability Assessment of Hospitals in Kathmandu Valley

Kathmandu, Nepal
August 2002

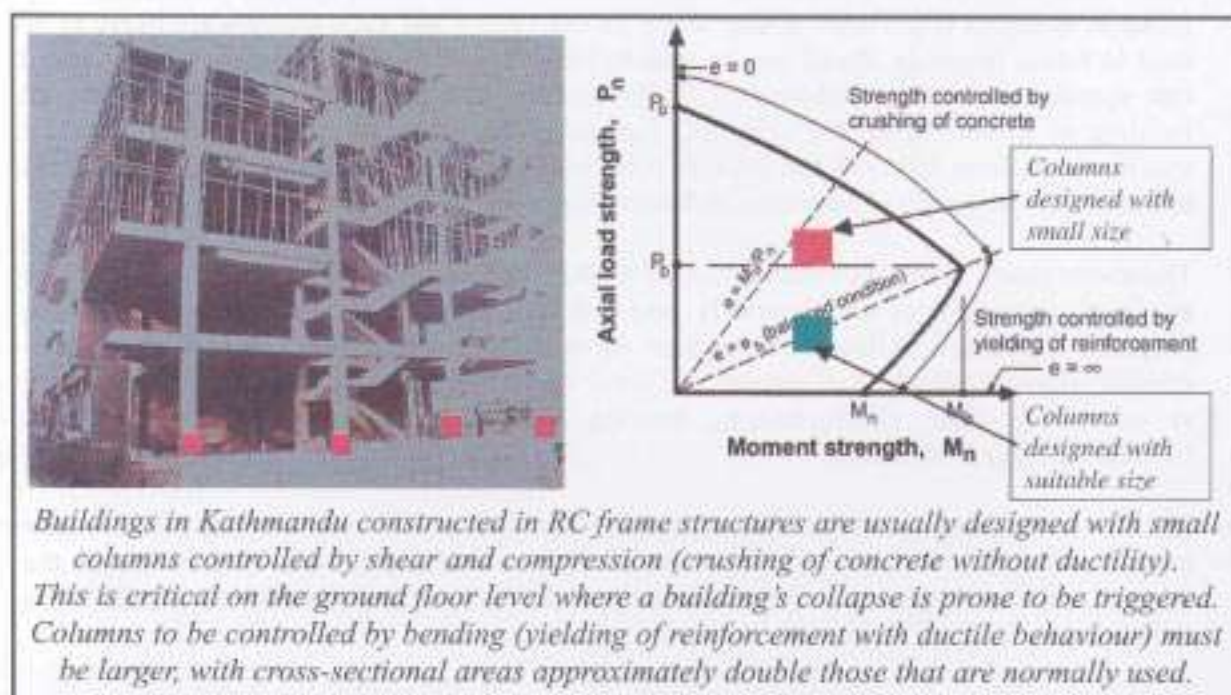
In some hospital buildings and most of the ordinary buildings in Kathmandu Valley the size of columns was found to be insufficient at the lower levels. The use of small columns in moment-resistant-frame-structures reduces strength capacity and ductility to withstand moderate and high intensity earthquakes (MMI = VIII–IX) and was found to be one of the major potential causes of building collapse in RC structures.

When column size is insufficient, the failure mechanism is fragile, without ductility, and is controlled by compression and shear. Buildings built with small columns will collapse in a "pancake" mode (slab on slab) and the life-safety target is not achieved.

Larger columns than those normally used in Kathmandu need to be designed and constructed. The small size of columns is critical at the ground floor level, where a weak storey can usually be found and a building's collapse is expected to be triggered.

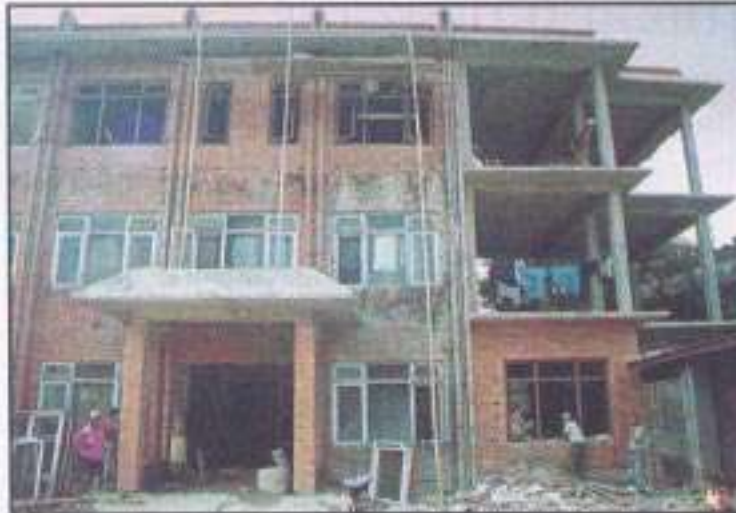
Birendra Police Hospital

Columns are 23 x 23 cm (9 x 9 inches) in size, from ground to top floor.

They should be 40 x 40 cm at the ground floor, 35 x 35 cm at the first floor, and 30 x 30 cm at the top (second) floor.

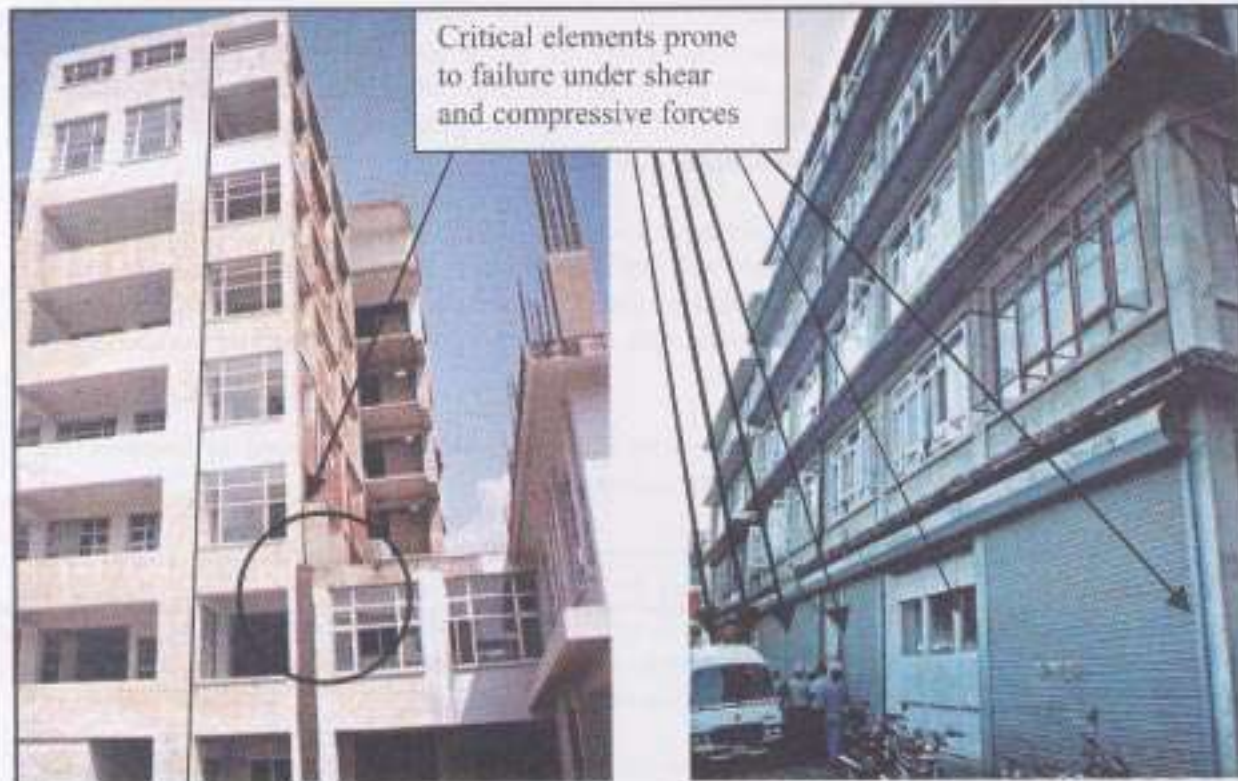
Critical elements prone to failure under shear and compressive forces

Left: Nepal Medical College at Aterkhel. An 8-storey building that is under construction. Columns are 45 x 45 cm throughout the building. 70 x 70 cm columns are required on the ground floor. Right: Model Hospital's surgery block at Baghbazar. A 5-storey building with 23 x 23 cm columns. On the ground floor 50 x 50 cm columns are required. Private hospitals are usually designed like ordinary buildings using RC structures.

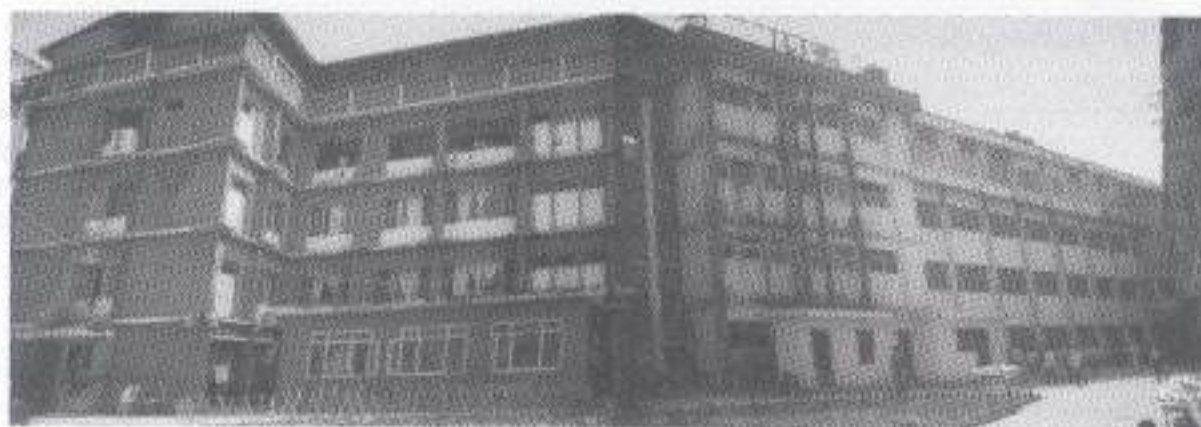
Left building: "L" (intensive care block). Central building: The "wedge". Right building: One of the "I" building wings (surgical block) connected to a yellow "V" building (VIP block) by a "weak corridor".

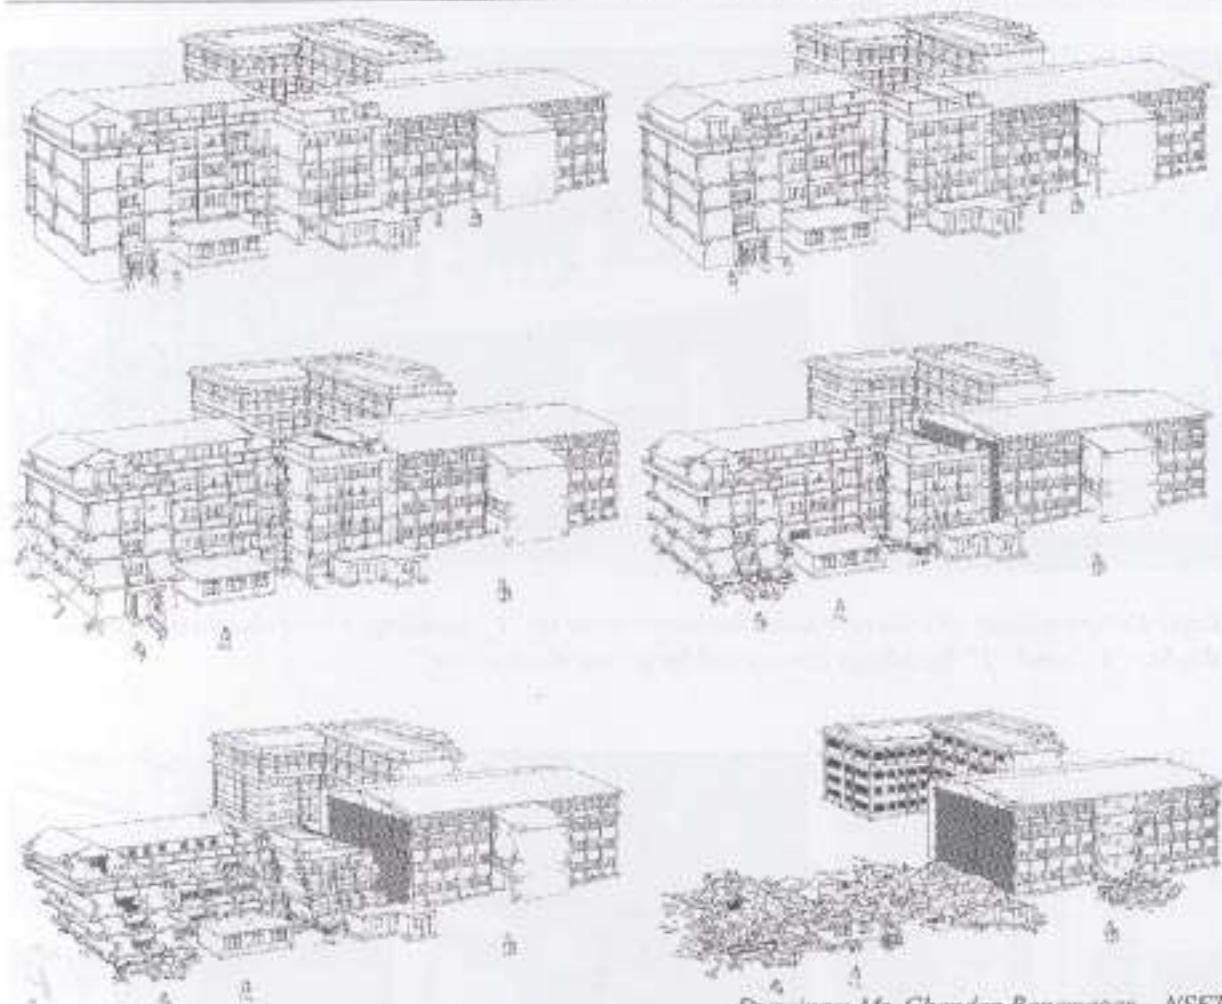
*Probable pattern of collapse to "L" building, or intensive care unit,
during a MMI = VII earthquake.*

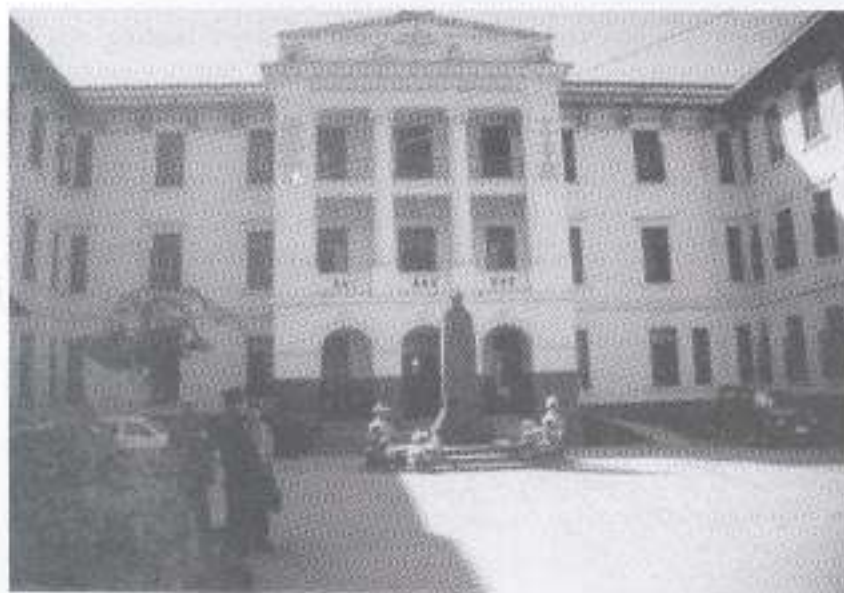
The Old Military Hospital building, which is considered to be able to withstand up to intensity MMI = IX earthquakes.

It is of low structural vulnerability because of its thick walls (70 - 80 cm).

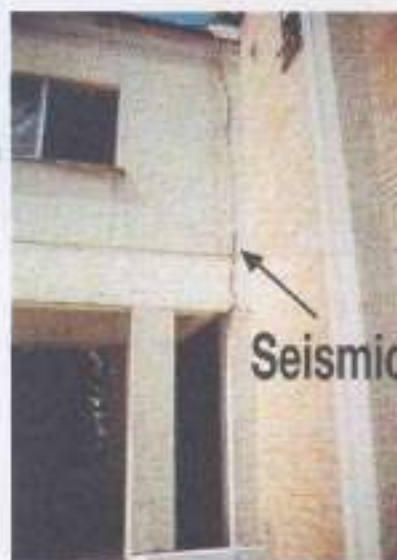
Seismic joints are not totally open. The buildings can dynamically interact and pound during earthquakes. This may cause slight to moderate damage to non-structural components during high intensity earthquakes (MMI = IX).

Left: A seismic joint between block B and a weak corridor connecting it with block C. Mortar plastering has already cracked due to previous ground shakings.

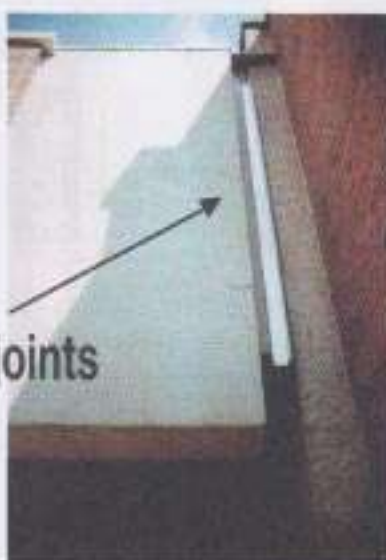
Middle: Small cracks can be found in masonry walls due to pounding between structures. The buildings are interacting to some extent. This may cause slight to moderate damage to non-structural components during high intensity earthquakes (MMI = IX).

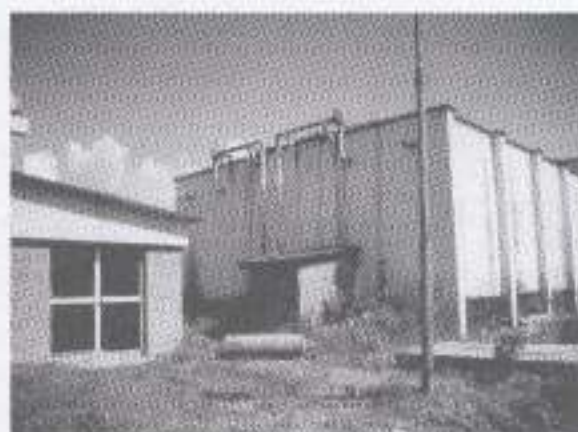
Left: Water tanks (12 cubic-metres in capacity) on the roofs of buildings. The stability of such structures under intensity MMI = VIII-IX earthquakes need to be assessed.

Right: The main tank of the water treatment plant which is large enough to cope with water demand for at least a week.

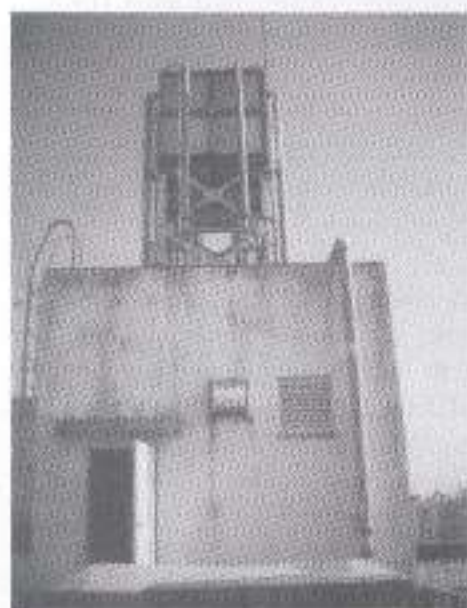
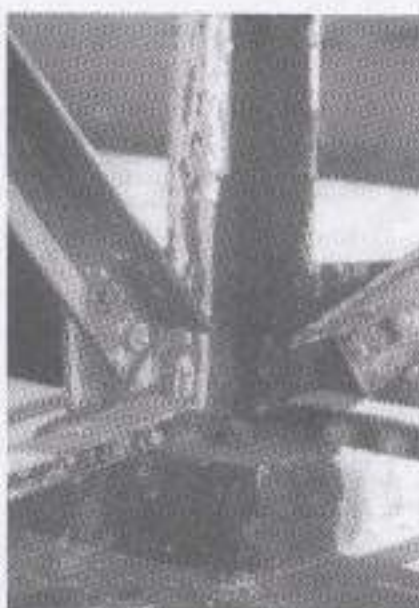
Left: A 12 cubic-metre water tank on the roof of a 4-storey block.

Right: The strength capacity of water tank restraints should be checked.

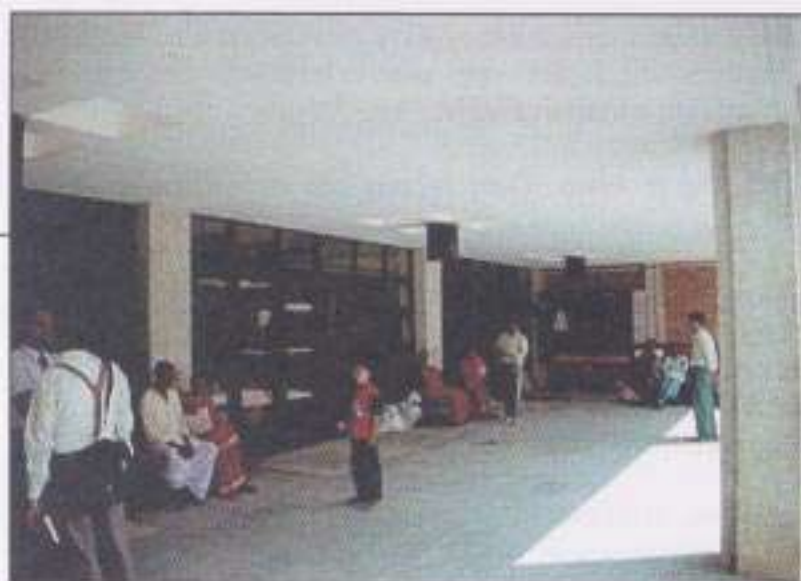
Entrance Hall of block A, next to the emergency department room.

This is a potential area into which the emergency department area can be extended.

It is also recommend that the stability of the glass wall located in this area is increased.

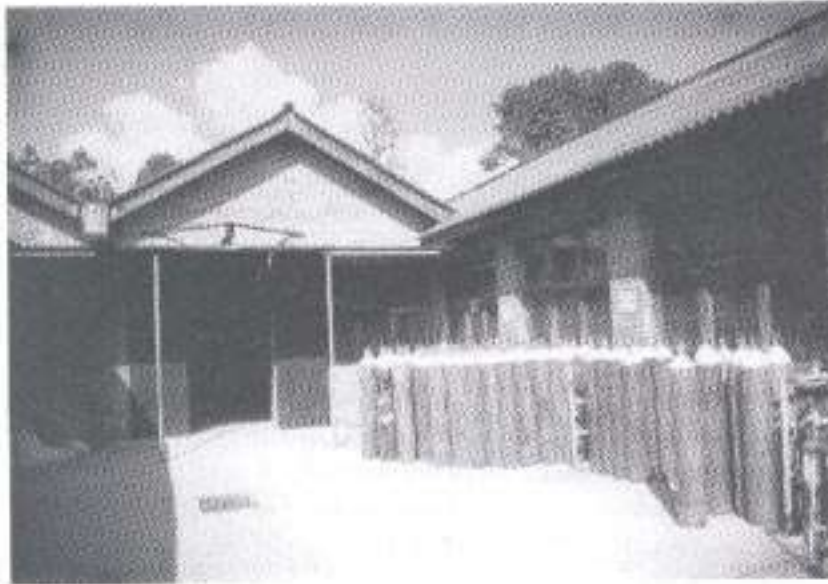
The oxygen room stores 10 cylinders. Most of the cylinders are stored outside, some are full and others empty, waiting for replacement from outside the hospital. These cylinders are not restrained to prevent overturning. The hospital is planning to build a central room for oxygen to cope with the hospital's requirements, but the location has not yet been decided and there are financial problems related to this construction.

Oxygen cylinders storage area.

To reduce non-structural vulnerability it is necessary to keep all of the slender equipment which can be harmful to people well-fitted and restrained against overturning.

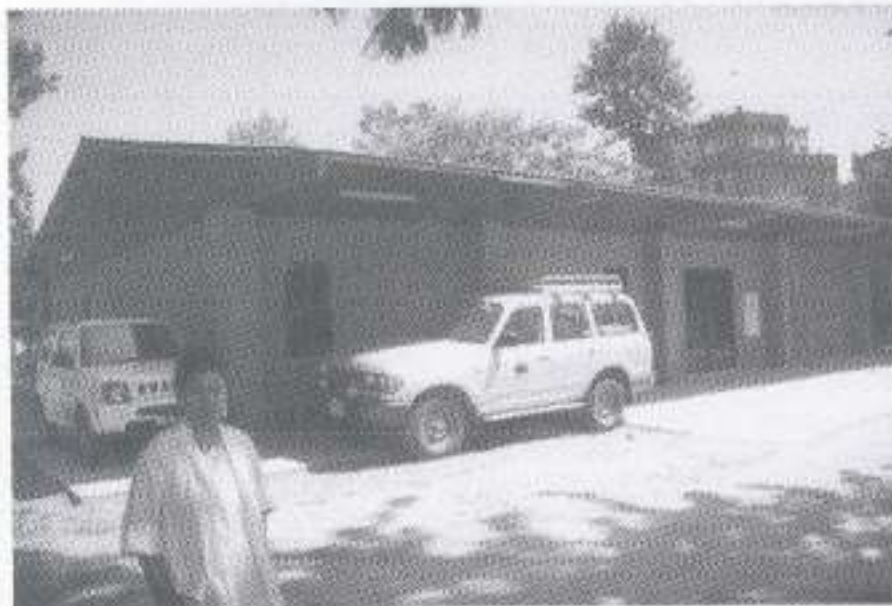
The emergency block. An earthquake resistant building with 7 observation beds. This is a new facility constructed in 2001.

It is not operating yet, because of a lack of furniture, medical equipment and electricity supply. It is of high priority to make it operational.

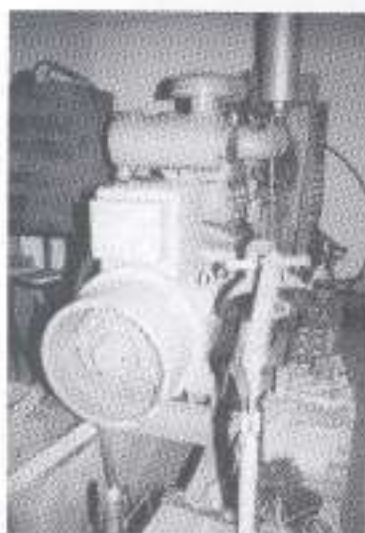
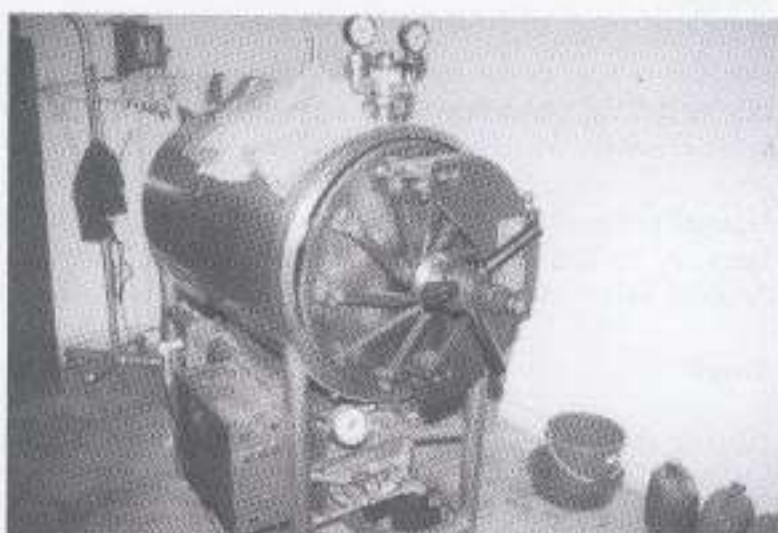
Left: Manually operated emergency-backup electricity generator.

Right: Main autoclave at the central sterilisation supply department (CSSD). In the event of a shortage of electricity from the city network, the autoclaves at CSSD will not be functioning. The backup generator can only supply electricity to operating theatres and the emergency department.

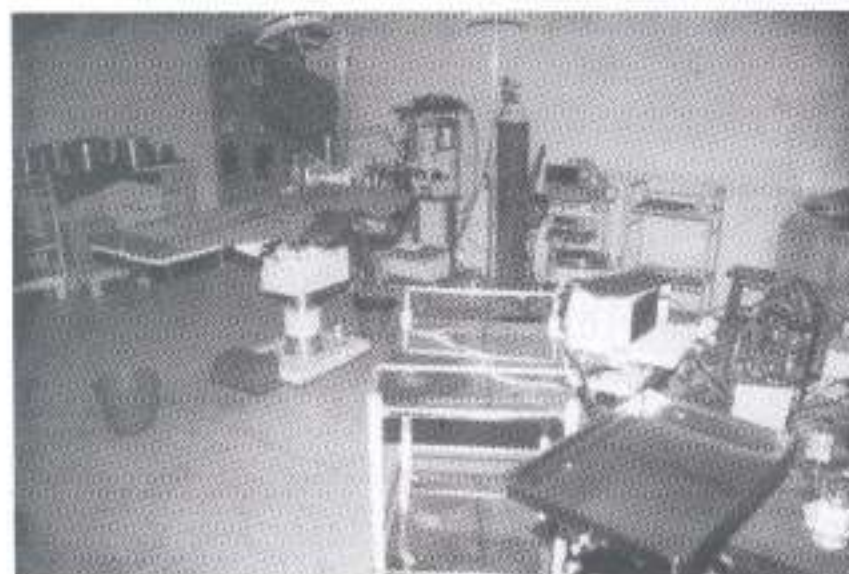
Main operating theatre. Less than 8 minor and major surgeries are conducted in the hospital per day. There is no intensive care unit.

An undesirable contrast: low demand from the community during most of the year, while a very big demand is expected during earthquake emergencies.
