Government of Nepal
Ministry of Physical Planning and Works
Department of Urban Development and Building Construction
**Earthquake Risk Reduction and Recovery
Preparedness Programme for Nepal**

SEISMIC VULNERABILITY EVALUATION GUIDELINE FOR PRIVATE AND PUBLIC BUILDINGS

May 2011

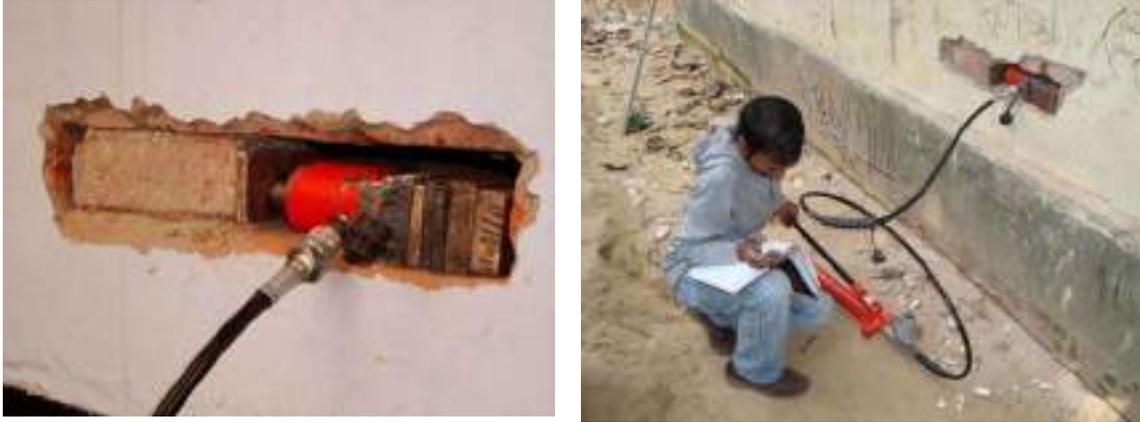
Inspect the collar joint and estimate the percentage of the collar joint that was effective in resisting the force from the ram. The brick that was removed should then be replaced and the joints re-pointed.

Fig 3. Test Set up for In-Situ Shear Test

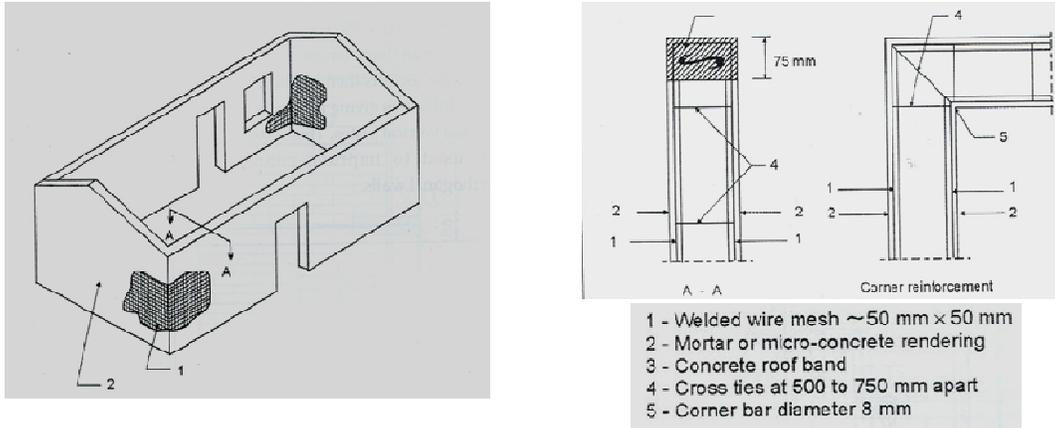
Fig 5.(a) General Scheme of Jacketing

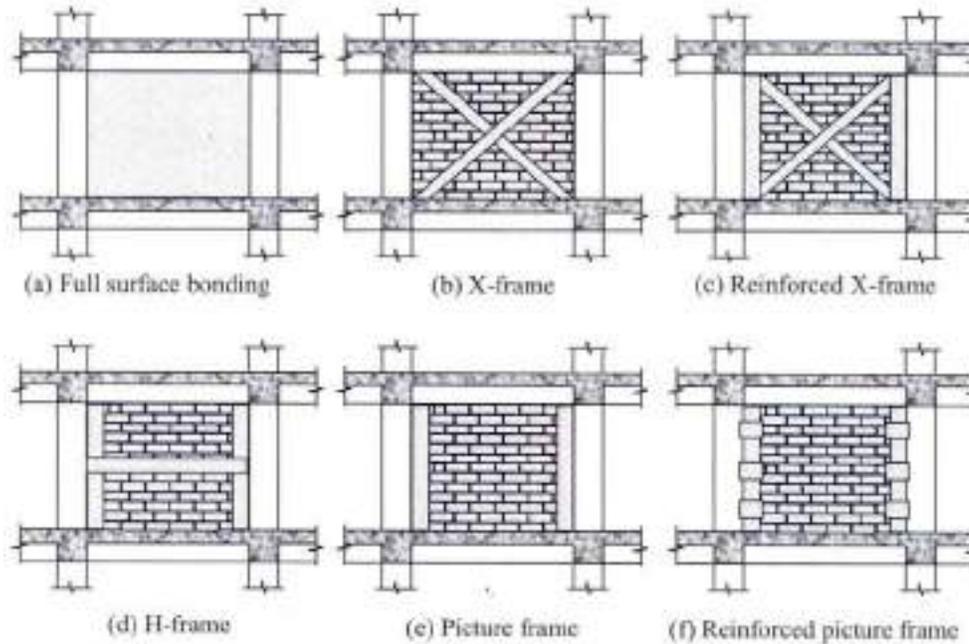
Even though the materials used in FRP are relatively expensive as compared to the traditional strengthening materials such as steel and concrete, the labor, equipment and construction costs are often lower. It is a promising technique since its application is more easy and rapid with minimum disturbance to the occupants. Application of FRP, with care, provides significant increase in lateral strength but it does not provide as much ductility as the RC wall would provide, because of the brittleness of the material. For effective use, a firm anchorage should be provided between FRP and the wall panel. The possible schemes of layout of FRP wraps are shown in the figure below.

Fig 9. Configurations of FRP Laminates of Masonry Walls

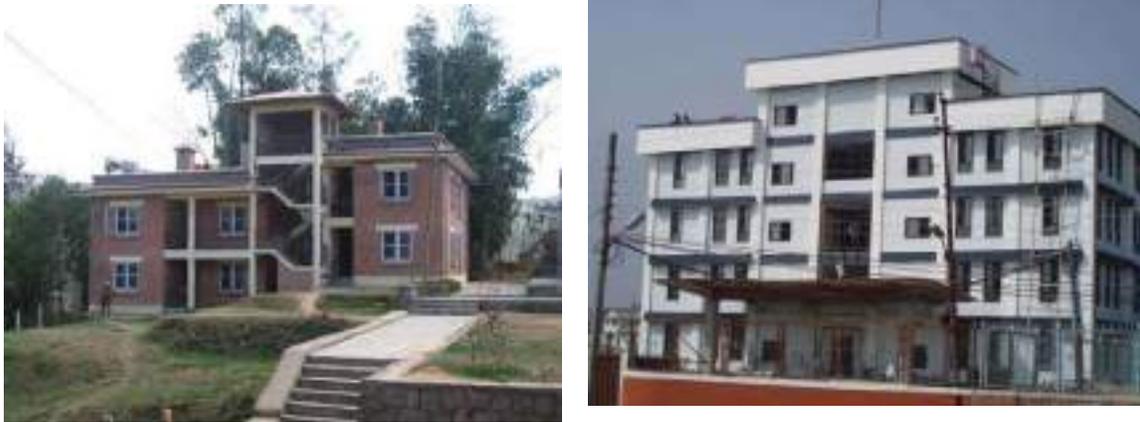
The seismic performance of this type of construction depends on the interaction between the frame and the infill panels. The combined behavior is more like that of a shear wall structure than a frame structure. Solidly in-filled masonry panels form diagonal compression struts between the intersections of the frame members. If the walls are offset from the frame and do not fully engage the frame members, the diagonal compression struts will not develop. The strength of the infill panel is limited by the shear capacity of the masonry bed joint or the compression capacity of the strut. The post-cracking strength is determined by an analysis of a moment frame that is partially restrained by the cracked infill. The shear strength of the concrete columns, after cracking of the infill, may limit the semi ductile behavior of the system.

Fig 1.4 Engineered Reinforced Concrete Moment Resisting Frame Buildings

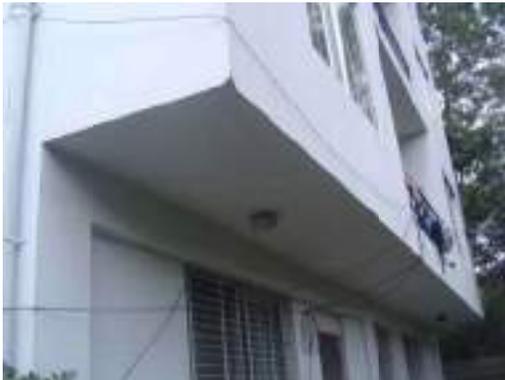
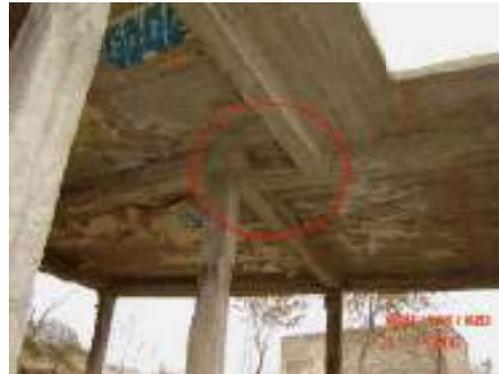
Examples of such structures would include a masonry shear wall that does not extend to the foundation, or a column in upper storey that does not continue to foundation.

Fig 2.1 (a) Full Brick Wall on Cantilever Slab Projection

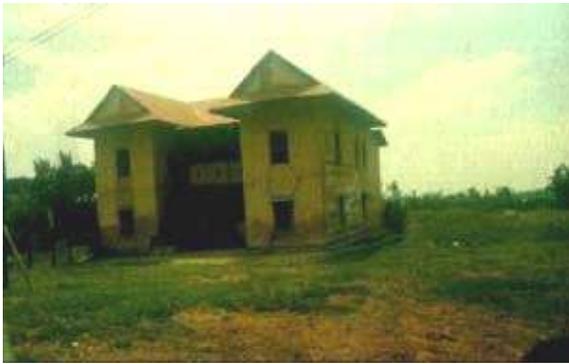
Fig 2.3 (a) U Shaped Building

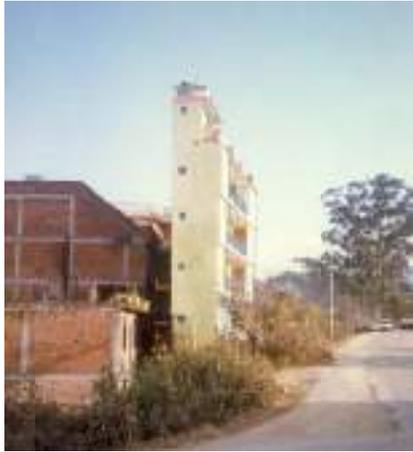
A distinction should be made between redundancy and adequacy. The redundancy mentioned here is intended to mean simply "more than one." This should not be interpreted as for large buildings two elements are adequate and for small buildings one is not enough.

Fig 2.4 (a) Single Bay RC Frame Building

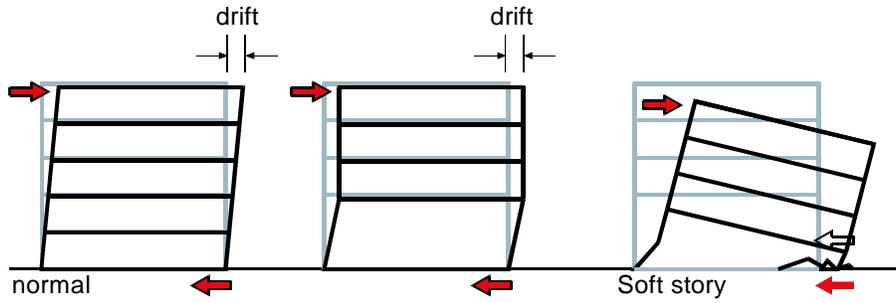
The difference between "soft" and "weak" stories is the difference between stiffness and strength. A column may be slender but strong, or stiff but weak. A change in column size can affect strength and stiffness, and both need to be considered.

Fig 2.5 (a) Soft Storey due to Excessive Floor Height in Ground Storey

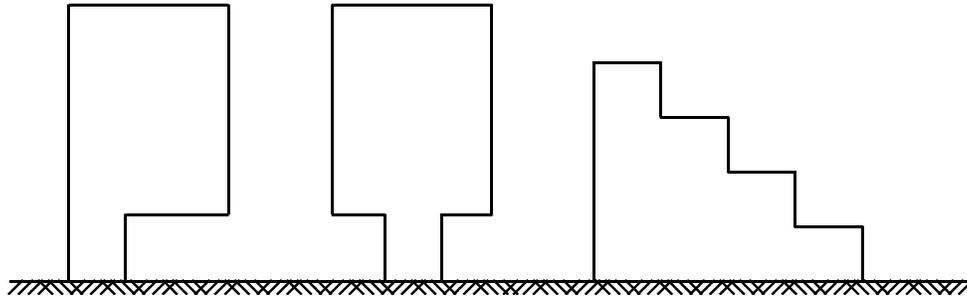
Geometric irregularities are usually detected in an examination of the storey-to-storey variation in the dimensions of the lateral-force-resisting system. A building with upper stories set back from a broader base structure is a common example. Another example is a storey in a high-rise that is set back for architectural reasons. It should be noted that the irregularity of concern is in the dimensions of the lateral-force-resisting system, not the dimensions of the envelope of the building, and, as such, it may not be obvious.

Fig 2.6 (a) Vertical Irregularity in Buildings

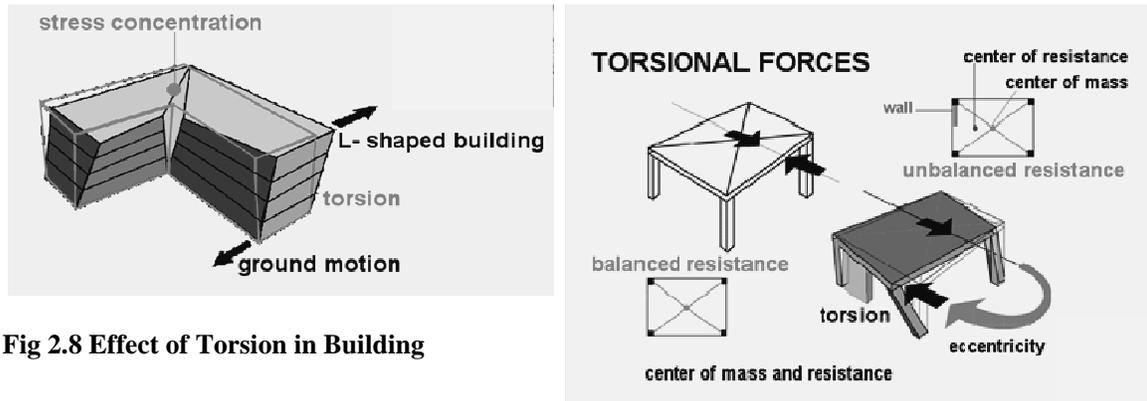
Whenever there is significant torsion in a building, the concern is for additional seismic demands and lateral drifts imposed on the vertical elements by rotation of the diaphragm. Buildings can be designed to meet code forces including torsion, but buildings with severe torsion are less likely to perform well in earthquakes. It is best to provide a balanced system at the start, rather than design torsion into the system.

Fig 2.8 Effect of Torsion in Building

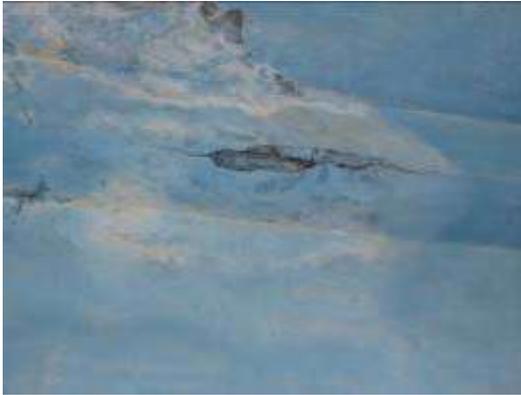
Fig 2.9 (a) Delamination due to Seepage of Water

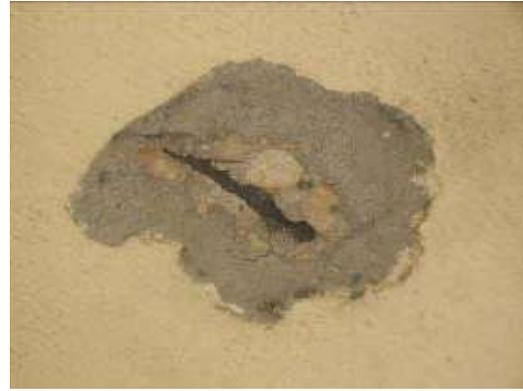
Deterioration is a concern when the concrete cover has begun to spall, and there is evidence of rusting at critical locations.

Fig 2.9 (b) Rusting of Steel Bar

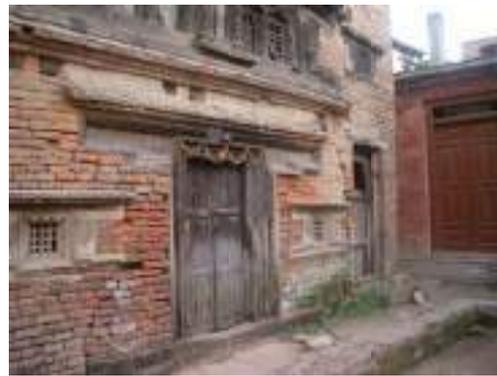
Deteriorated or poor quality masonry elements can result in significant reductions in the strength of structural elements. Older buildings constructed with lime mortar may have surface re-pointing but still have deteriorated mortar in the main part of the joint. Mortar that is severely eroded or that can easily be scraped away has been found to have low shear strength, which results in low wall strength.

Fig 2.10 Problem due to Deterioration of Masonry Units and Joints

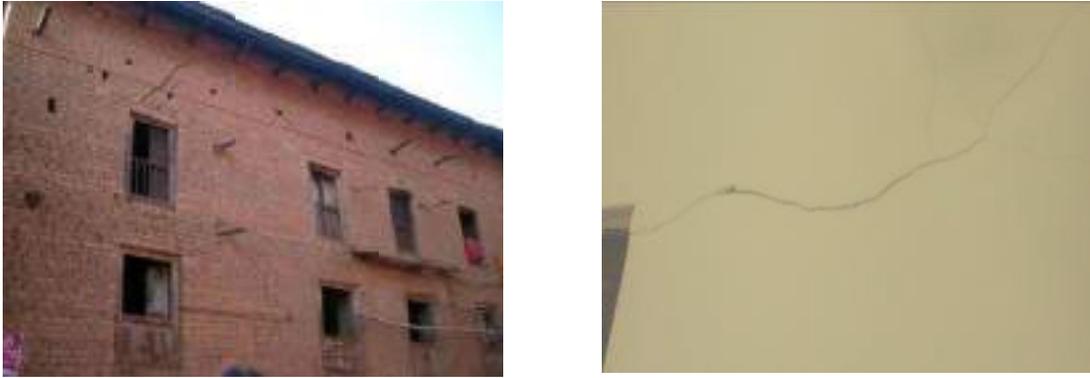
Crack width is commonly used as a convenient indicator of damage to a wall, but it should be noted that other factors, such as location, orientation, number, distribution and pattern of the cracks to be equally important in measuring the extent of damage present in the shear walls. All these factors should be considered when evaluating the reduced capacity of a cracked element.

Fig 2.11 Problem due to Crack in Brick Wall

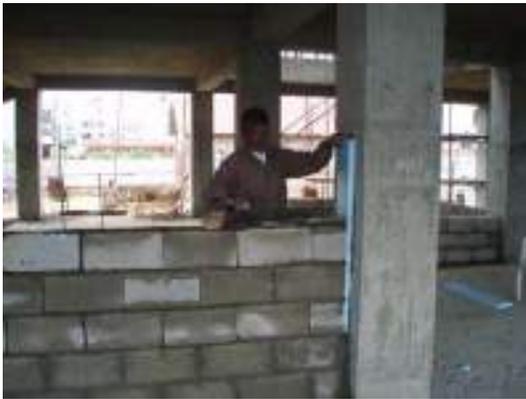
A positive connection is needed to anchor the infill panel for out-of-plane forces. In this case, a positive connection can consist of a fully grouted bed joint in full contact with the frame, or complete encasement of the frame by the brick masonry.

Fig 2.12 (a) Separation of Infill Wall from Frame using Flexible Material

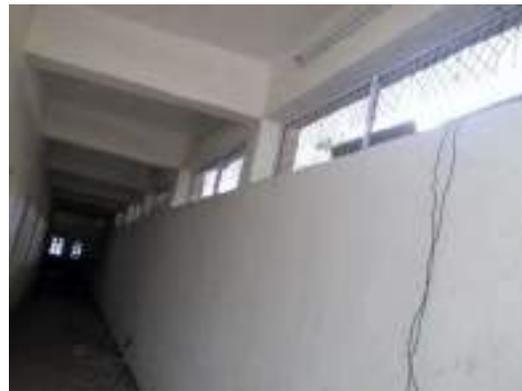
A captive column that can develop the shear capacity to develop the flexural strength over the clear height will have some ductility to prevent sudden non-ductile failure of the vertical support system.

Fig 2.13 (a) Beam at Mid Height of Column

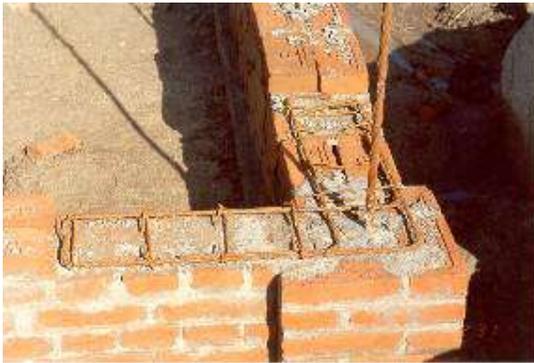
Unreinforced Masonry walls have very low (almost negligible) tension resisting capacity. Hence, the presence of bands at lintel, sill and roof level, corner stitches, vertical reinforcements at corners and junctions of wall, mitigate the damage due to tension and shear cracks.

Fig 2.16 (a) Vertical Reinforcement and Corner Stitch

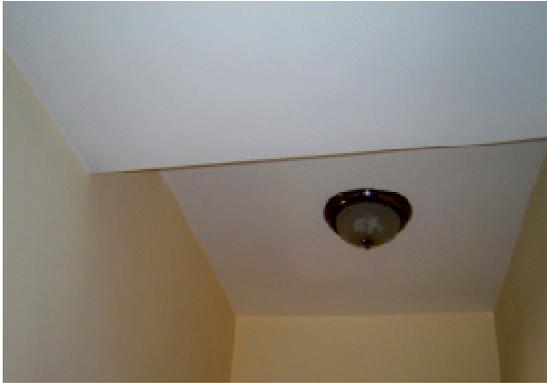
provided at the vertical offset of the diaphragm or on both sides of the expansion joint. Such a discontinuity may cause the diaphragm to function as a cantilever element or three-sided diaphragm. If the diaphragm is not supported on at least three sides by lateral-force-resisting elements, torsional forces in the diaphragm may cause it to become unstable.

Fig 2.17 (a) Drop in Floor Slab

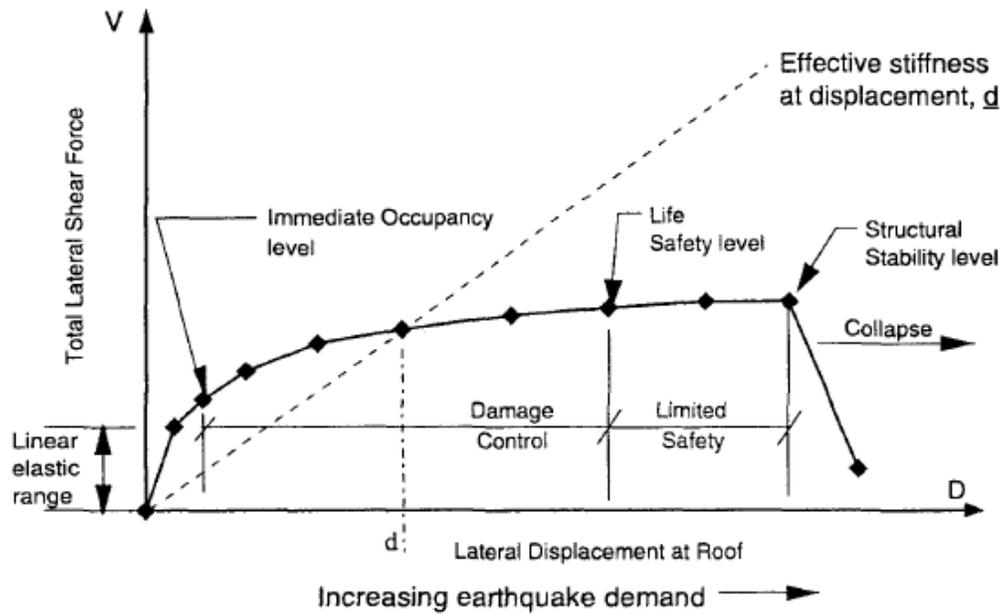
displacement capacity curve of the structure (i.e. Pushover) and compares it to the response spectra representations of the earthquake demand. It is a very useful tool in the evaluation and retrofit design of existing concrete buildings. The procedure help demonstrate how buildings really work by identifying modes of failure and the potential for progressive collapse. In order to provide reliable seismic performance, a building must have a complete lateral force resisting system, capable of limiting earthquake-induced lateral displacements to levels at which the damage sustained by the building’s element will be within acceptable levels for the intended performance objective as shown in fig below.

Fig 6.1.1 Typical Capacity Curve

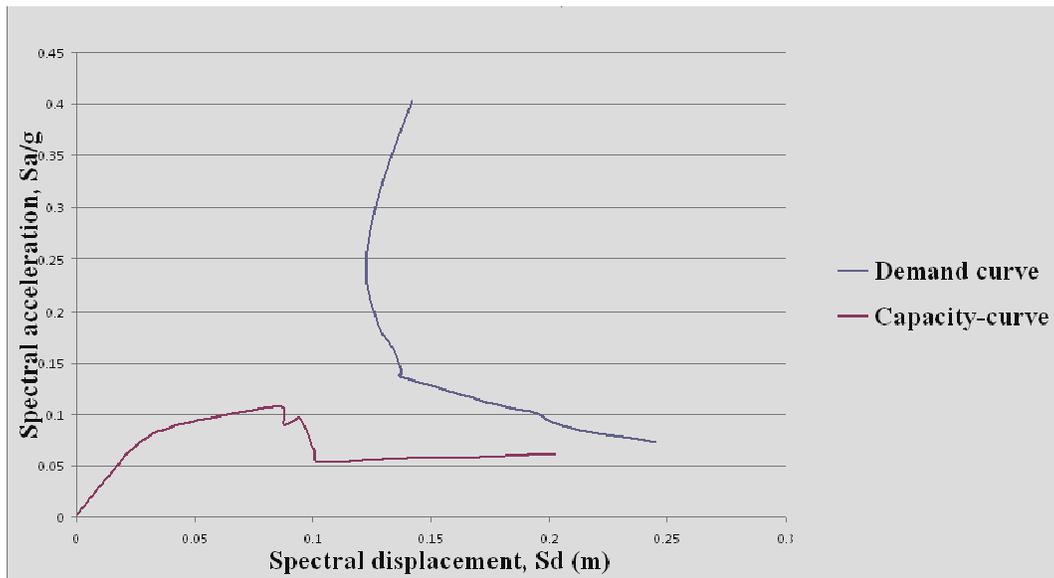
Capacity Spectrum i.e. spectral acceleration vs. Spectral displacement curve and Base Shear vs. Spectral displacement curve for the building is plotted as shown in Fig. below. Analysis results show that the capacity of the existing building does not meet the seismic demand of the region. Hence retrofitting is recommended for the building under consideration.

Fig 6.1.5 Capacity Spectrum (Comparison of Demand and Capacity Curve)

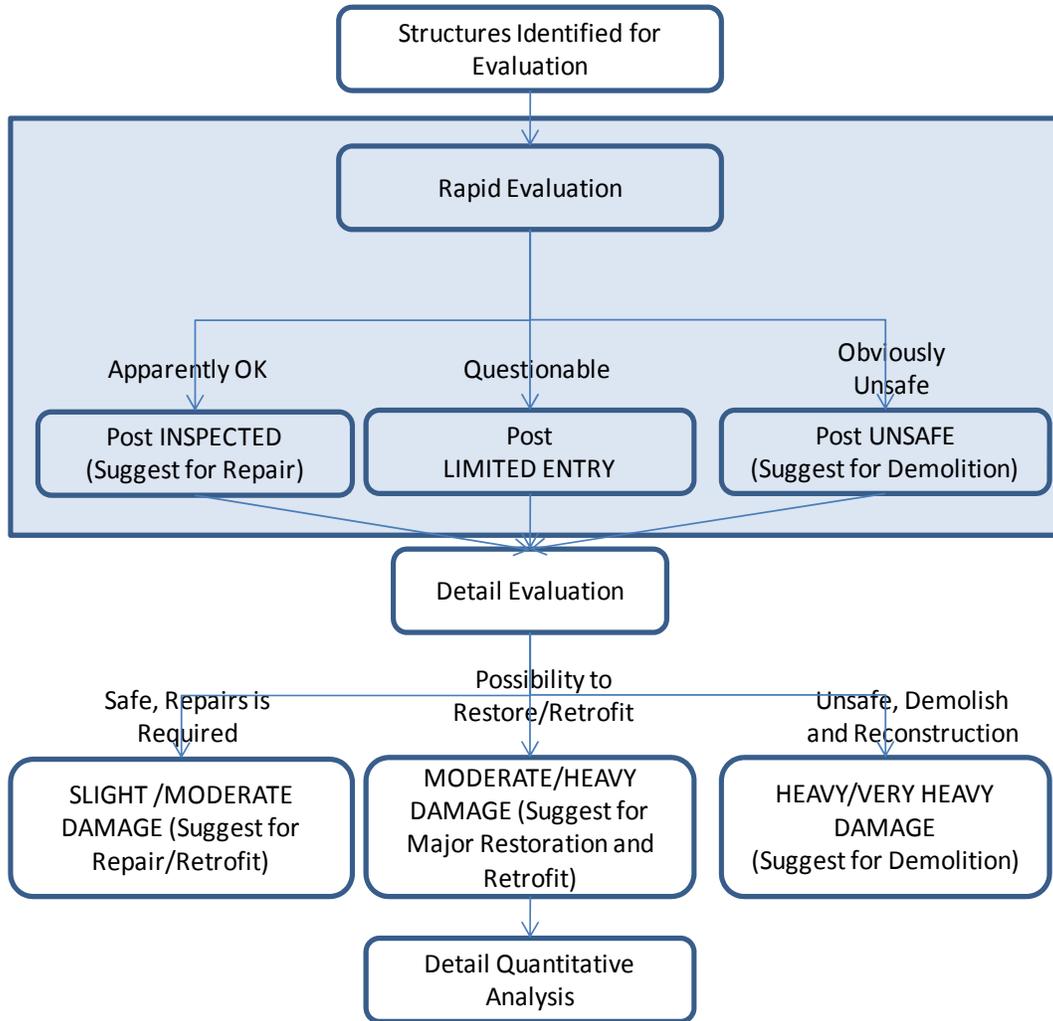
This system of overall safety evaluation of earthquake damaged buildings is based on experience of such assessment in Pakistan after *Kashmir* earthquake. The purpose of rapid evaluation is similar to ATC-20.

Figure 1: Flowchart showing damage assessment process

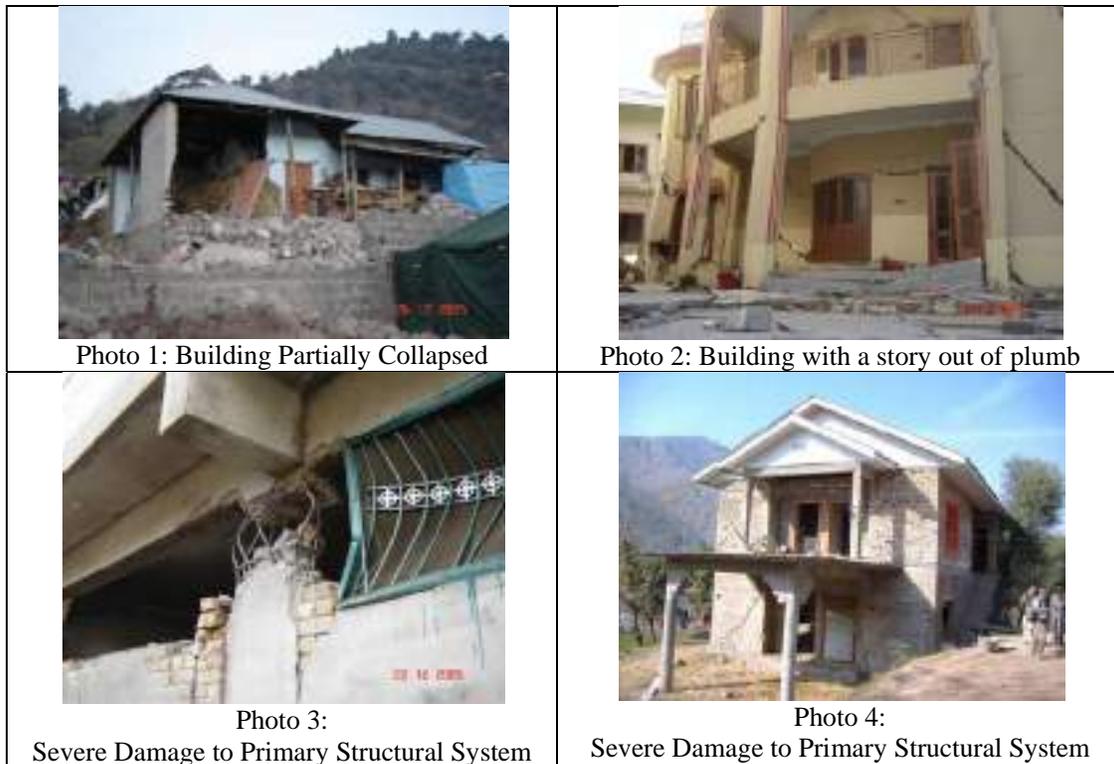
Photo 1-4 below show different types of damage resulting to unsafe building.

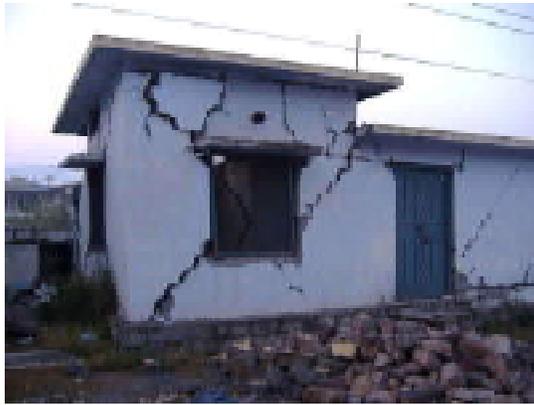
Photo7: Diagonal cracking of masonry piers starting from corner of openings

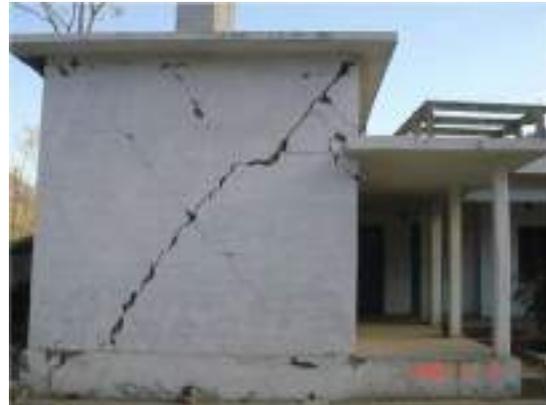
Photo 8: Diagonal cracking of solid wall

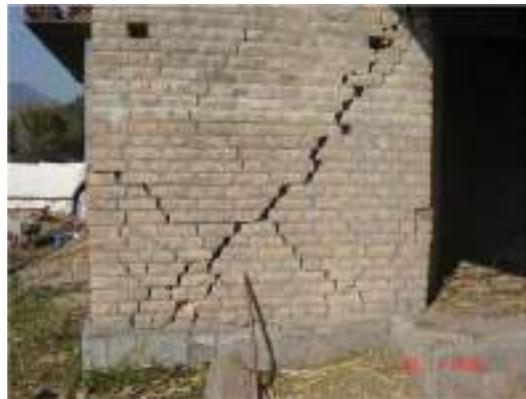
Photo 9: Diagonal cracking of solid wall (Bed joint sliding mode)

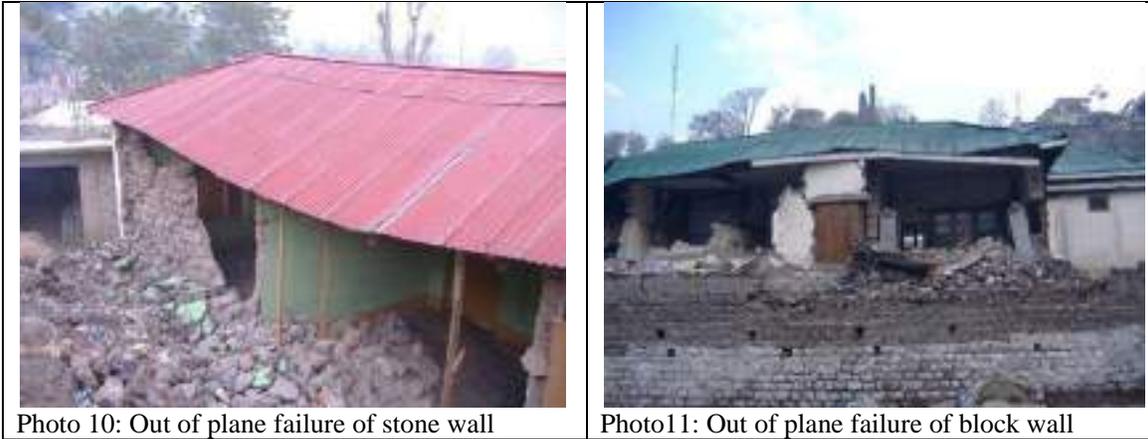
<p>Extreme</p>	<ol style="list-style-type: none"> 1. Vertical-load-carrying ability is threatened: <ul style="list-style-type: none"> • Significant out-of-plane or in-plane movement at top and bottom of piers "walking"). • Significant crushing/spalling of bricks at crack locations. 	<p>Replacement or enhancement required.</p>

Photo 10: Out of plane failure of stone wall

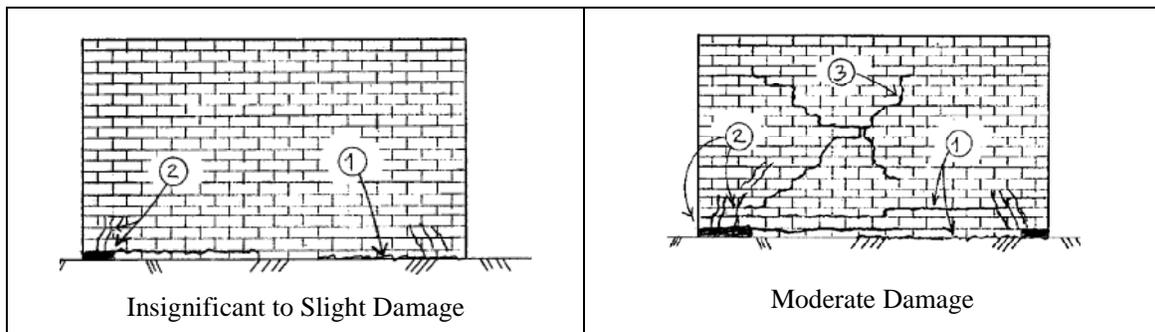
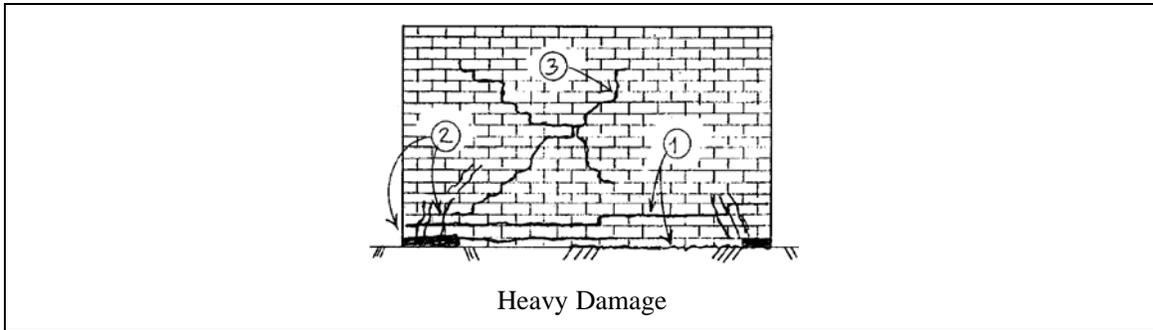
Figure 2: Illustrations on in-plane flexural failure of masonry wall (Flexural Cracking/Toe Crushing/Bed Joint Sliding Case)

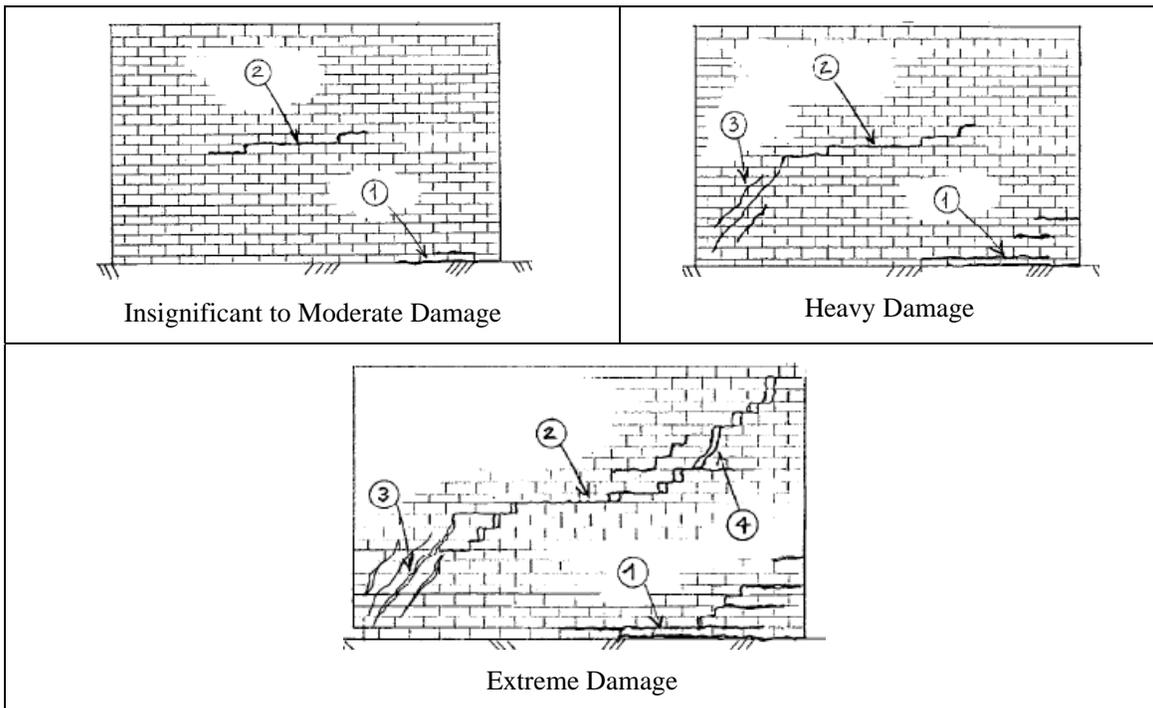
Fig 3: Illustrations on in-plane flexural failure of masonry wall (Flexural Cracking/Toe Crushing)

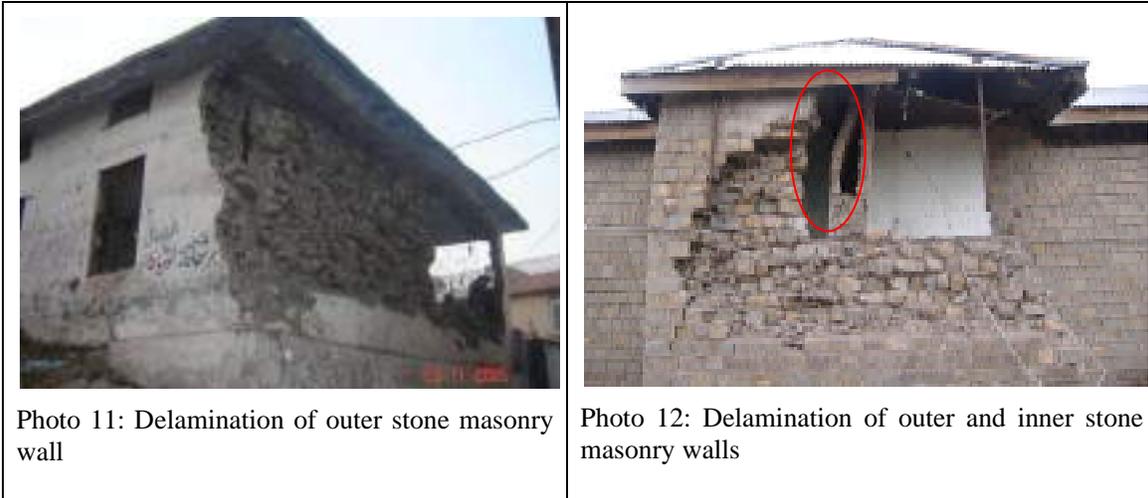
Delamination of two wyths of masonry walls is another type of damage. This type of damage can be tested by sounding test described in section 4.9.1. At the last stage of this type of damage one wyth of the wall get collapsed. Phot 11 and 12 show the delamination of walls during earthquakes.

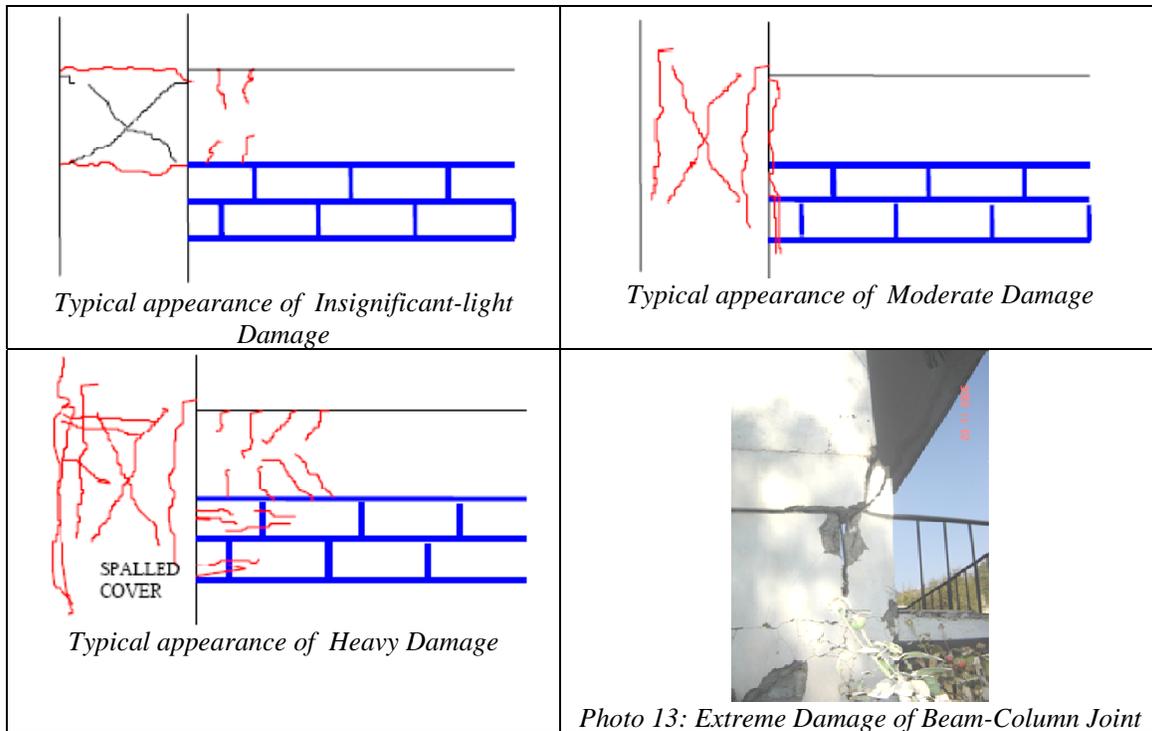
Illustrations and photographs of Beam-Column Joint damage are given below. Illustrations are from FEMA 306.

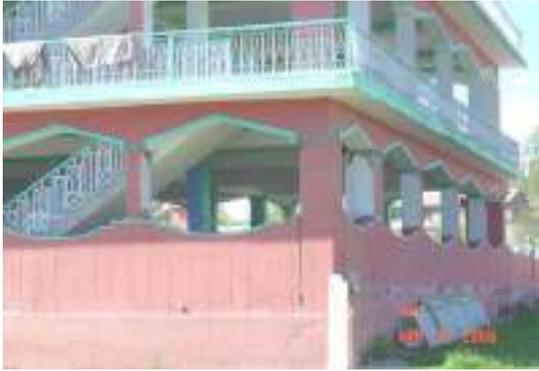
Photo 15: Slight-moderate damage

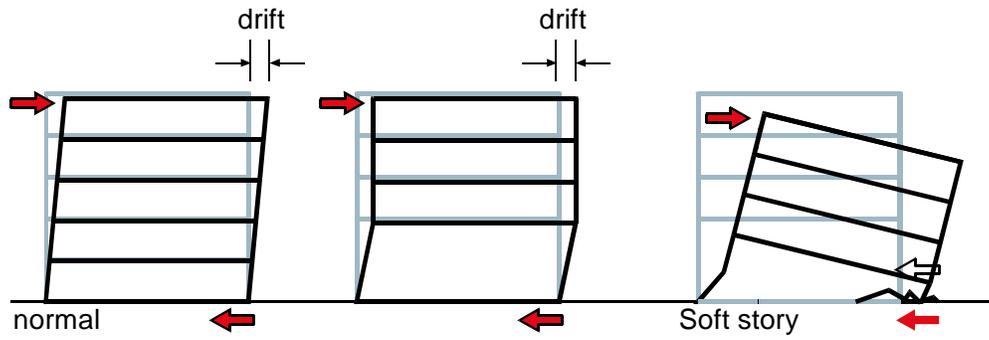
Figure 4: Soft-story failure mechanism

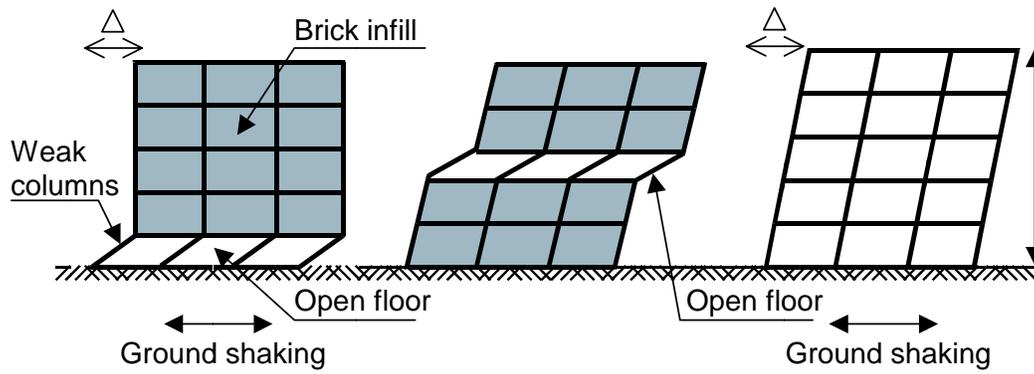
Figure 5: Soft-story failure in a building with masonry infill

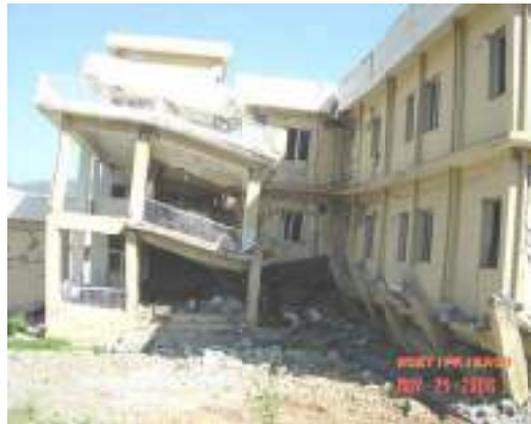
Photo 18: Earthquake damage due to soft story

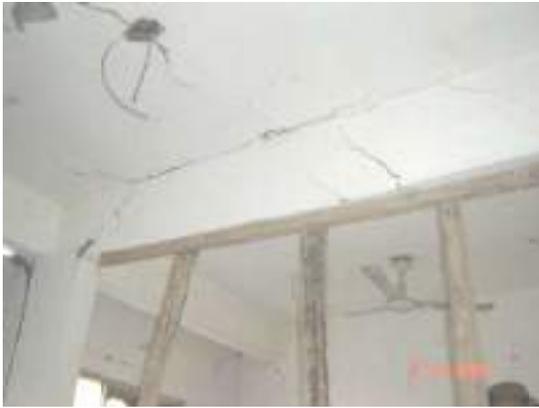
Photo 19: Shear cracks in beam near to support and at mid span

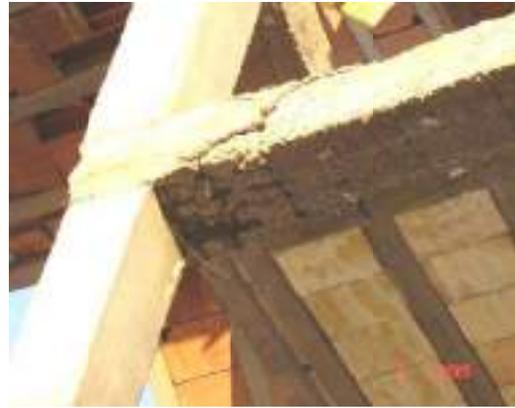
Photo 20: Shear crack in beam near to support

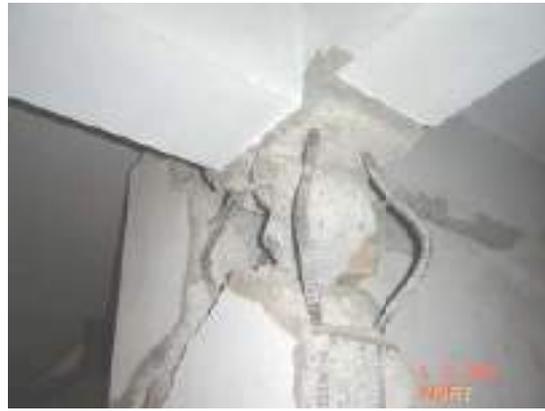
Photo 22: Buckling of column bars

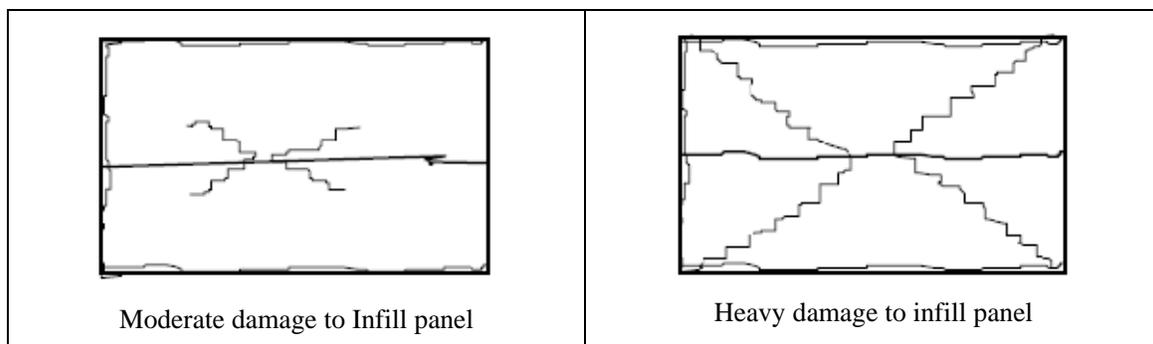
Figure 6: Illustration of infill panel damage.

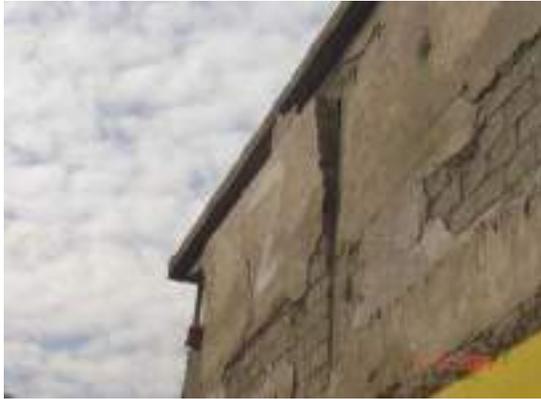
Photo 23: Moderate-Heavy Damage to Infill wall

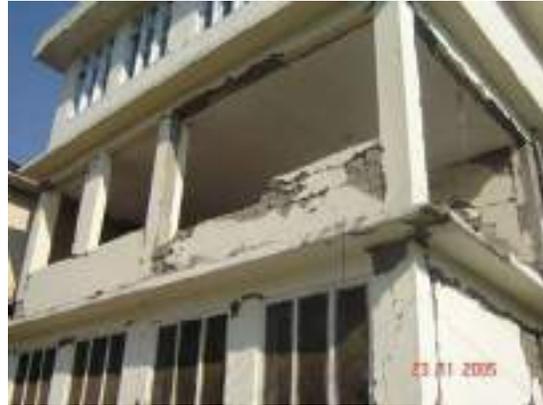
Photo 24: Extreme Damage to Infill wall

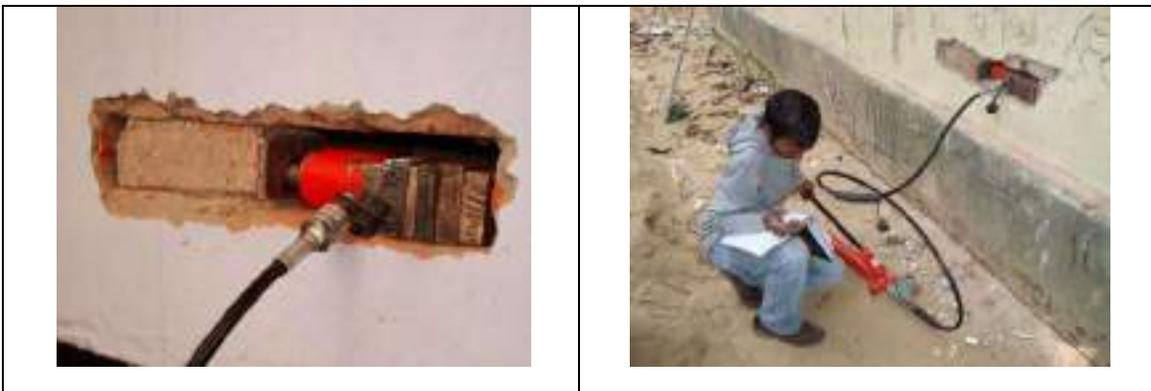
Photo 29-30: Test set up for In-situ Shear test

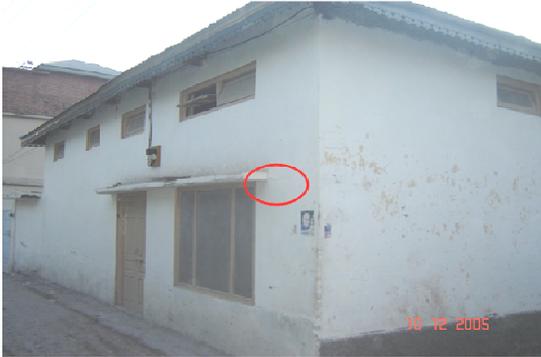
Thin cracks in plaster, falling of plaster bits in limited parts, fall of loose stone from upper part of building in rare cases	Building need not be vacated, only architectural repairs needed, Seismic strengthening advised

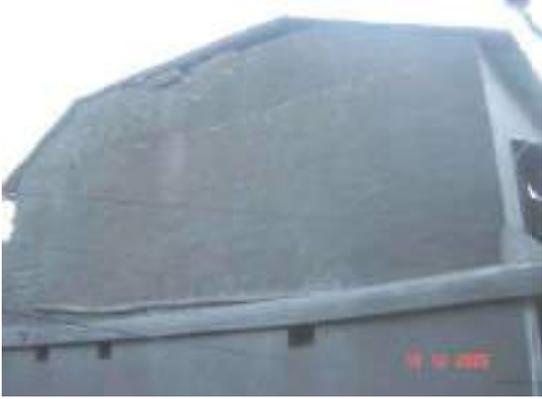
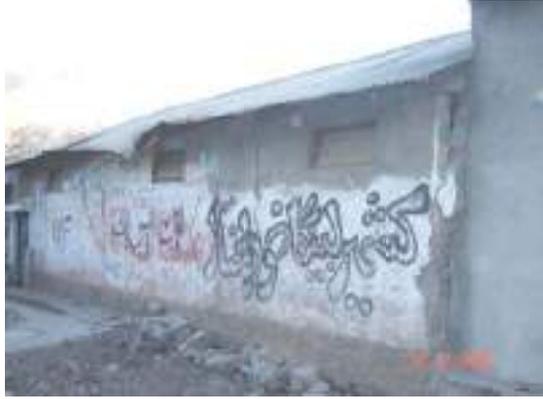
Thin cracks in many walls, falling of plaster in last bits over large area, damage to non-structural parts like chimney, projecting cornices; The load carrying capacity s not reduced appreciably.	Architecture repairs needed, Seismic strengthening advised.

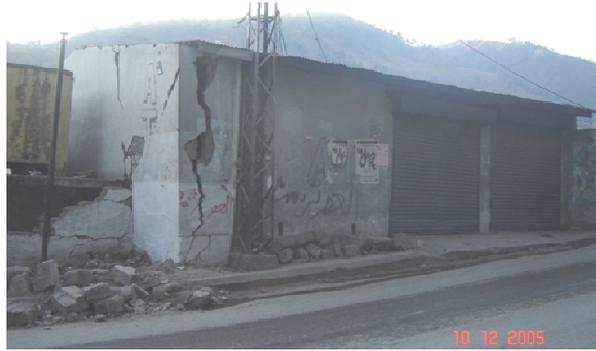
Large and extensive cracks in most walls, roof tiles detach, tilting or falling of chimneys, failure of individual non-structural elements such as partition/ gable walls. Load carrying capacity of structure is partially reduced.

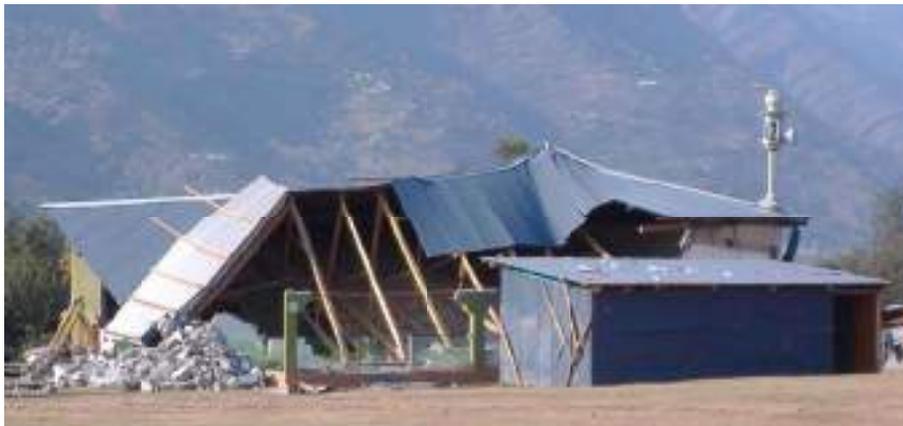
Gaps occur in walls, walls collapse, partial structural failure of floor/ roof, Building takes a dangers state.

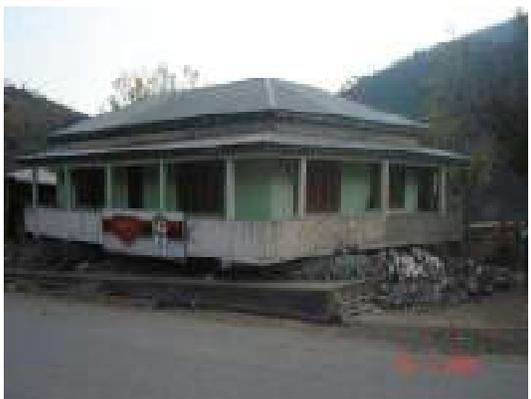
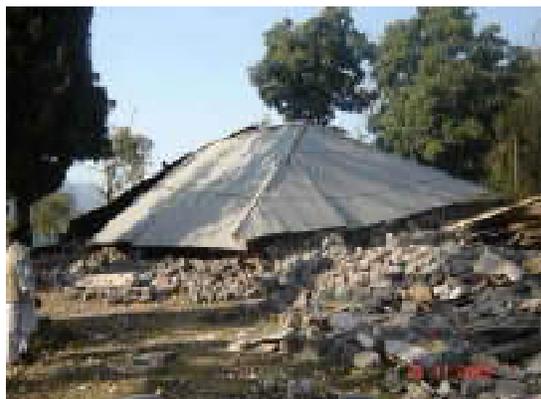
<p>Total or near total collapse</p>	<p>Clear the site and reconstruction</p>

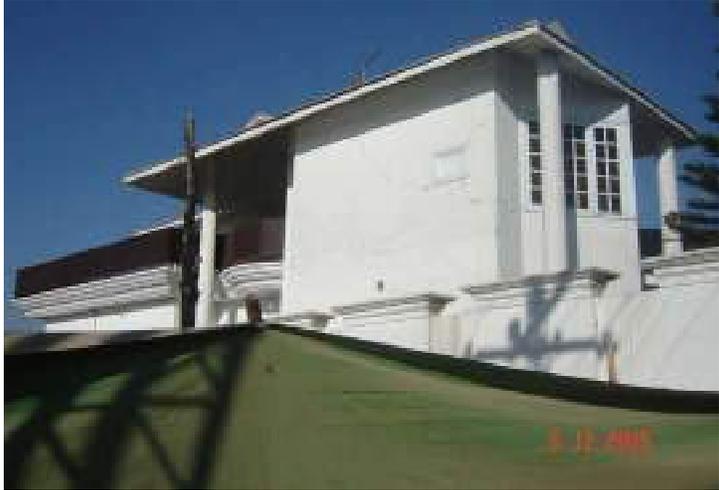
<p>Thin cracks in plaster, falling of plaster bits in limited parts, fall of loose stone from upper part of building in rare cases</p>	<p>Building need not be vacated, only architectural repairs needed, Seismic strengthening advised</p>

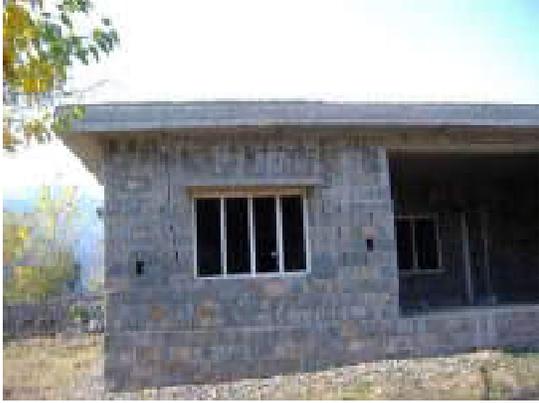
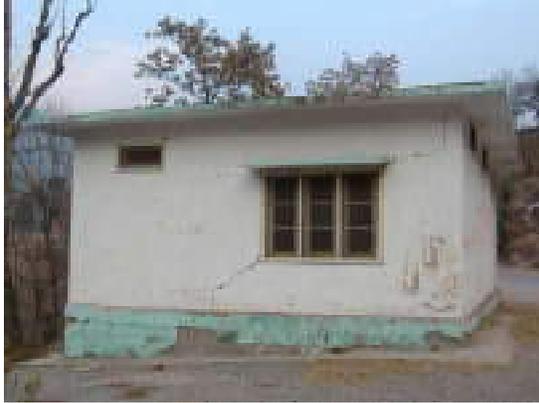
<p>Thin cracks in many walls, falling of plaster in last bits over large area, damage to non-structural parts like chimney, projecting cornices; The load carrying capacity is not reduced appreciably.</p>	<p>Architecture repairs needed, Seismic strengthening advised.</p>

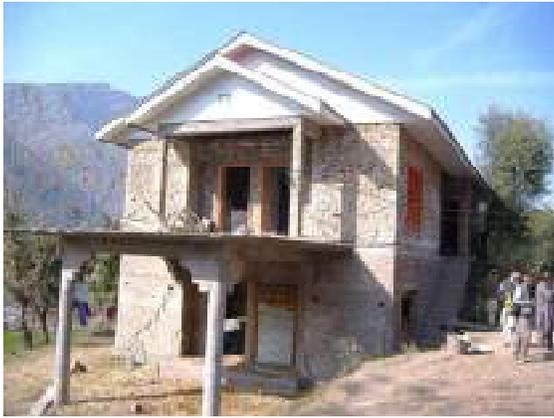
<p>Large and extensive cracks in most walls, roof tiles detach, tilting or falling of chimneys, failure of individual non-structural elements such as partition/ gable walls. Load carrying capacity of structure is partially reduced.</p>	<p>Cracks in wall need grouting, architectural repairs required, Seismic strengthening advised</p>

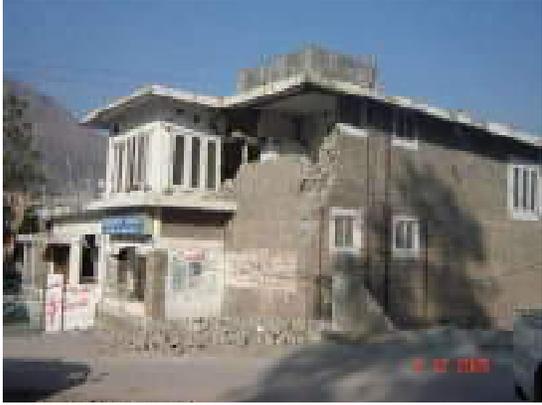
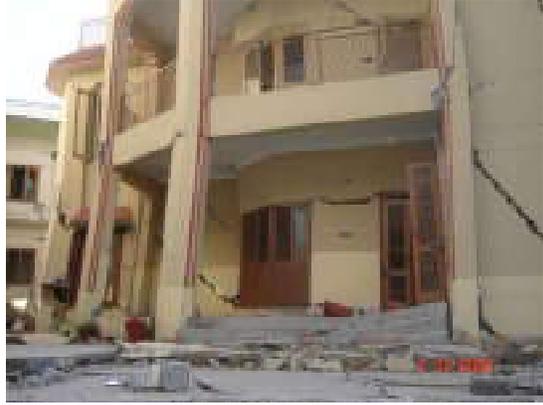
<p>Gaps occur in walls, walls collapse, partial structural failure of floor/ roof, Building takes a dangers state.</p>	<p>Vacate the building, demolish and construct or extensive restoration and strengthening</p>

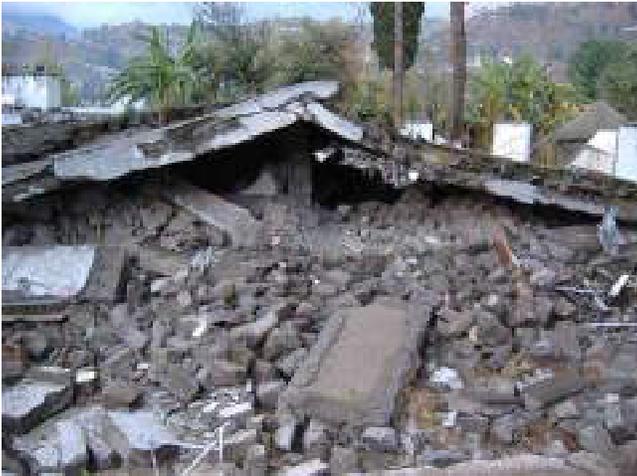
<p>Total or near total collapse</p>	<p>Clear the site and reconstruction</p>
