Government of Nepal
Ministry of Physical Planning and Works
Department of Urban Development and Building Construction
**Earthquake Risk Reduction and Recovery
Preparedness Programme for Nepal**

SEISMIC VULNERABILITY EVALUATION GUIDELINE FOR PRIVATE AND PUBLIC BUILDINGS

May 2011

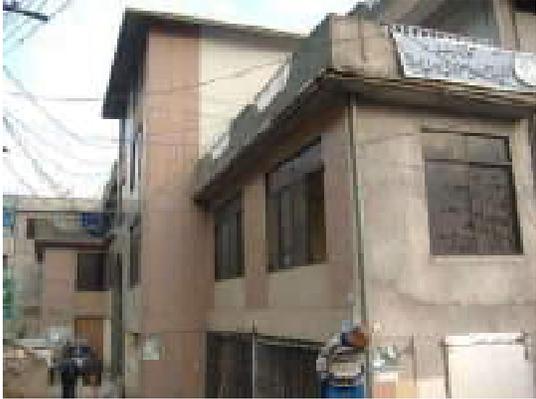
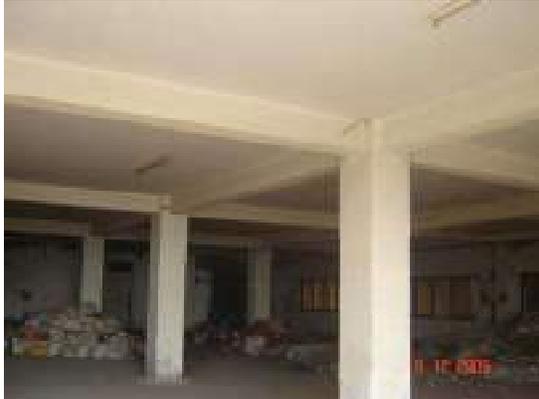
<p>Fine cracks in plaster over frame members or in walls at the base, Fine cracks in partitions and infill</p>	<p>Building need not be vacated, only architectural repairs needed, Seismic strengthening advised.</p>

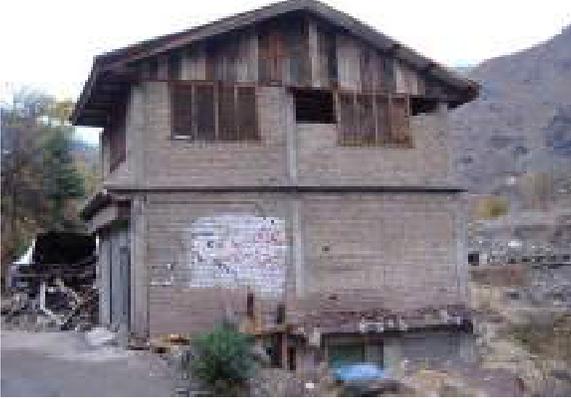
<p>Cracks in columns and beams of frame and in structural walls, Cracks in partition and infill walls, fall of brittle plaster and cladding, falling mortar from joints of wall panel</p>	<p>Architecture repairs needed, Seismic strengthening advised.</p>
---	---	--

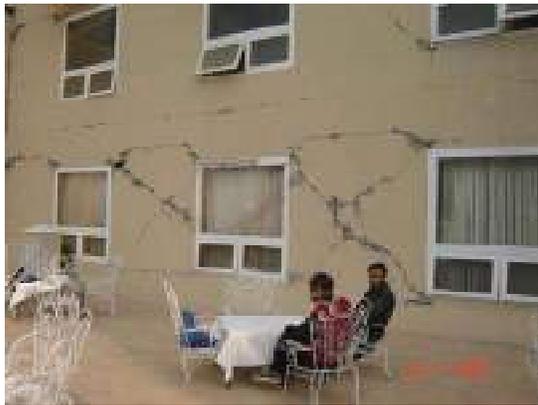
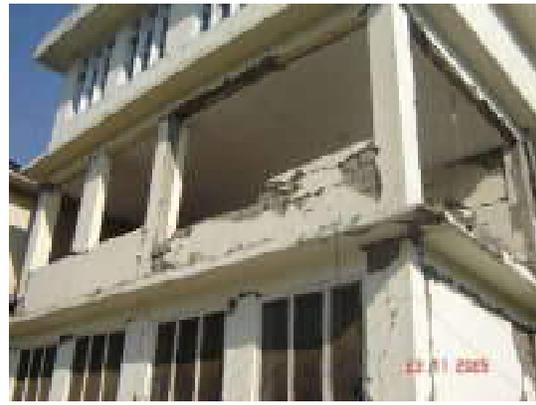
Cracks in column and beam at the base, spalling of concrete covers, buckling of steel bars, Large cracks in partitions and infill walls, failure of individual infill panels

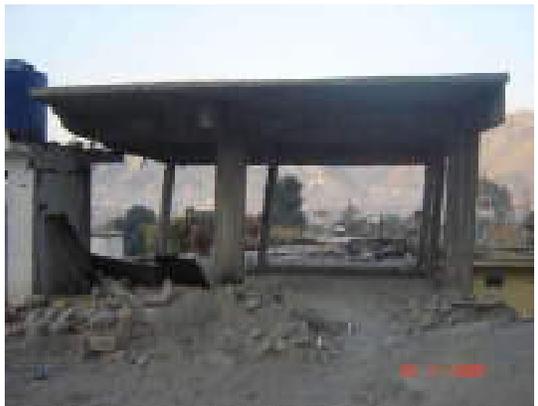
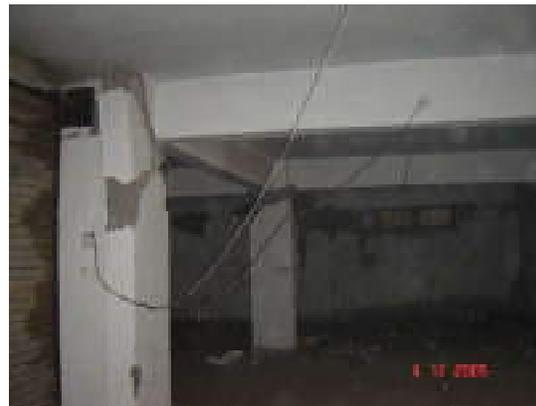
Large cracks in structural elements with compression failure of concrete and fracture of rebars, bond failure of beam bars, tilting of columns, collapse of few columns or single upper floor

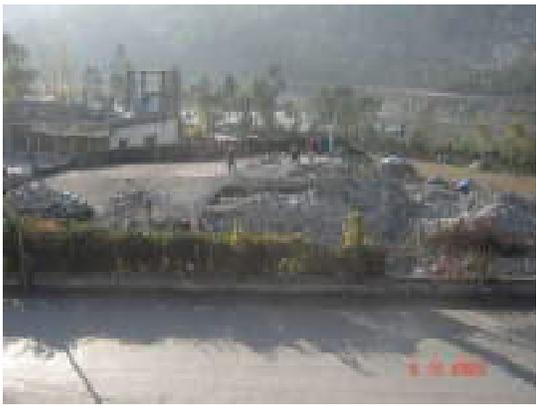
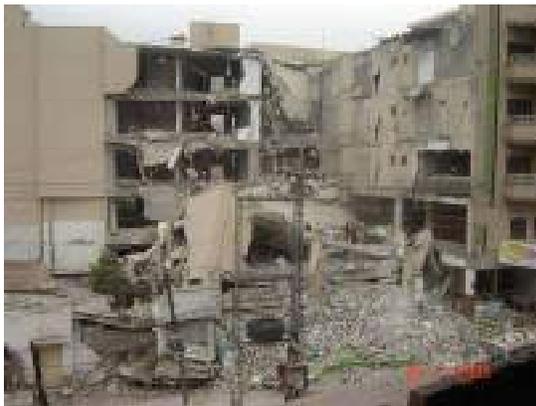
<p>Collapse of ground floor or parts of the building</p>	<p>Clear the site and reconstruction</p>
